Issues in SuperKEKB Phase 2 Operation

Y. Funakoshi for the SuperKEKB commissioning team

Accelerator Laboratory, KEK

2018.10.15@B2GM

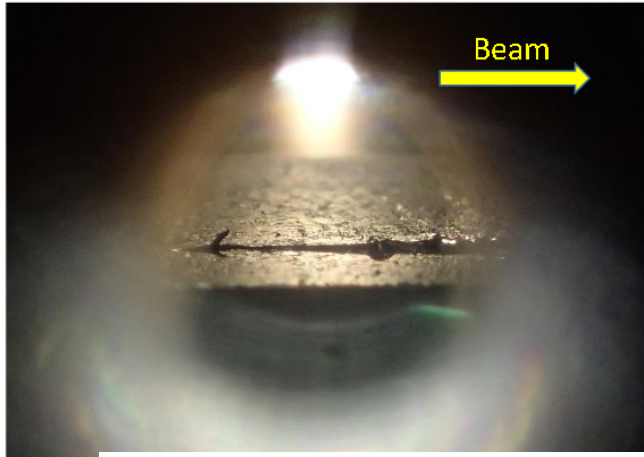
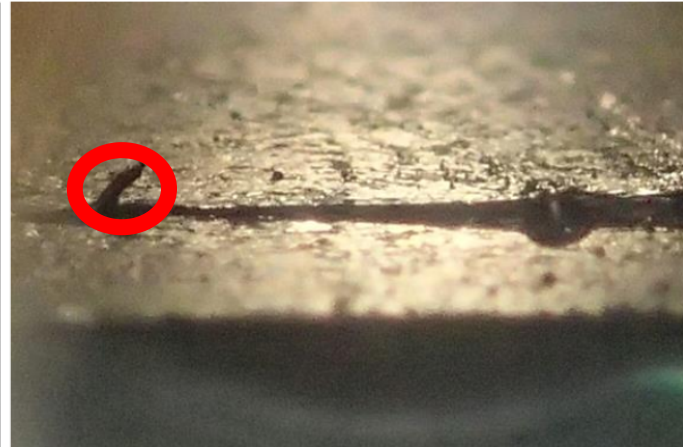
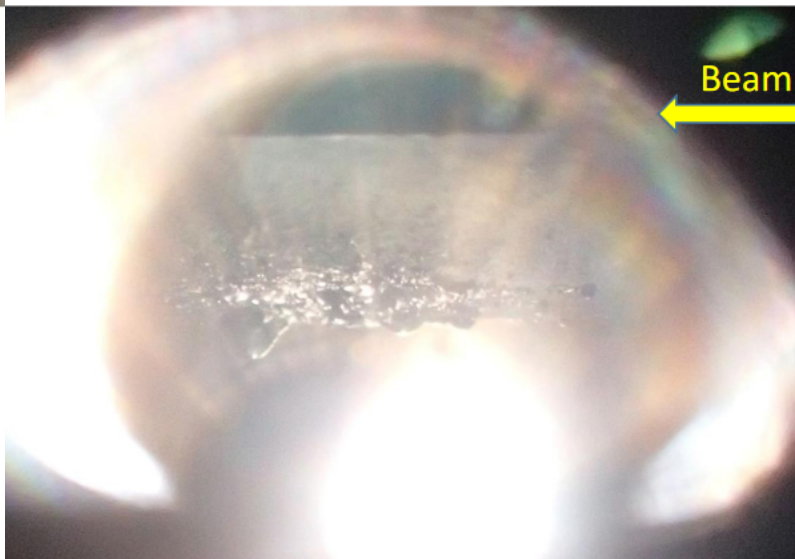
Damage of collimator (LER D02V1)

Beam hit bottom of collimator.
Sputtered material (W) stuck to top?

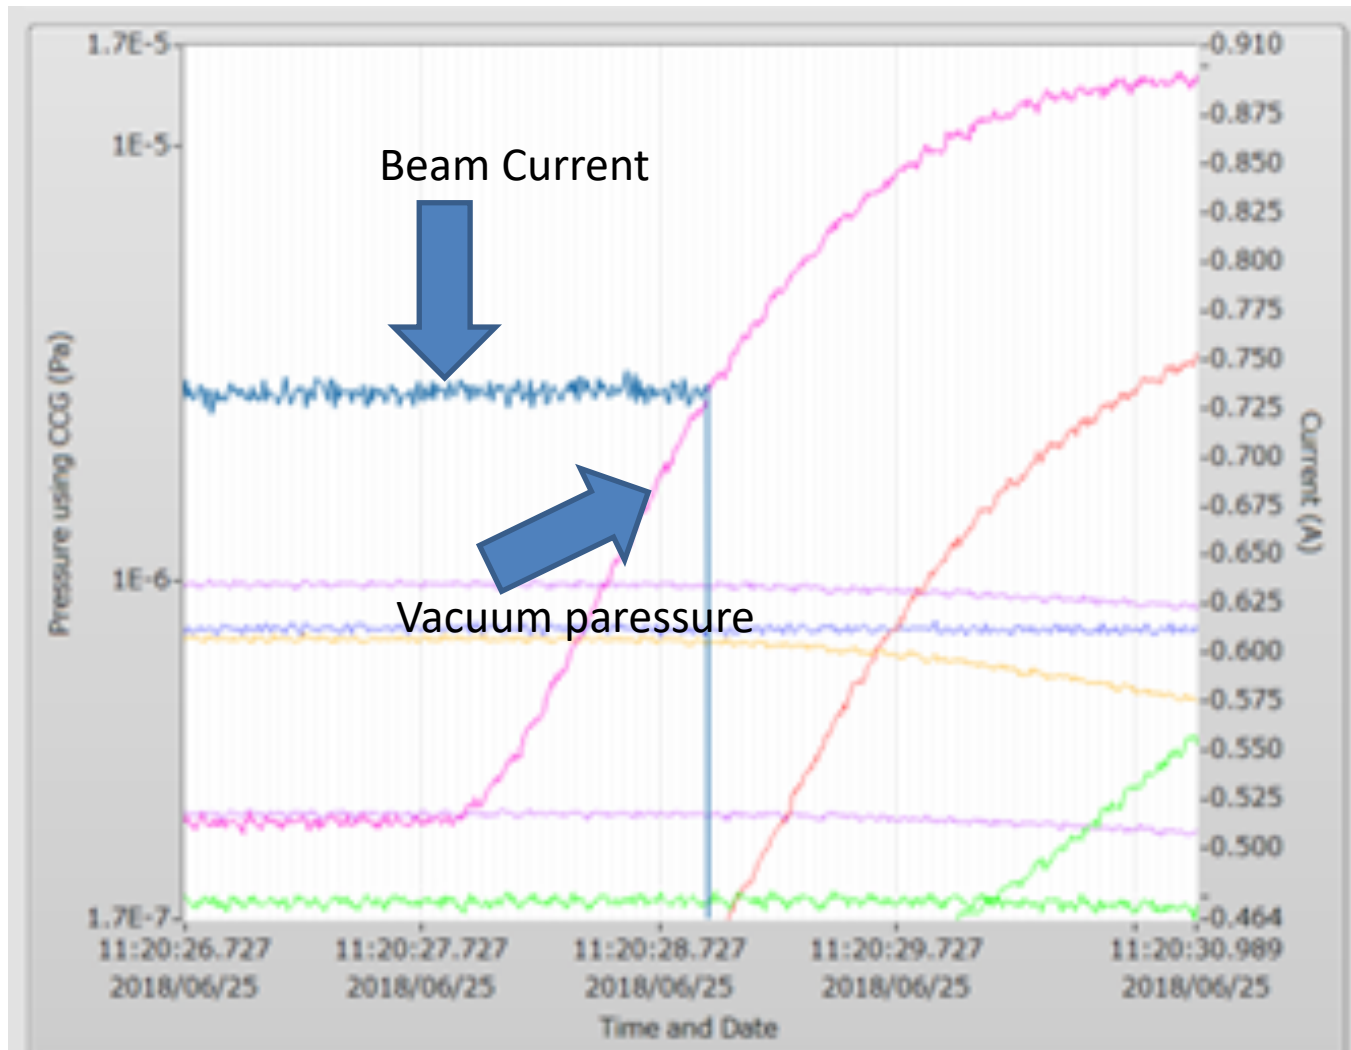
Vacuum burst when collimator was damaged

Date	Time	Quenched Magnet	Beam Line	Causes	Injection/storage
2018/6/25	11:20	QC1RP	LER	D02V1 collimator was damaged. At this moment, a big beam loss (~100mA) was induced. A vacuum burst was observed.	Storage (728mA)
		QC1RP-b1			
		QC1LP			
2018/7/3	5:14	QC1RP-b1	LER	Continuous bad injection?	Injection
2018/7/9	11:20	QC1LE	HER	D01V1 collimator was damaged. At this moment, a big beam loss (~100mA) was induced. A vacuum burst was observed.	Storage(766mA)
		QC1LE-b1			
		QCSL Cancel			
2018/7/15	22:32	QC1RP	LER	LER QCS quench happened first due to longitudinal instability. A vacuum burst was observed. LER QCS quench induced HER beam loss and HER QCS quench.	Storage (LER: 793mA)
		QC1LE	HER		
		QC1LE-b1			
		QCSL Cancel			
2018/7/16	17:53	QC1LE-b1	HER	A vacuum burst at D02H collimator was observed.	Storage (HER: 670mA)
		QCS Cancel

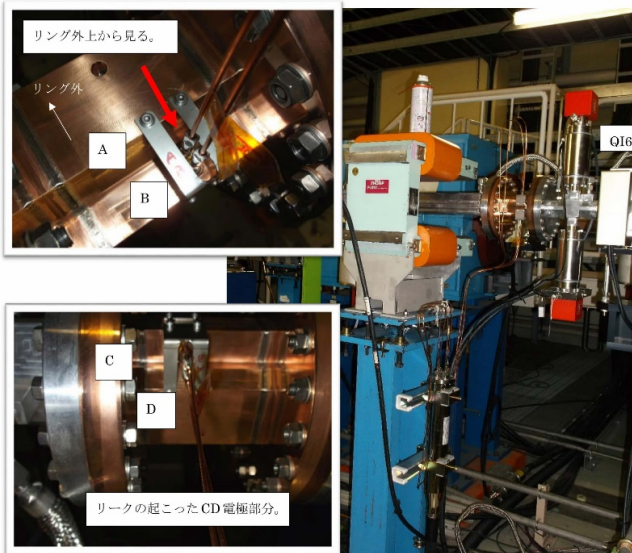
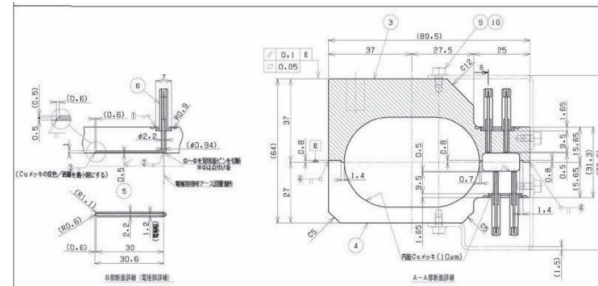
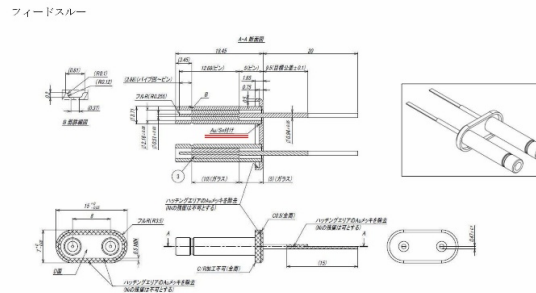
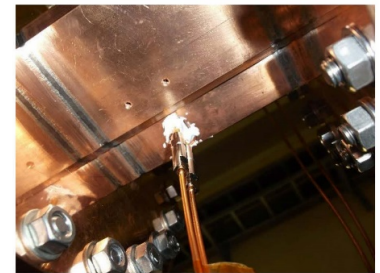
リーク場所: D7LER 入射点モニター (Q16Pの隣)

- LER入射部入射点BPMのフィードスルーろう付部からリーク。
 - 3月28日(水)、トールシールで対処した。

- 入射部入射点BPMの信号はPhase-2後半常時モニターできるようになった(モニターグループ)。
- 運転(入射調整)に有効そうなので再製作、交換を検討中。フィードスルーの構造は変更する。

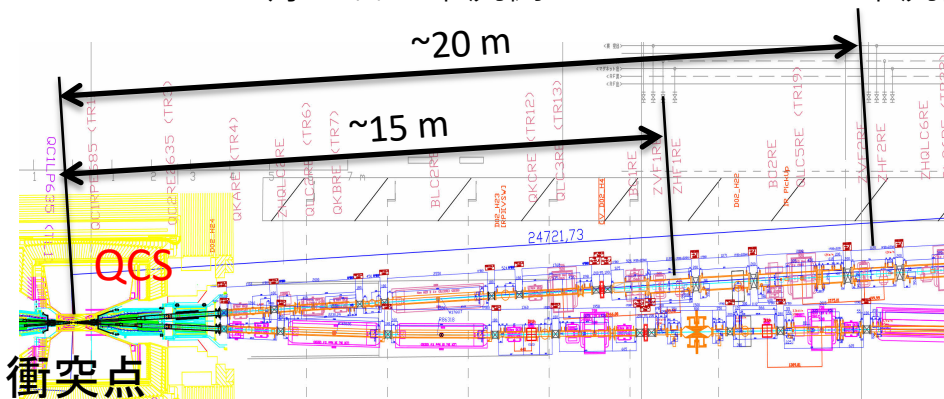
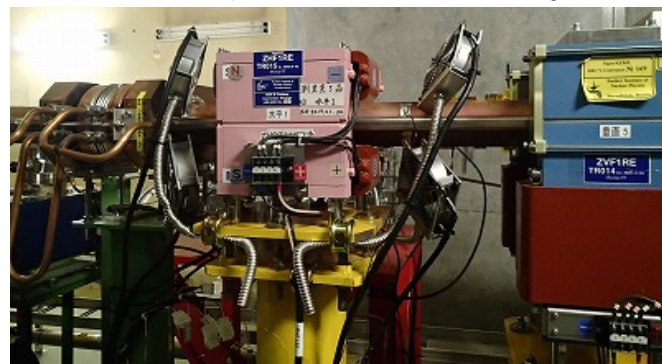
- HER衝突点部下流のステンレス製ビームパイプの発熱、リーク
 - 衝突点部の最終収束超伝導電磁石から発生するシンクロトロン放射光が、下流15~20 mにあるステンレス製ビームパイプに当たり発熱。
 - **ステンレスフランジとクロム銅フランジ接続部で3回大気リーク。**
 - 5月11日：上流側SUSチェンバーの下流側フランジからリーク。増し締め+バックシール。チェンバーをリング外側にシフト。
 - 6月29日：下流側SUSチェンバーの下流側フランジからリーク。増し締め+バックシール。
 - 7月14日：下流側SUSチェンバーの下流側フランジからリーク。ガスケット交換。

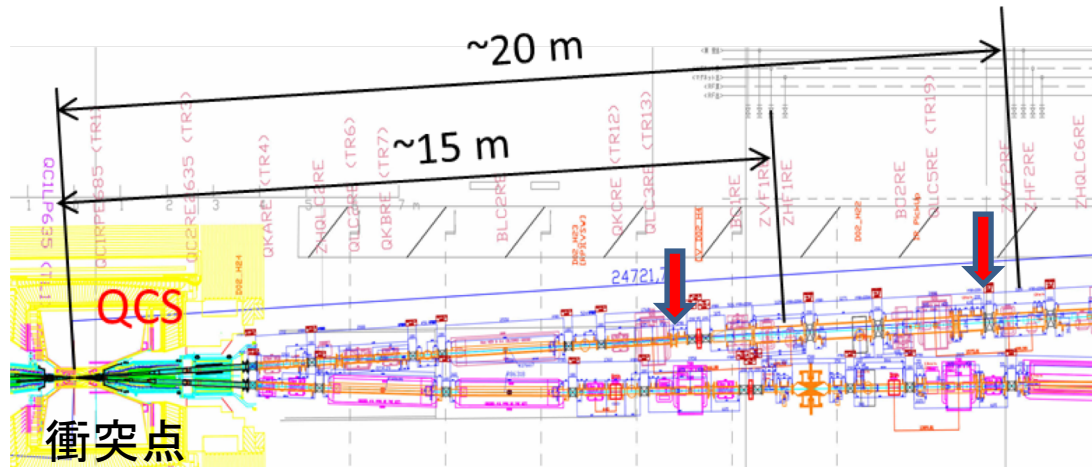
- HER衝突点部下流のステンレス製ビームパイプの発熱、リーク
 - 衝突点部の最終収束超伝導電磁石から発生するシンクロトロン放射光が、下流15~20 mにあるステンレス製ビームパイプに当たり発熱。
 - ビームが四極電磁石の中心を通過していないため放射光が発生。
 - 1 mmずれた軌道の場合、1mradの角度に照射される放射光パワーは約40 W(@300 mA)。ステンレスパイプを局所的に温めるには十分。
 - BLC2REの接線よりも外側にある。ビームチャンネル部に照射されている。
 - 測定していた温度はせいぜい50°C程度。材質(線膨張率)が異なるフランジ部での熱サイクルが問題か。
- 対応策：上流側2か所に放射光マスクを設ける。
- フランジをクロム銅にしたビームパイプに変更することも検討中。

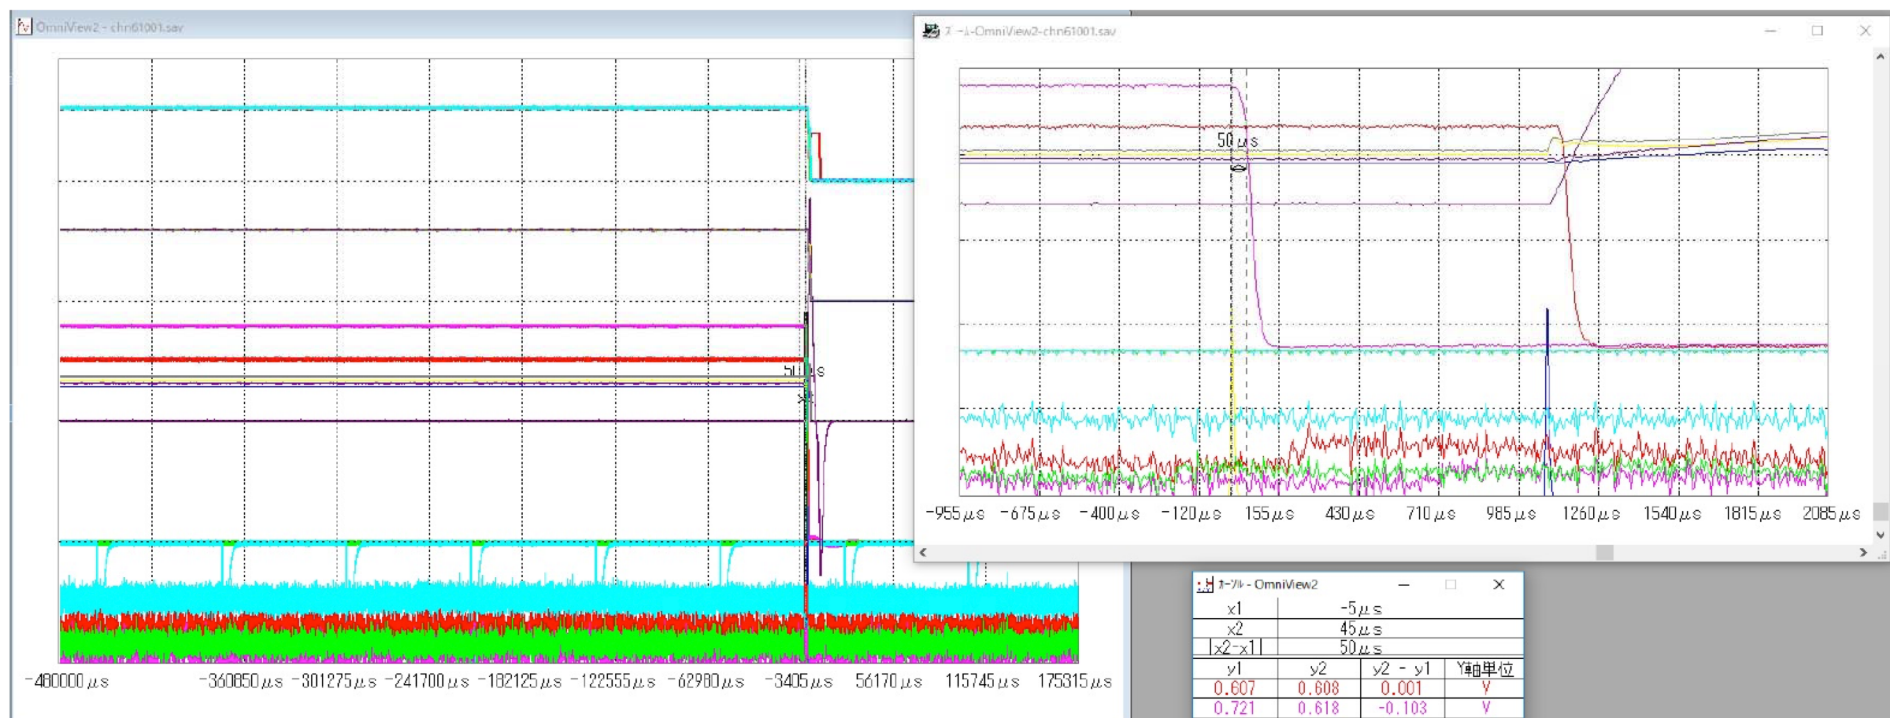
- 6/25 (D2 collimator LM Abort)
 大きなbeam loss ($\sim 100\text{mA}$) があって、一瞬でD2直線部にbeamをばらまいた。
 その時に、LMやQCSに同時にbeamが入って、abort&クエンチを引き起こした。
 Abort時に急に信号が出ていて、その前後で特に高くなっていた様子はない。
 入射タイミングとは非同期

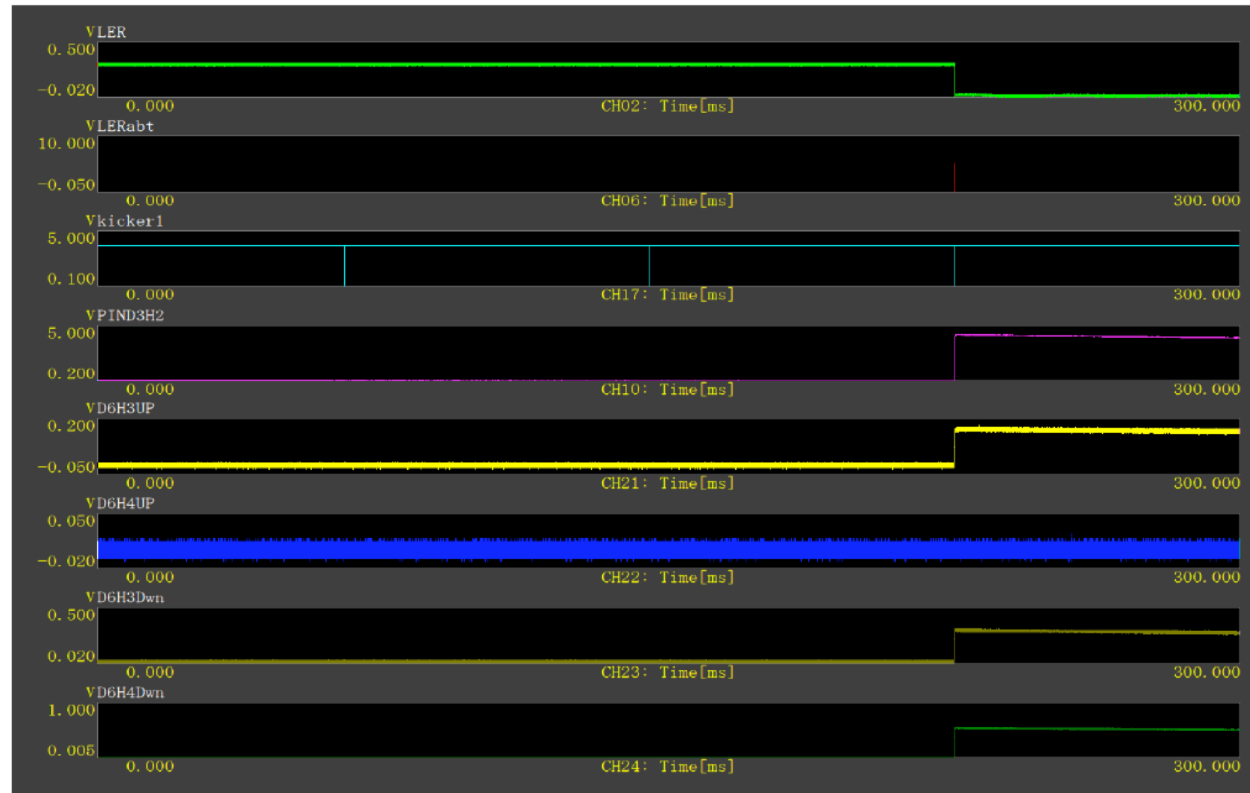
7/3(D2V1collimator LM Abort)

- 大きなbeam lossは見られない.
- LM信号が数秒前から上昇、~1s前からQCS coil voltage 変動.
- Abort は入射信号に同期.
- 入射ビームがQCS, collimatorに違うタイミングでぶつかった

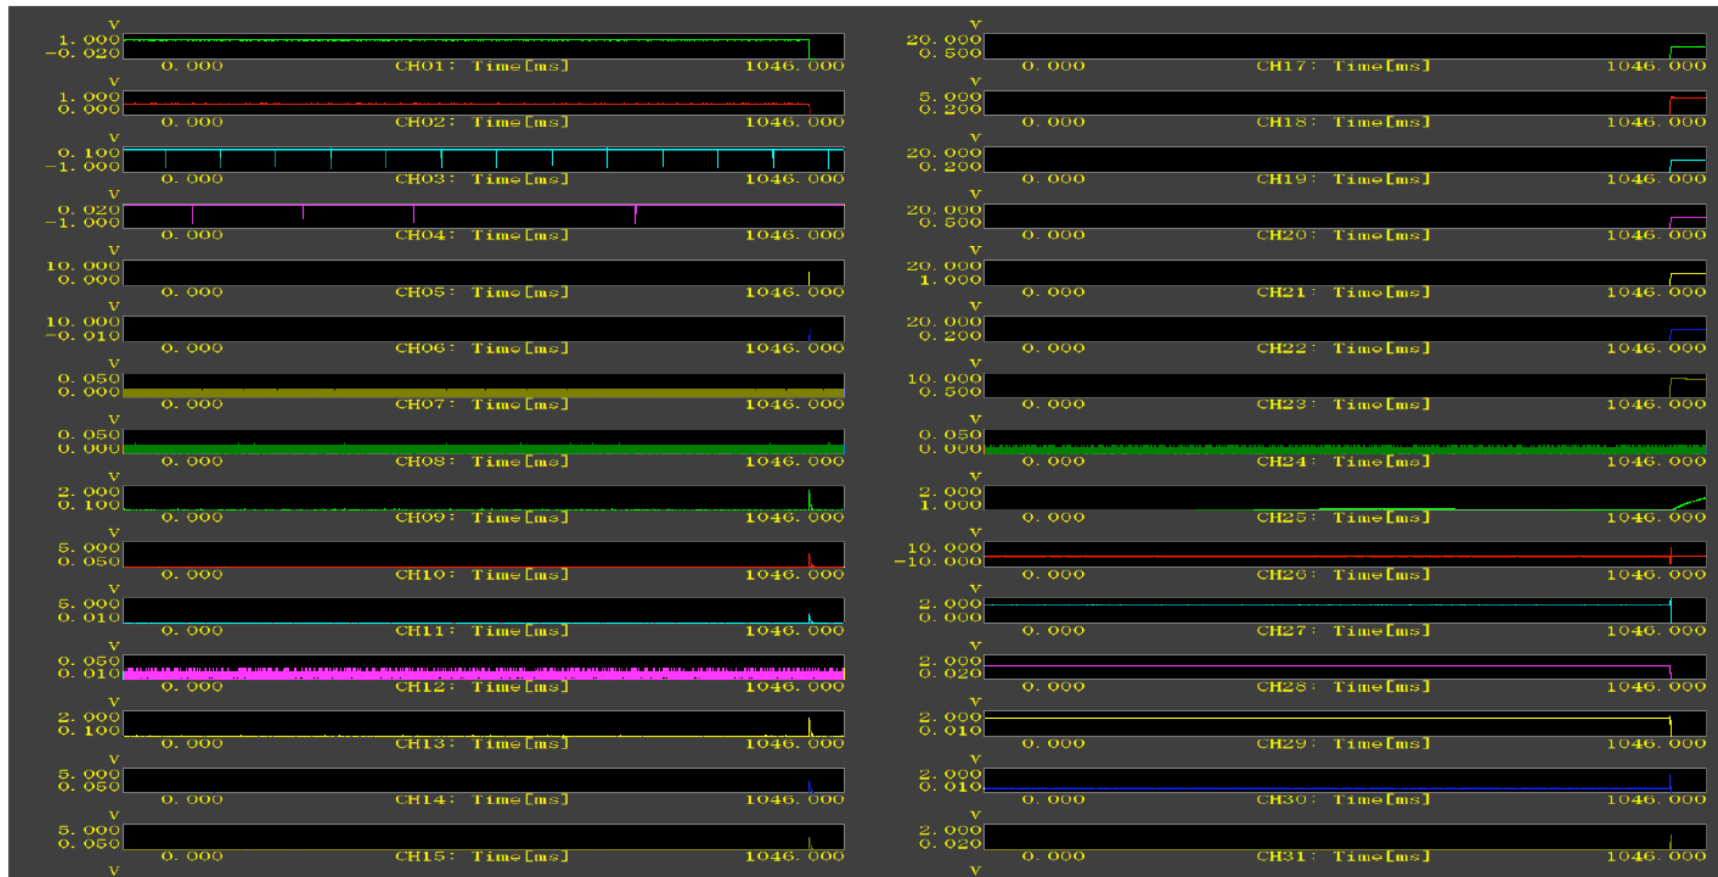
7/9

D12 collimator, D1 collimator, D1V1 collimator 下流のケーブルラックに付いたICの順でAbort trigger発報、両リングAbort
大きなbeam loss (~100mA) があって、一瞬でD1直線部にbeamをばらまいた。
その時に、LMやQCSに同時にbeamが入って、abort&クエンチを引き起こした。

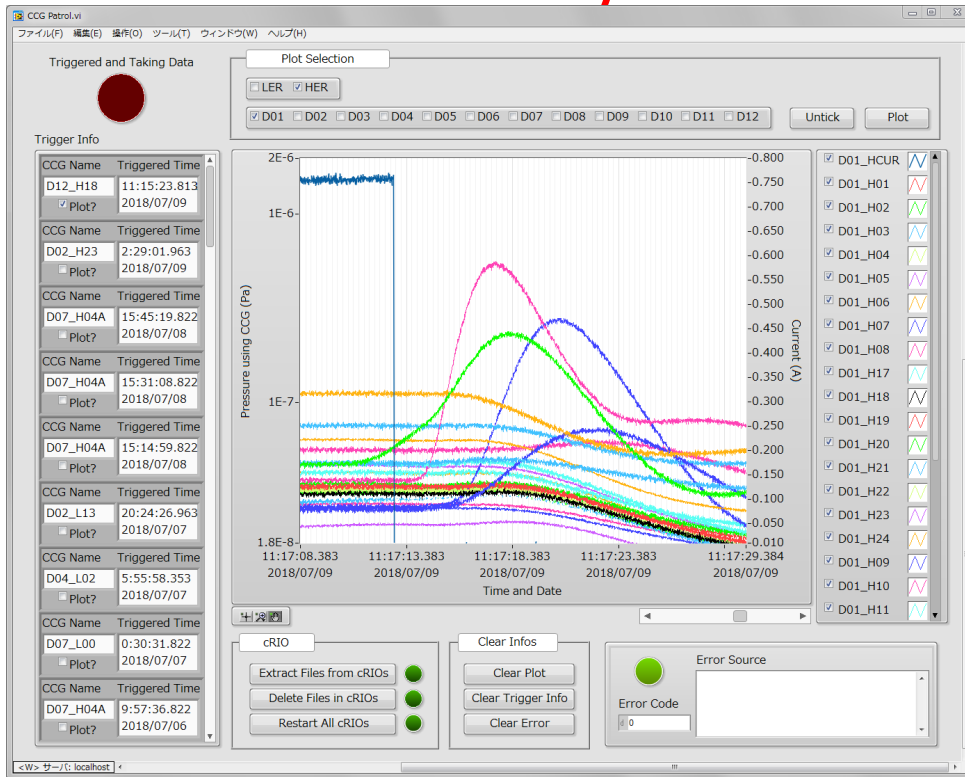
- D01_V1コリメータ部で圧力のバースト ($\sim 1E-6$ Pa)
- 下流のD01_H4コリメータ付近のイオンチェンバーも反応している。
- ヘッドにビームが衝突したか。

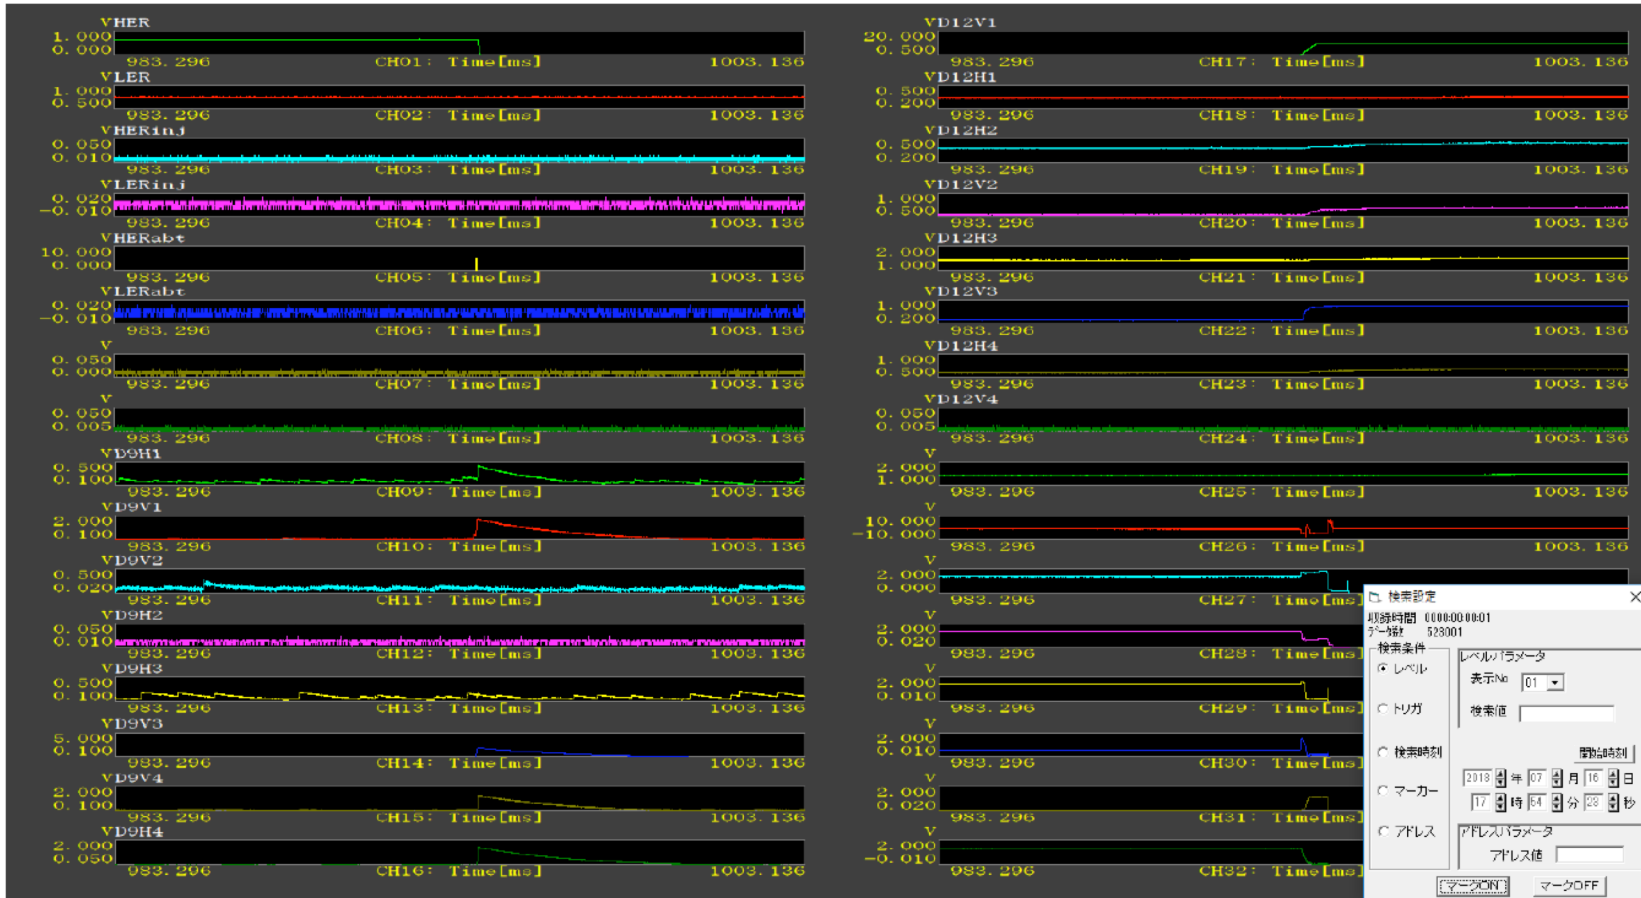
7/16

D1 collimator(HER) D12 collimator(HER)の順に発報。D9コリメータ部PINも鳴っている。
入射中ではない。
大きなビームロス無し。
