# The Fault Diagnosis of Event Timing System in SuperKEKB

KEK

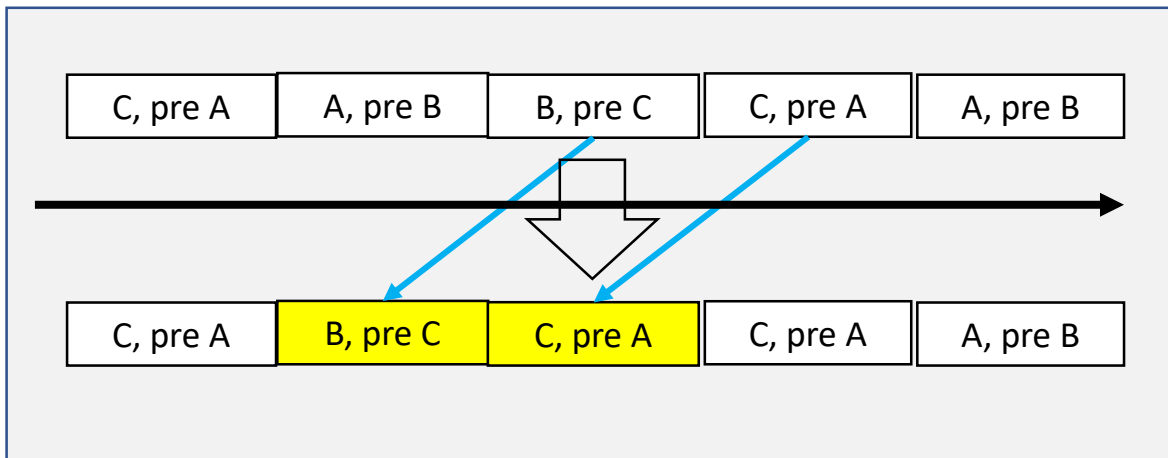
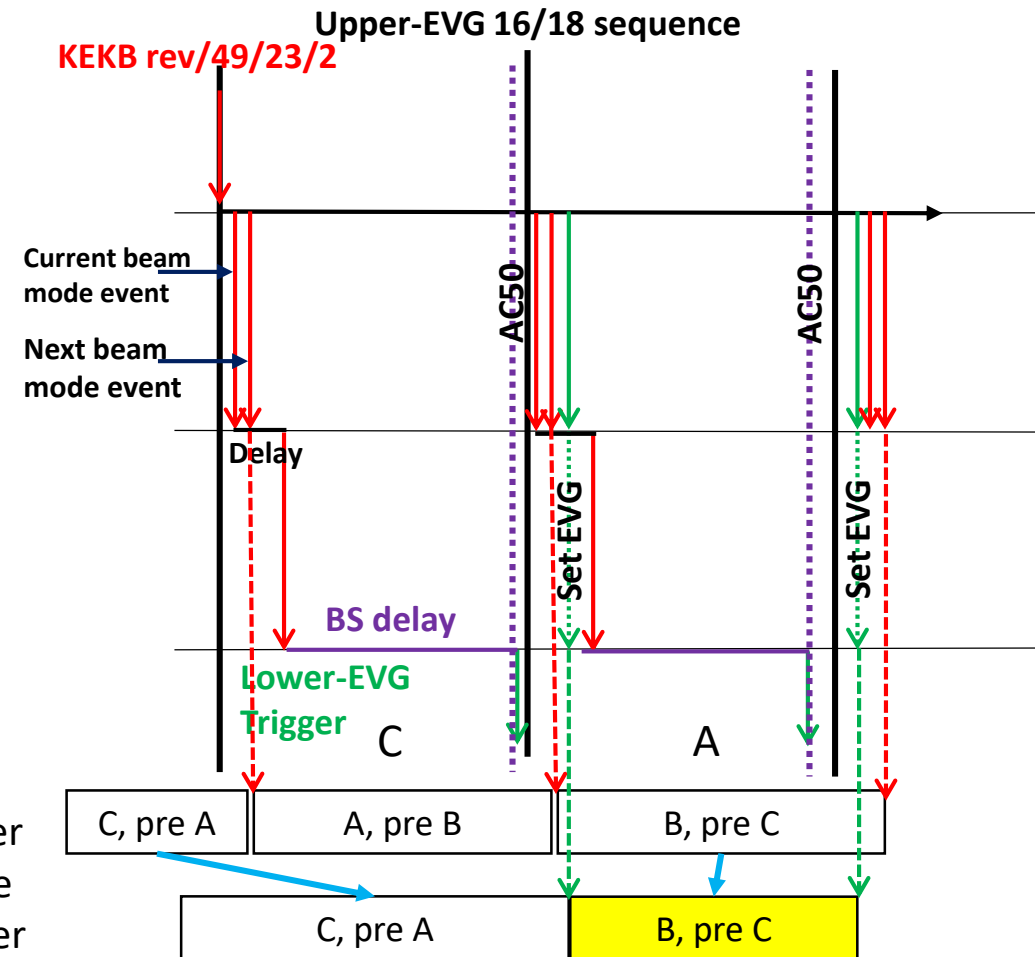
# Beam Mode Replacement

- AC50 comes very late
  - AC power fluctuation
  - Alternating during 16/18 sequences injection
- Bucket Selection delay increases
- 'Set EVG' signal comes late than pre event
- Current beam mode is replaced by the next beam mode
- Happened 15 times during 2-weeks operation in June

- Solution of beam mode replacement:
  - Upgrade the 50 Hz generator module
  - Decrease reference interval of AC50 (Already done)
- Solution of redundant beam mode:
  - Temporarily separate the positron beam mode and PF mode
  - Figure out the reason of abnormal bucket selection delay
- Much more data required to diagnose the bucket selection program
- Near future: On-line alarm system
- Furthestmost, a fault prediction system based on time series forecasting models or deep learning

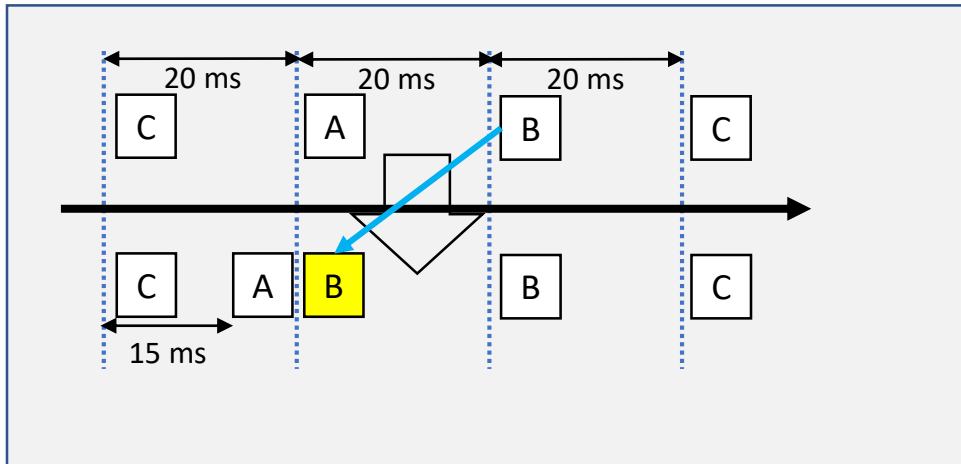
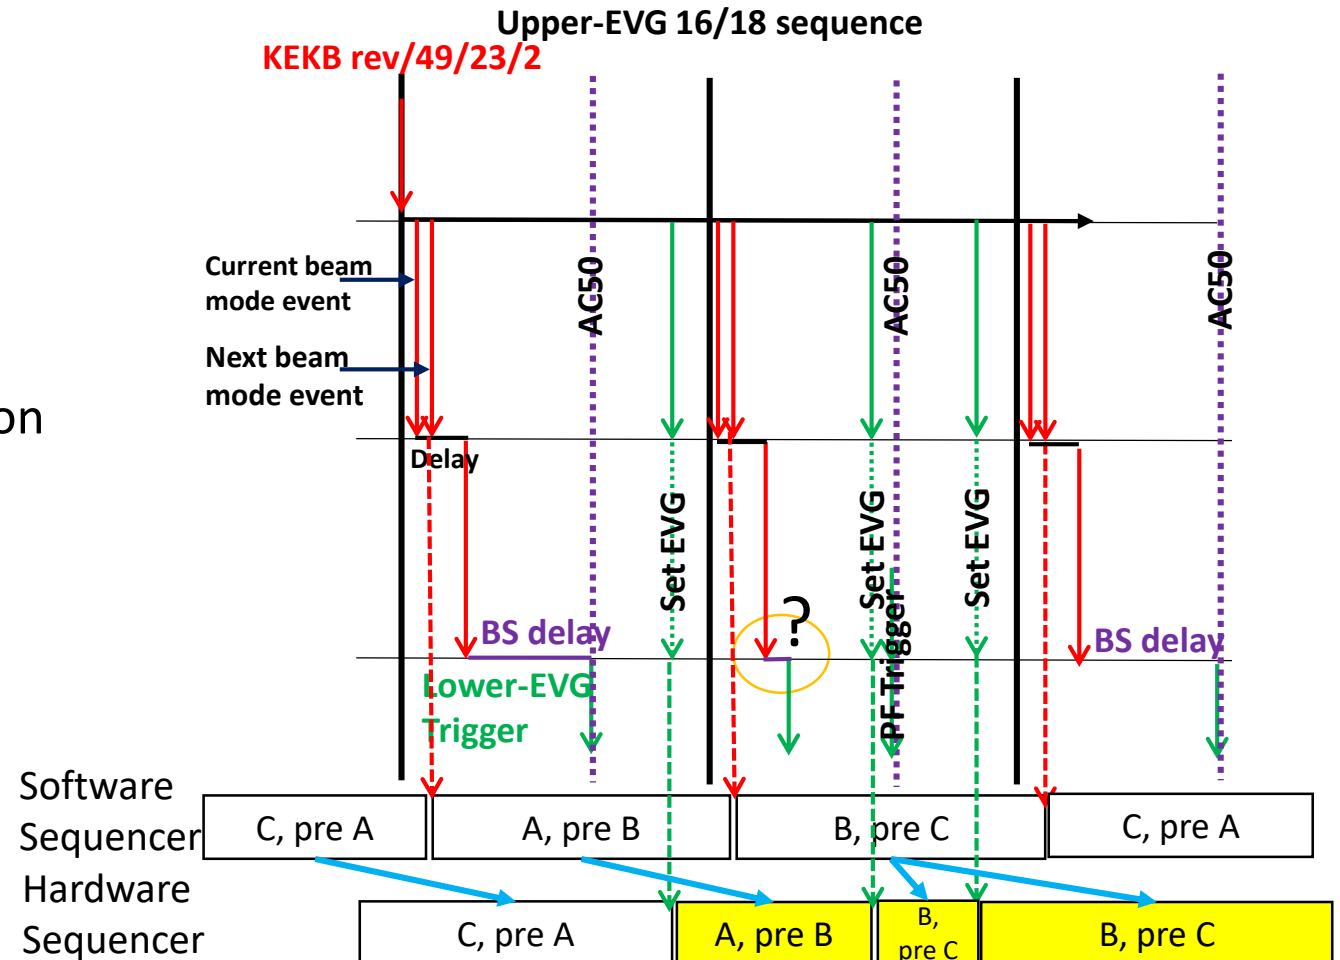
# Redundant Beam Mode

- Abnormal value of the calculation of bucket selection of positron in DR and MR
- A positron beam mode comes about 5 ms earlier than normal
- Sequencer trigger source changed
- PF Trigger signal is later than 'Set EVG'
- Happened 10 times during 2-weeks operation in June
