# SuperKEKB MR LS1 Status

(Progress after the previous B2GM)

Tetsuya Kobayashi (KEK)

B2GM 2023.6.5

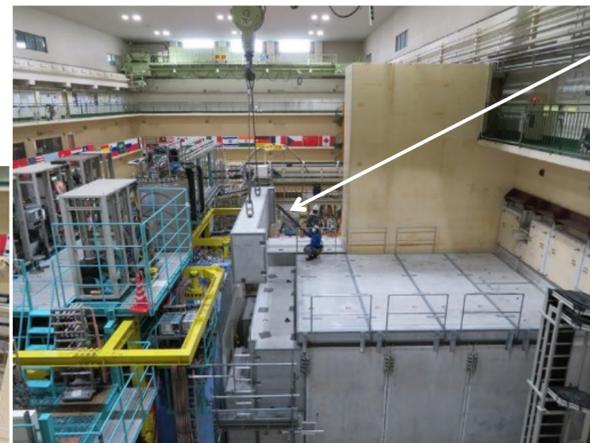
This shield will be replaced with new one.

- Concrete radiation shields disassembly  
Concrete radiation shields were temporarily removed for IR works.
- **They will be reinstalled in November 2023.**
  - To suppress background noise of Belle II, 2 concrete shields will be replaced with new ones.
  - New shields will be delivered in March 2023.

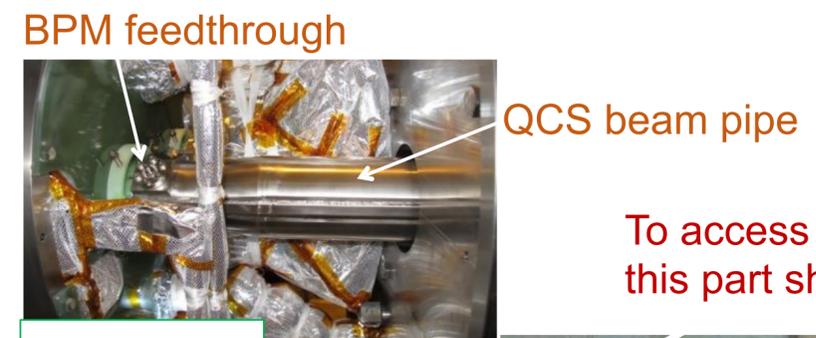
To access QCS pipes & BPMs, this part should be disassembled.

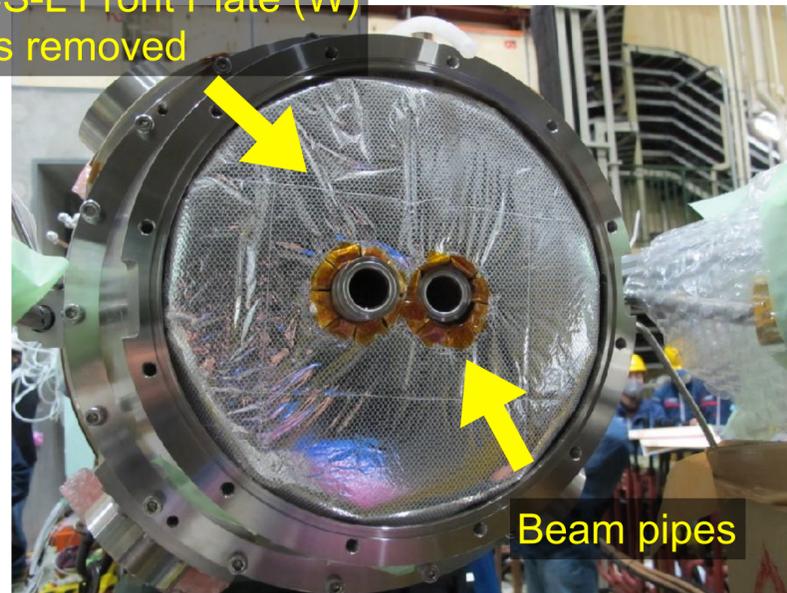
QCS-L Front Plate (W) was removed

- **QCS-L**
- **Changed the material of the front plate from tungsten to stainless steel**

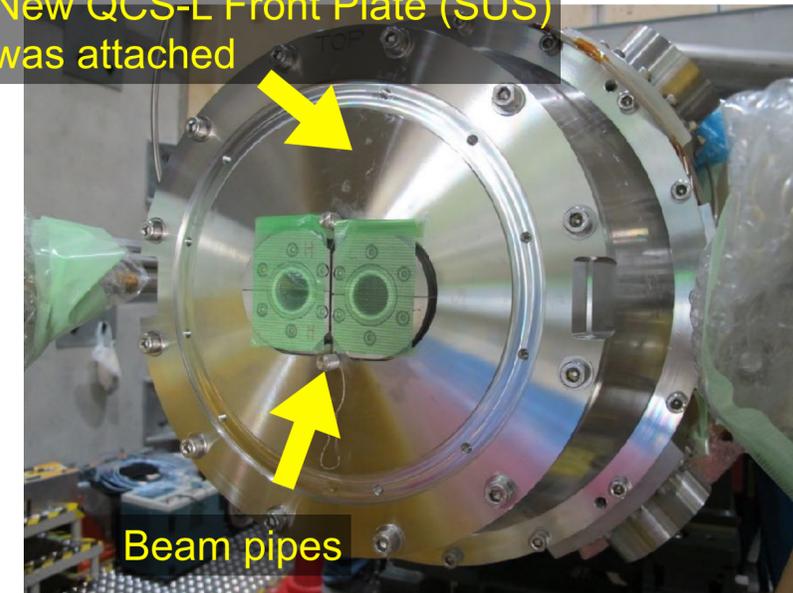
New QCS-L Front Plate (SUS) was attached

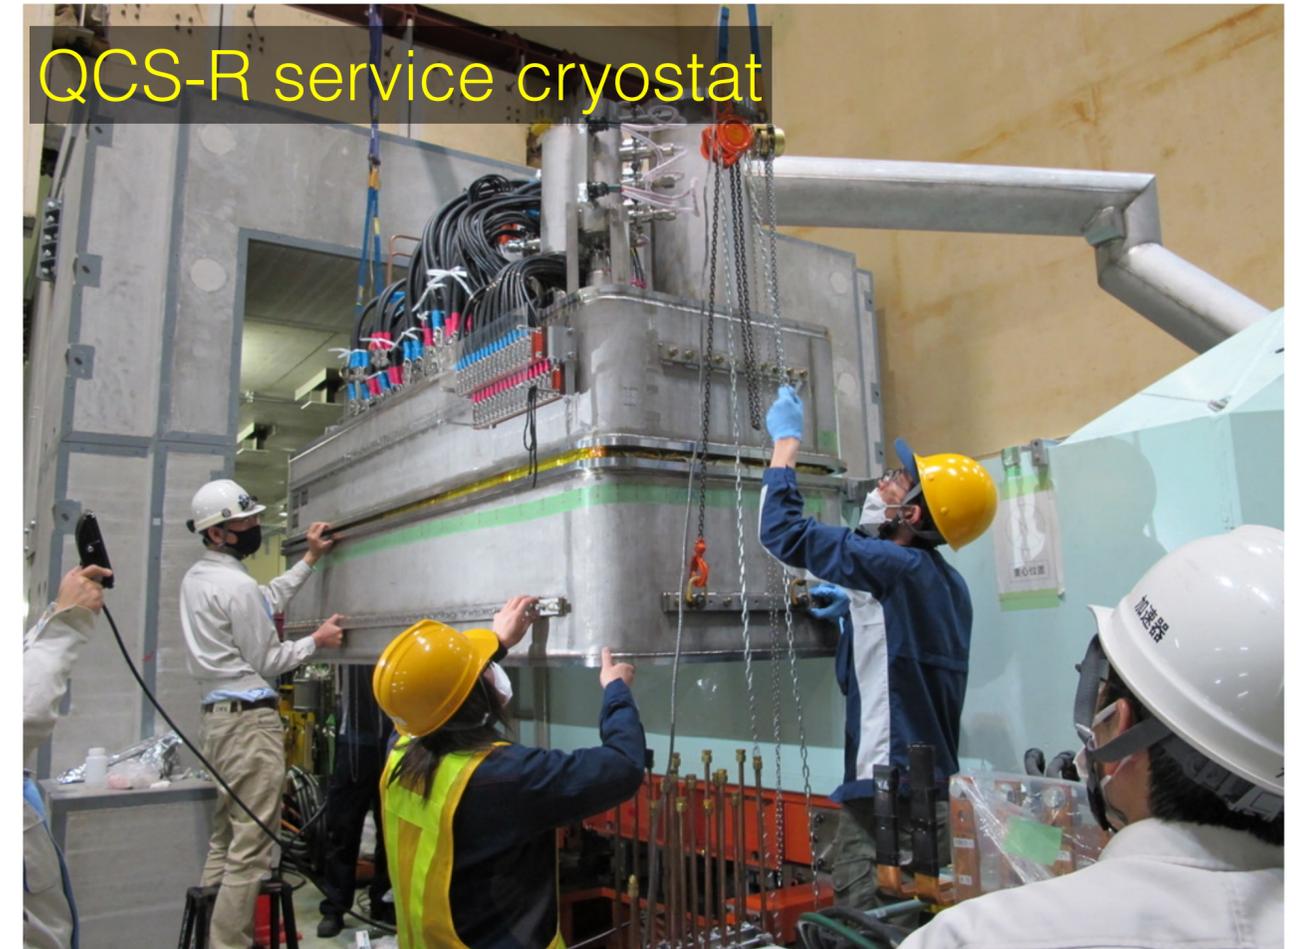
QCS R service cryostat

- We opened the service cryostat at QCS-R and checked the O-ring surface
- **The fiber-like object was found on the surface of the O-ring.**
- We replaced the O-ring with the new one, cleaned the groove and the flange surface, and reassembled the cryostat.
- **As the result of a helium leak test, It was confirmed that the leak has successfully stopped.**

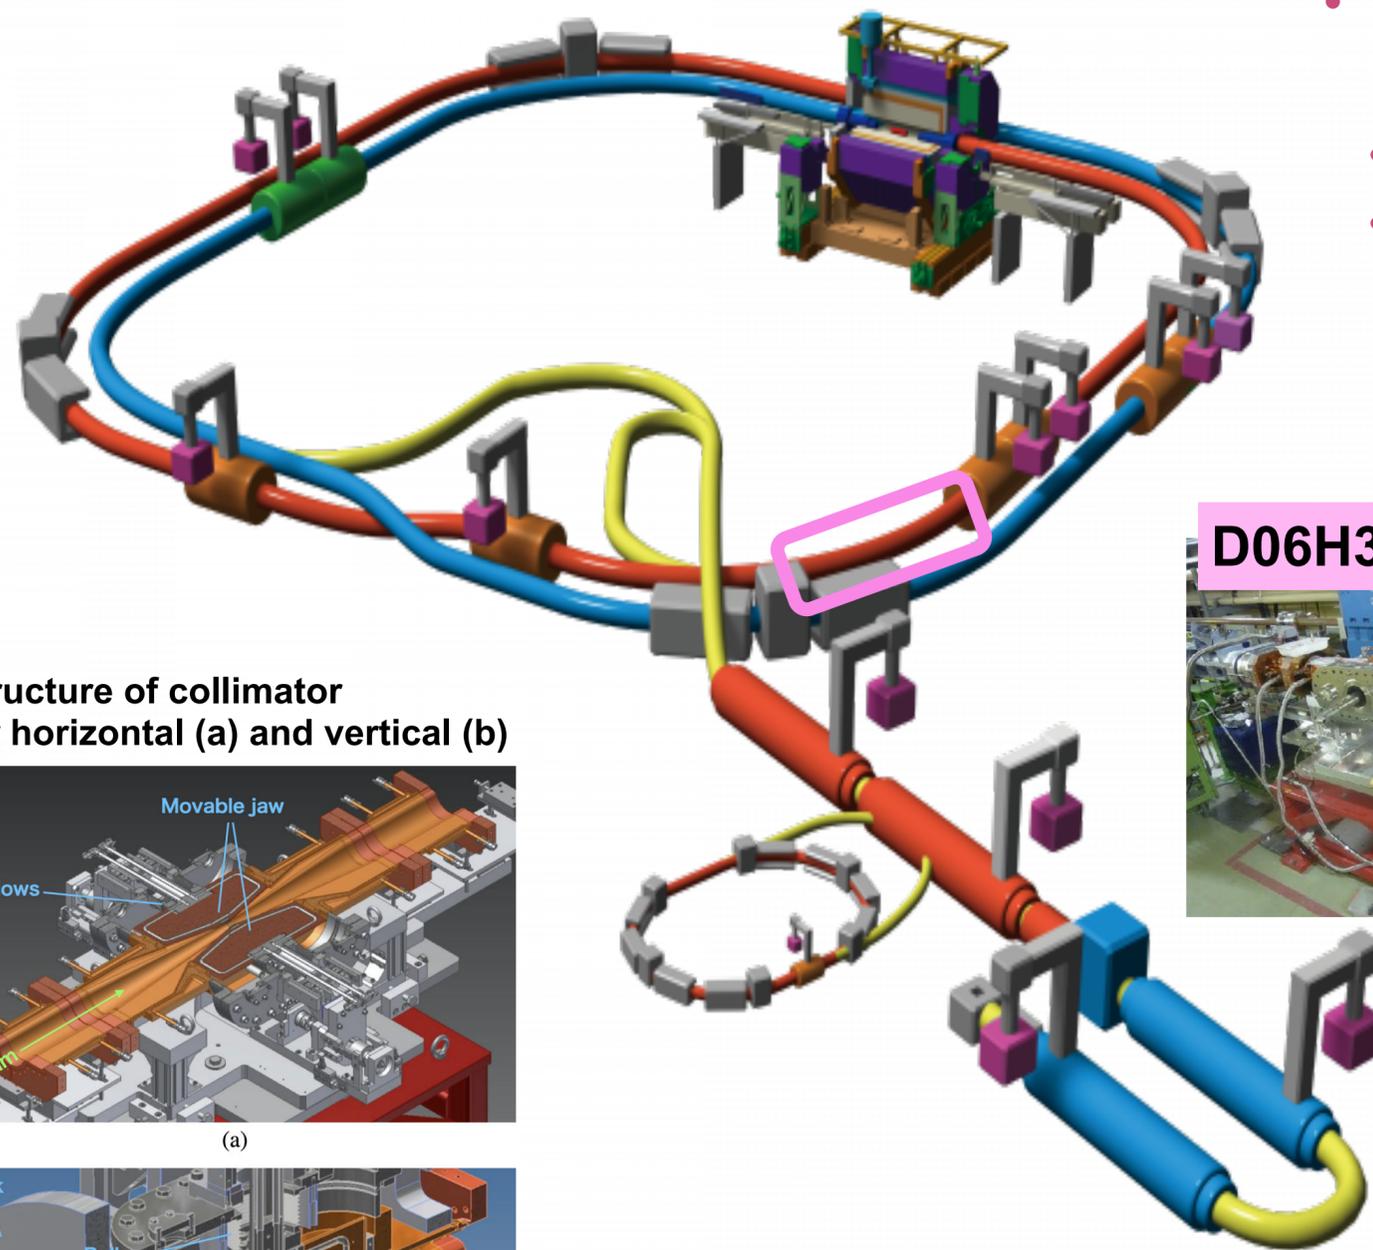
Structure of collimator for horizontal (a) and vertical (b)

- As countermeasures against collimator destruction due to kicker-pulsar misfiring,
- Replacement with carbon head of horizontal collimator D06H3.
- Collimator relocation from D06H1 (upstream of D06H3) to D06H4 (downstream of D06H3) to collimate the beam passing through D06H3.

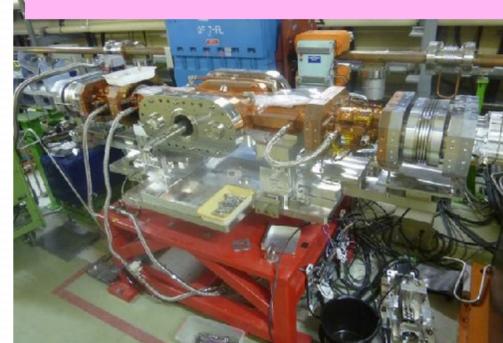
Extracted Head from D06H3

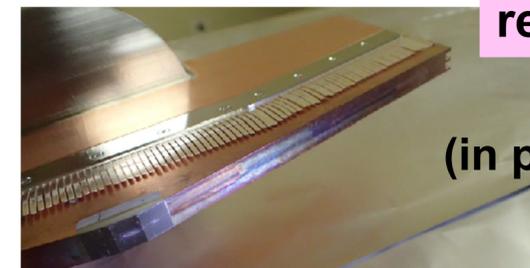
Ta or W Heads

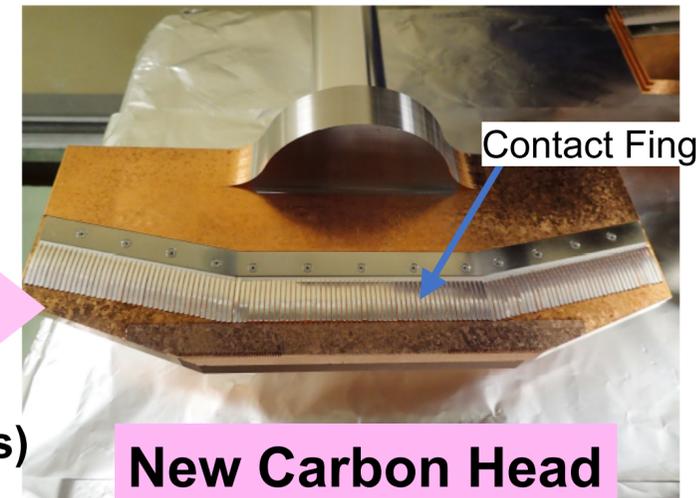
New Carbon Head

(wider head for robustness)

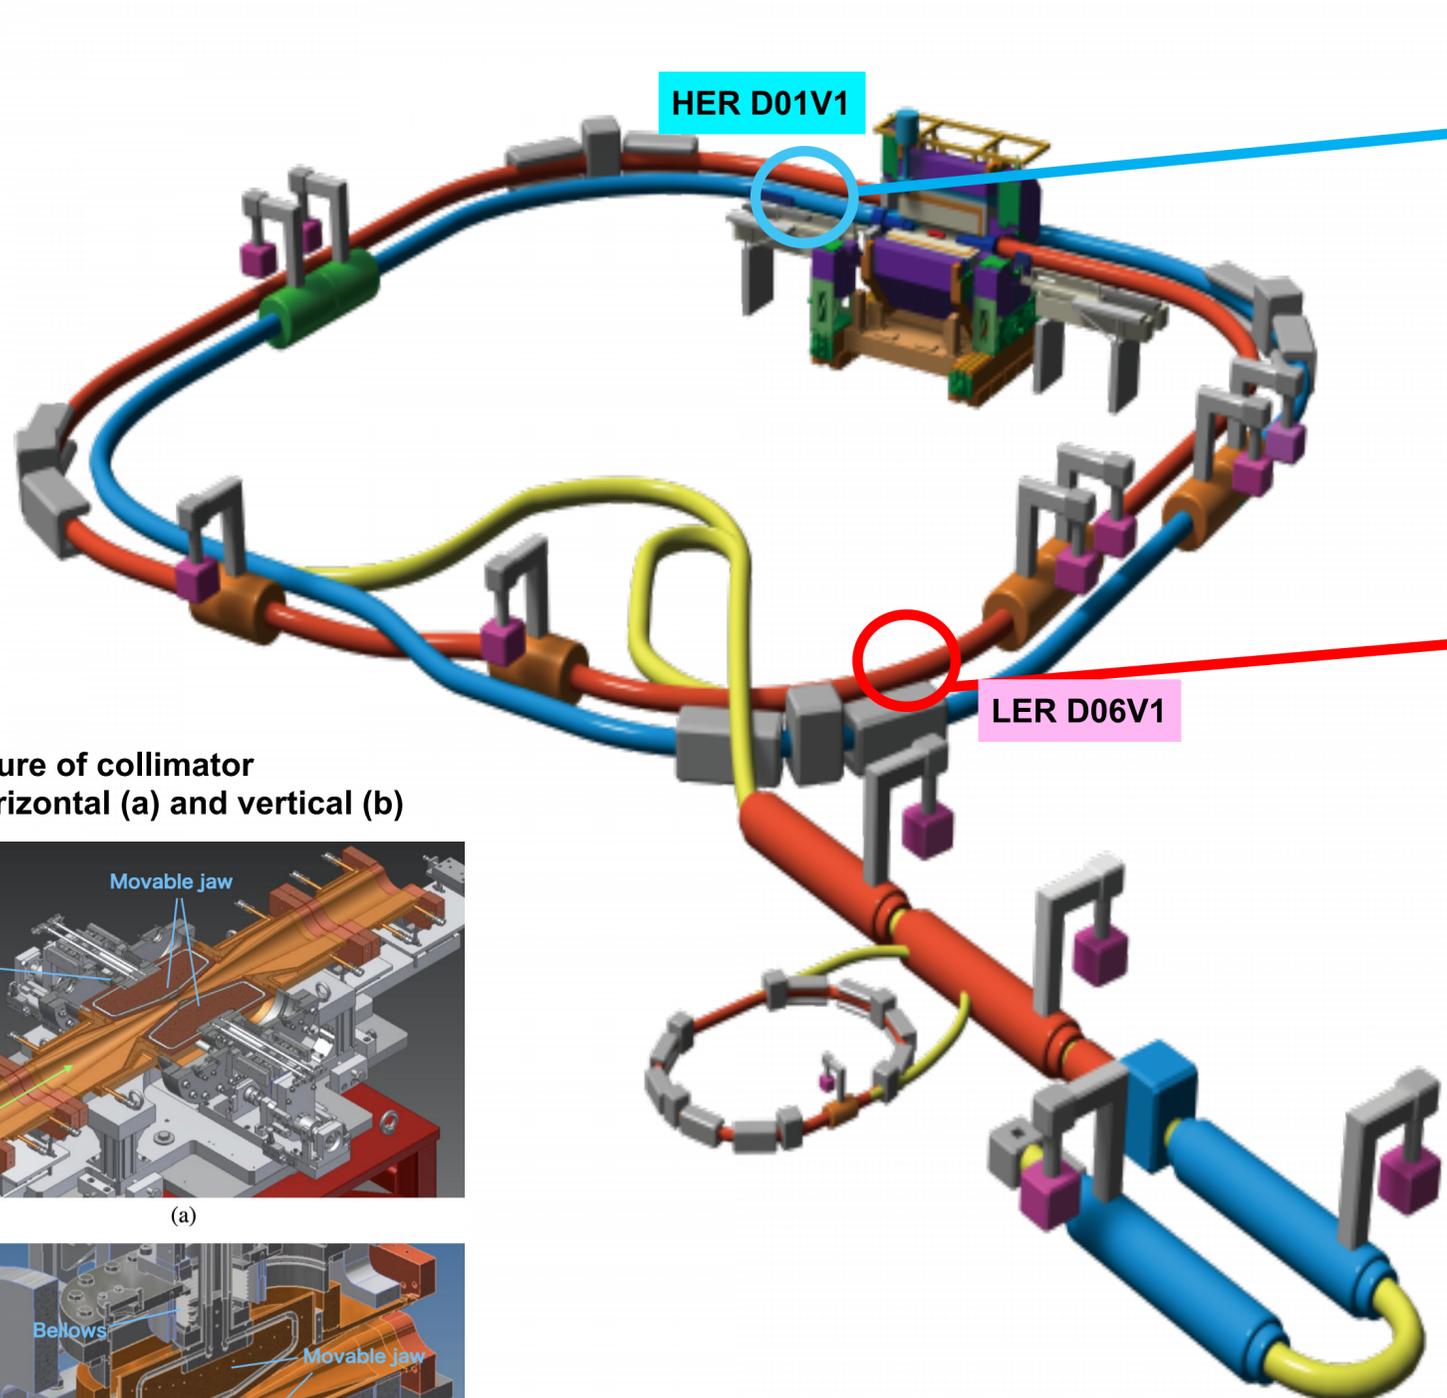
HER D01V1 collimator

LER D06V1 collimator

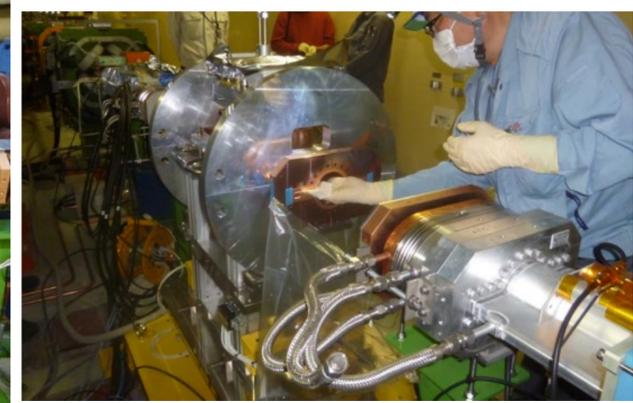
Structure of collimator for horizontal (a) and vertical (b)

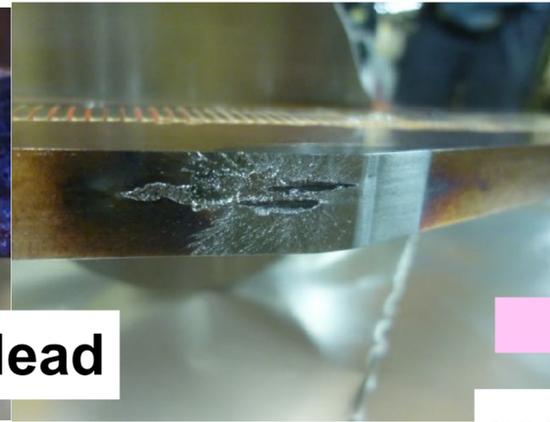
Ta Head

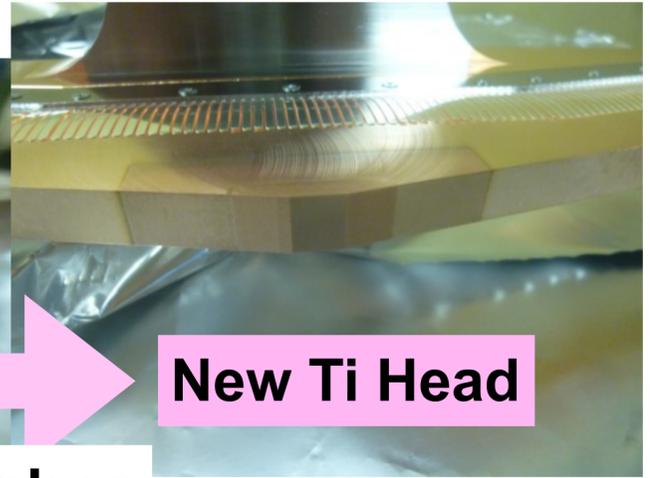
New Ti Head

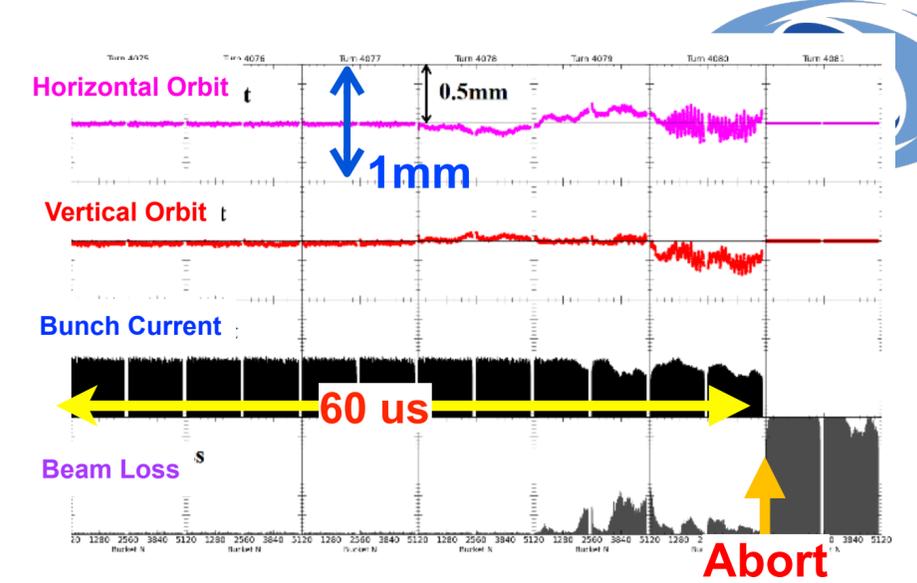
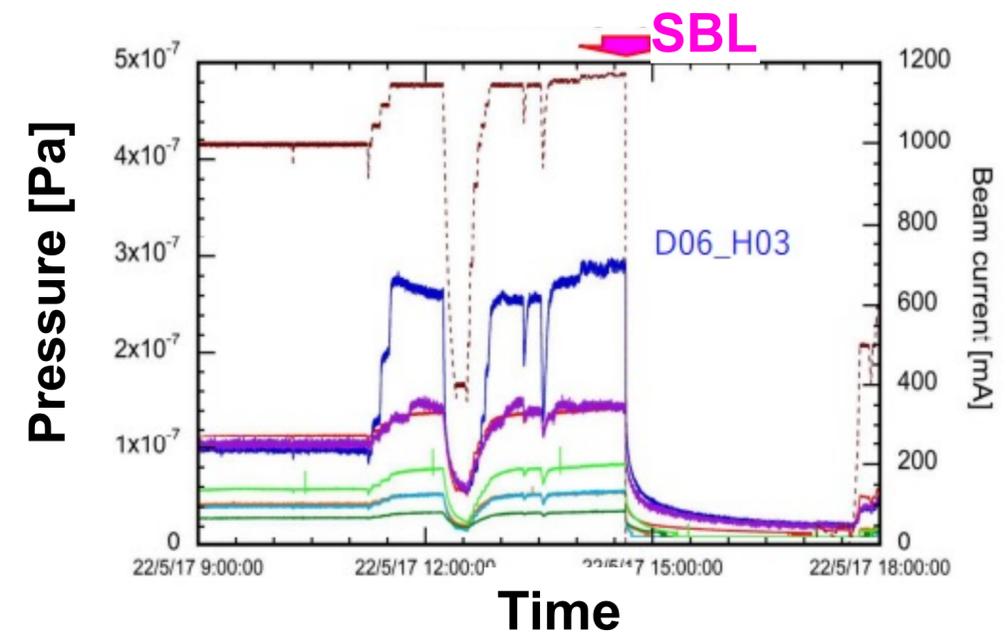
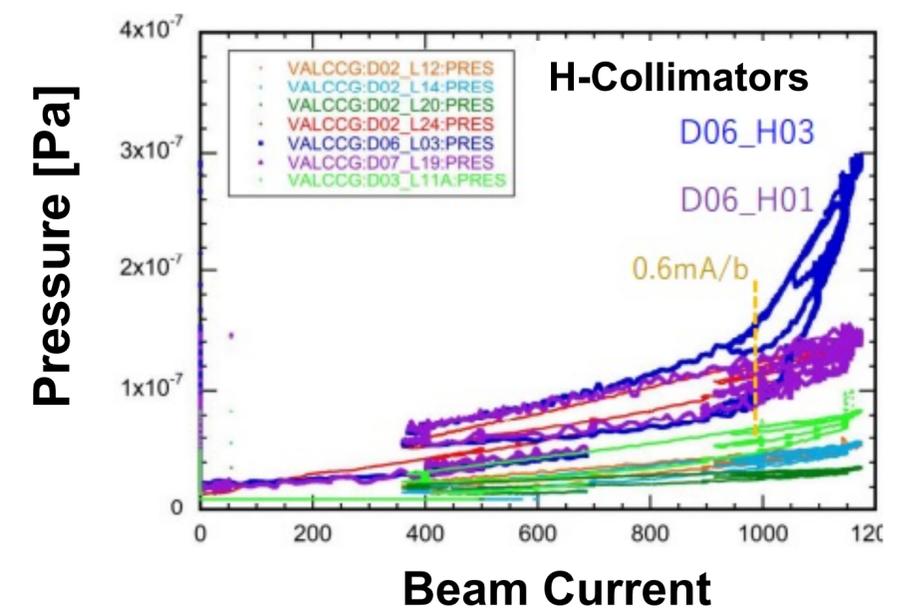
- **Regarding the pressure of D06H3 and H1 collimators, there are rapid or nonlinear increase of pressure depending on the beam current.**

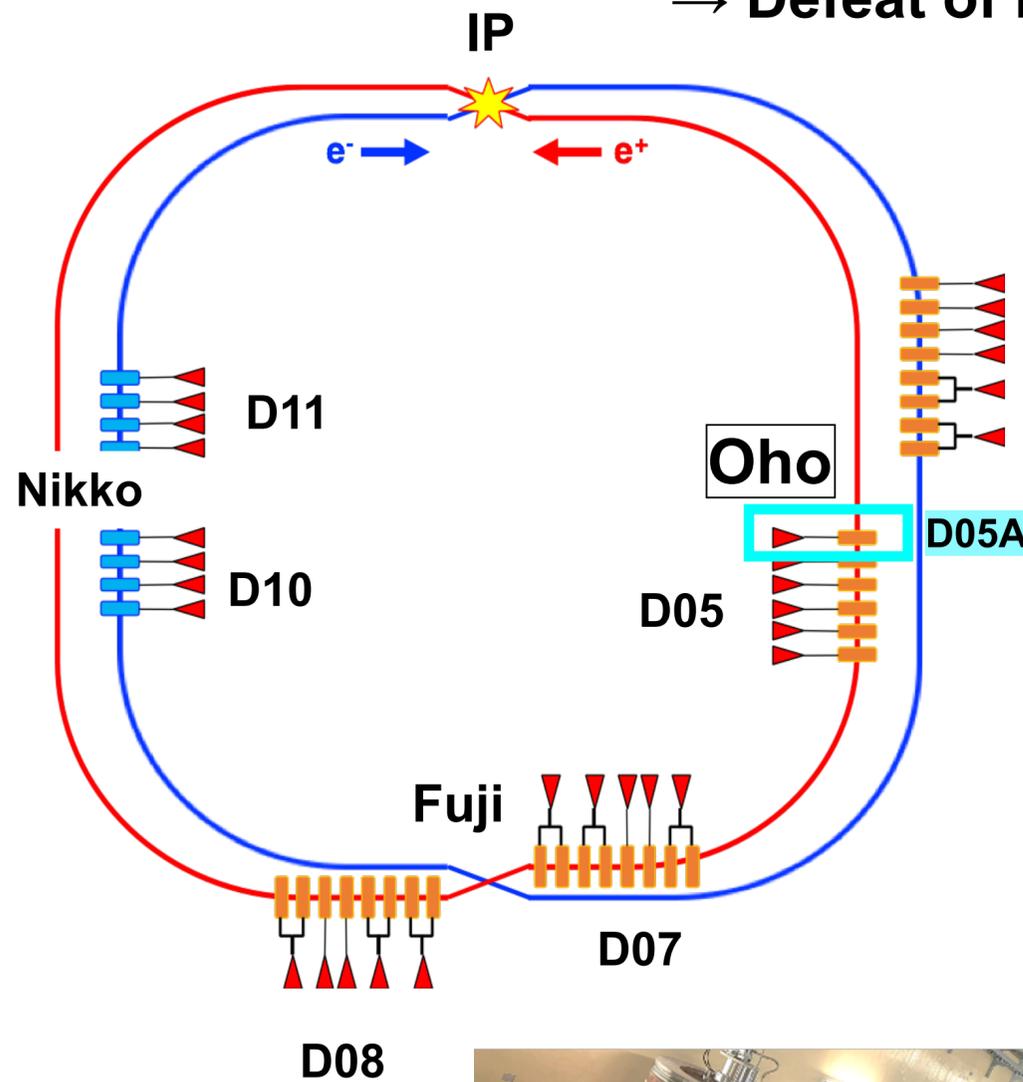
Breakdown often occurred at D05A cavity. (down rate was high at D05A)

→ Defeat of brazing was found in the coupling cavity. → Replaced

→ After the replacement, RF conditioning was successfully done in April 2023 (No problem was found).

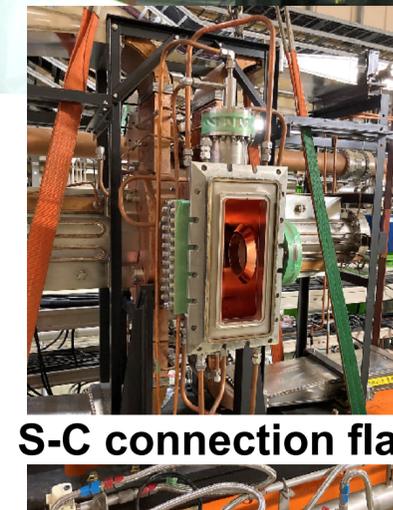
Replace

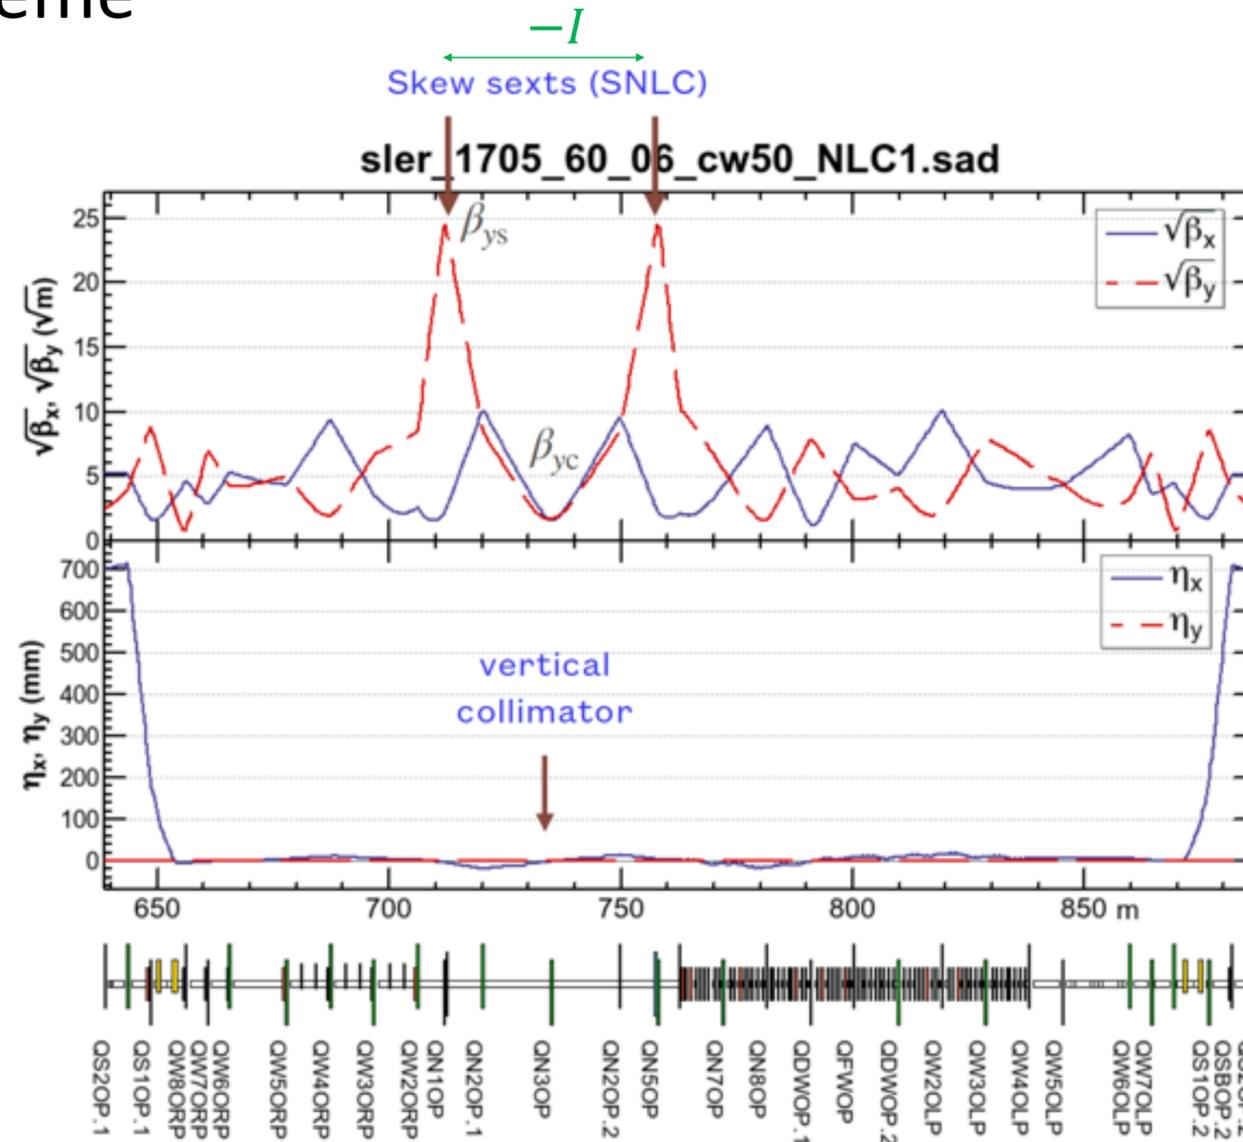
Requirements for the NLC optics:

- Large  $\beta_y = \beta_{ys}$  at the (skew) sextupole.
  - $\beta_y \equiv \beta_{yc}$  at the collimator:

$$\sqrt{\beta_{yc}\beta_{ys}} \approx 1.7 \times L_{sc}$$
- A (skew) sextupole pair connected by a  $-I$  transformation.
- No dispersion at the sextupoles and the collimator.
- $\approx 0.25$  vertical phase advance between the sexts and the IP.

Here the collimator is placed right before the center quad (QN3OP).  
 If the quad is split into two pieces, the collimator can be placed in the middle of them.

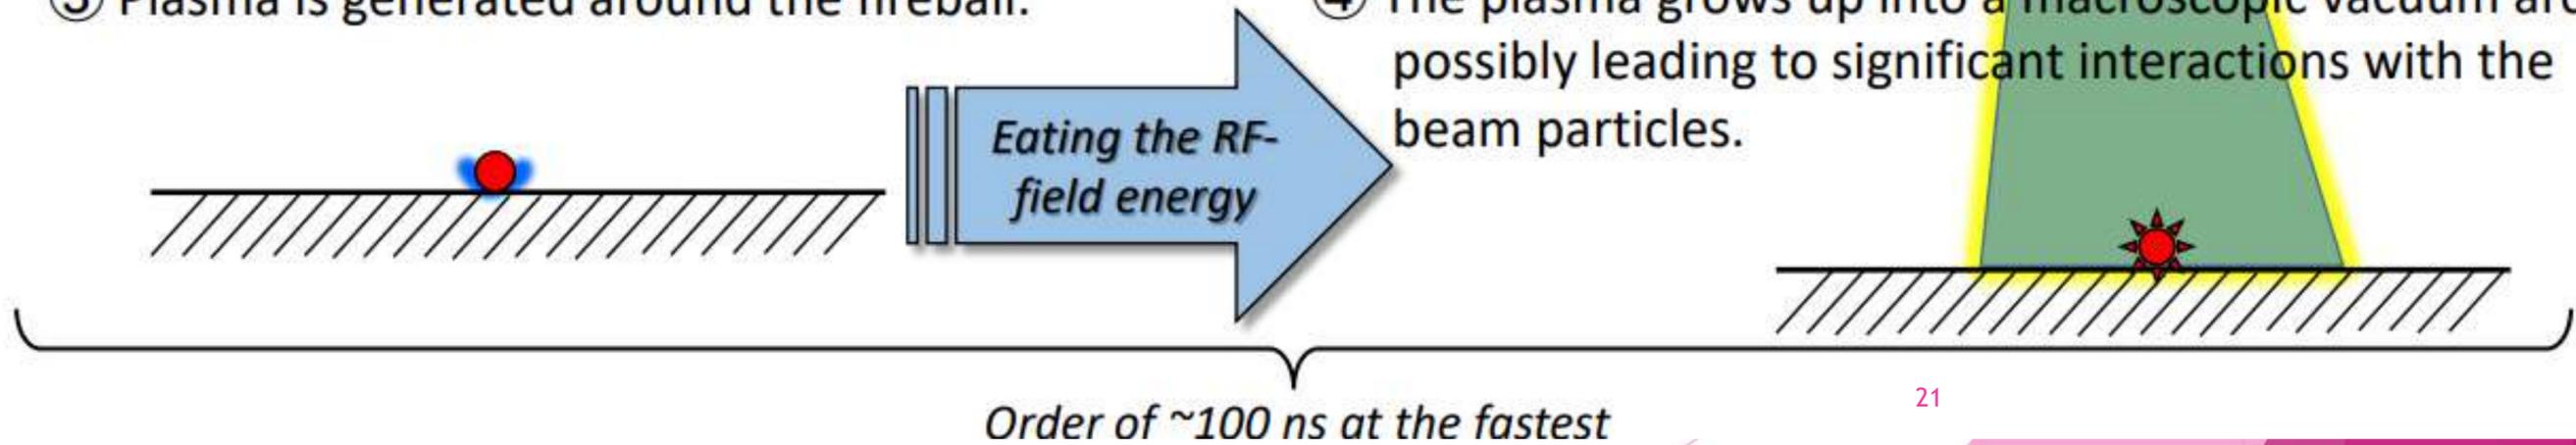
## Physical process of the “Fireball” hypothesis, leading to fast beam loss

① A microparticle with a high sublimation point is heated by the beam-induced field.

② The fireball touches some metal surface with a low sublimation point (e.g. copper).

③ Plasma is generated around the fireball.

④ The plasma grows up into a macroscopic vacuum arc, possibly leading to significant interactions with the beam particles.
