Collimators and TMCI

15th annual Belle PAC Review meeting
Machine, MDI, Beam background, Operation plan
T. Ishibashi

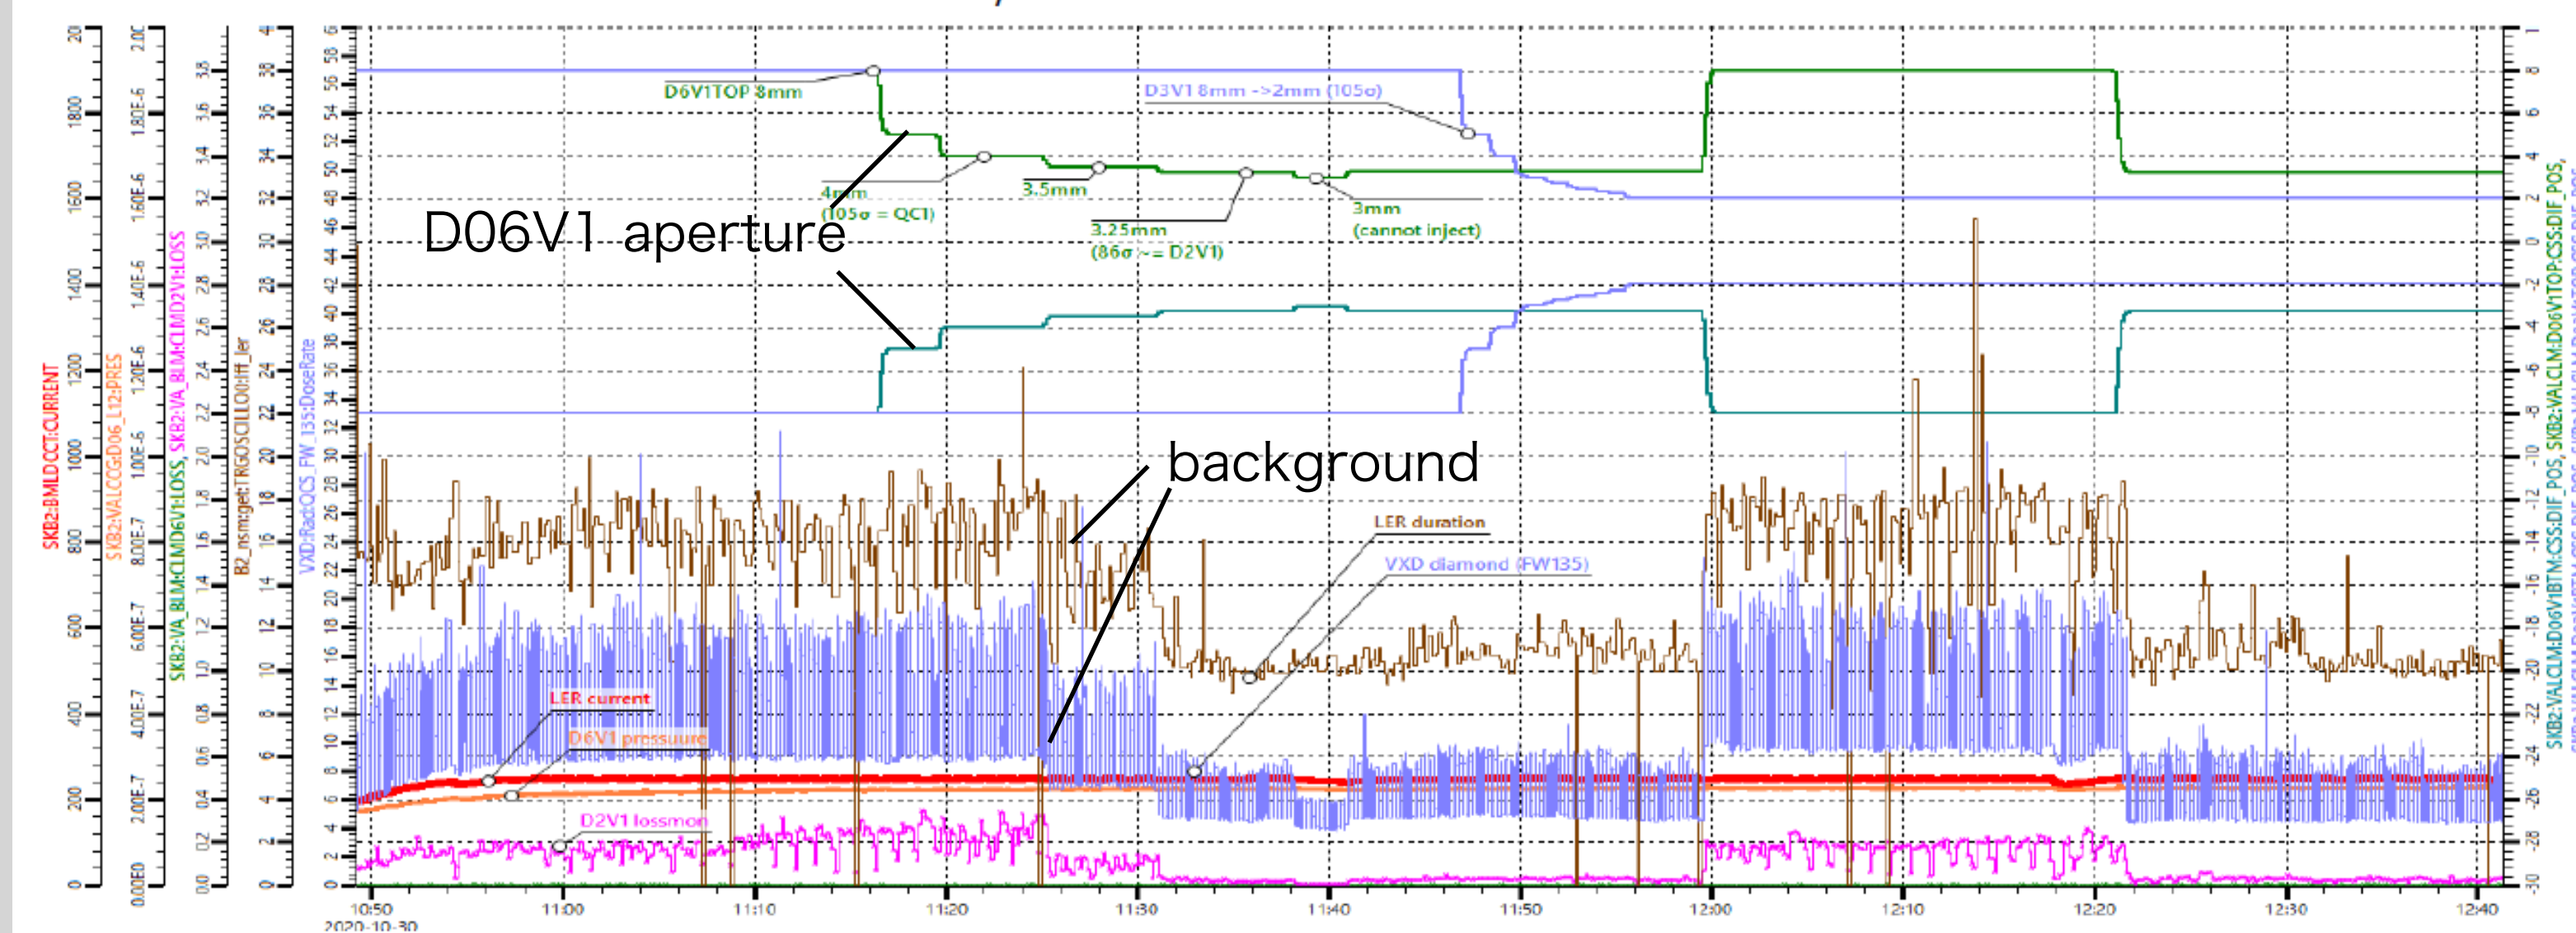
D6V1 vs. diamond, duration

- 1) We closed D6V1 down to 3mm at I=250mA and didn't observe pressure increase around D6V1. The collimator is well baked now ☺
- 2) The background changes as expected against D6V1 width:
 - When D6V1 became narrower than QC1, diamond injection/storage loss and injection duration significantly improved. D2V1 loss also became smaller.
 - When D6V1 became narrower than D2V1, injection efficiency dropped significantly, so we stopped there.
- 3) We also closed D3V1 down to 2mm and didn't observe any significant improvement in BG, as expected for $b^*y=1\text{mm}$ optics.

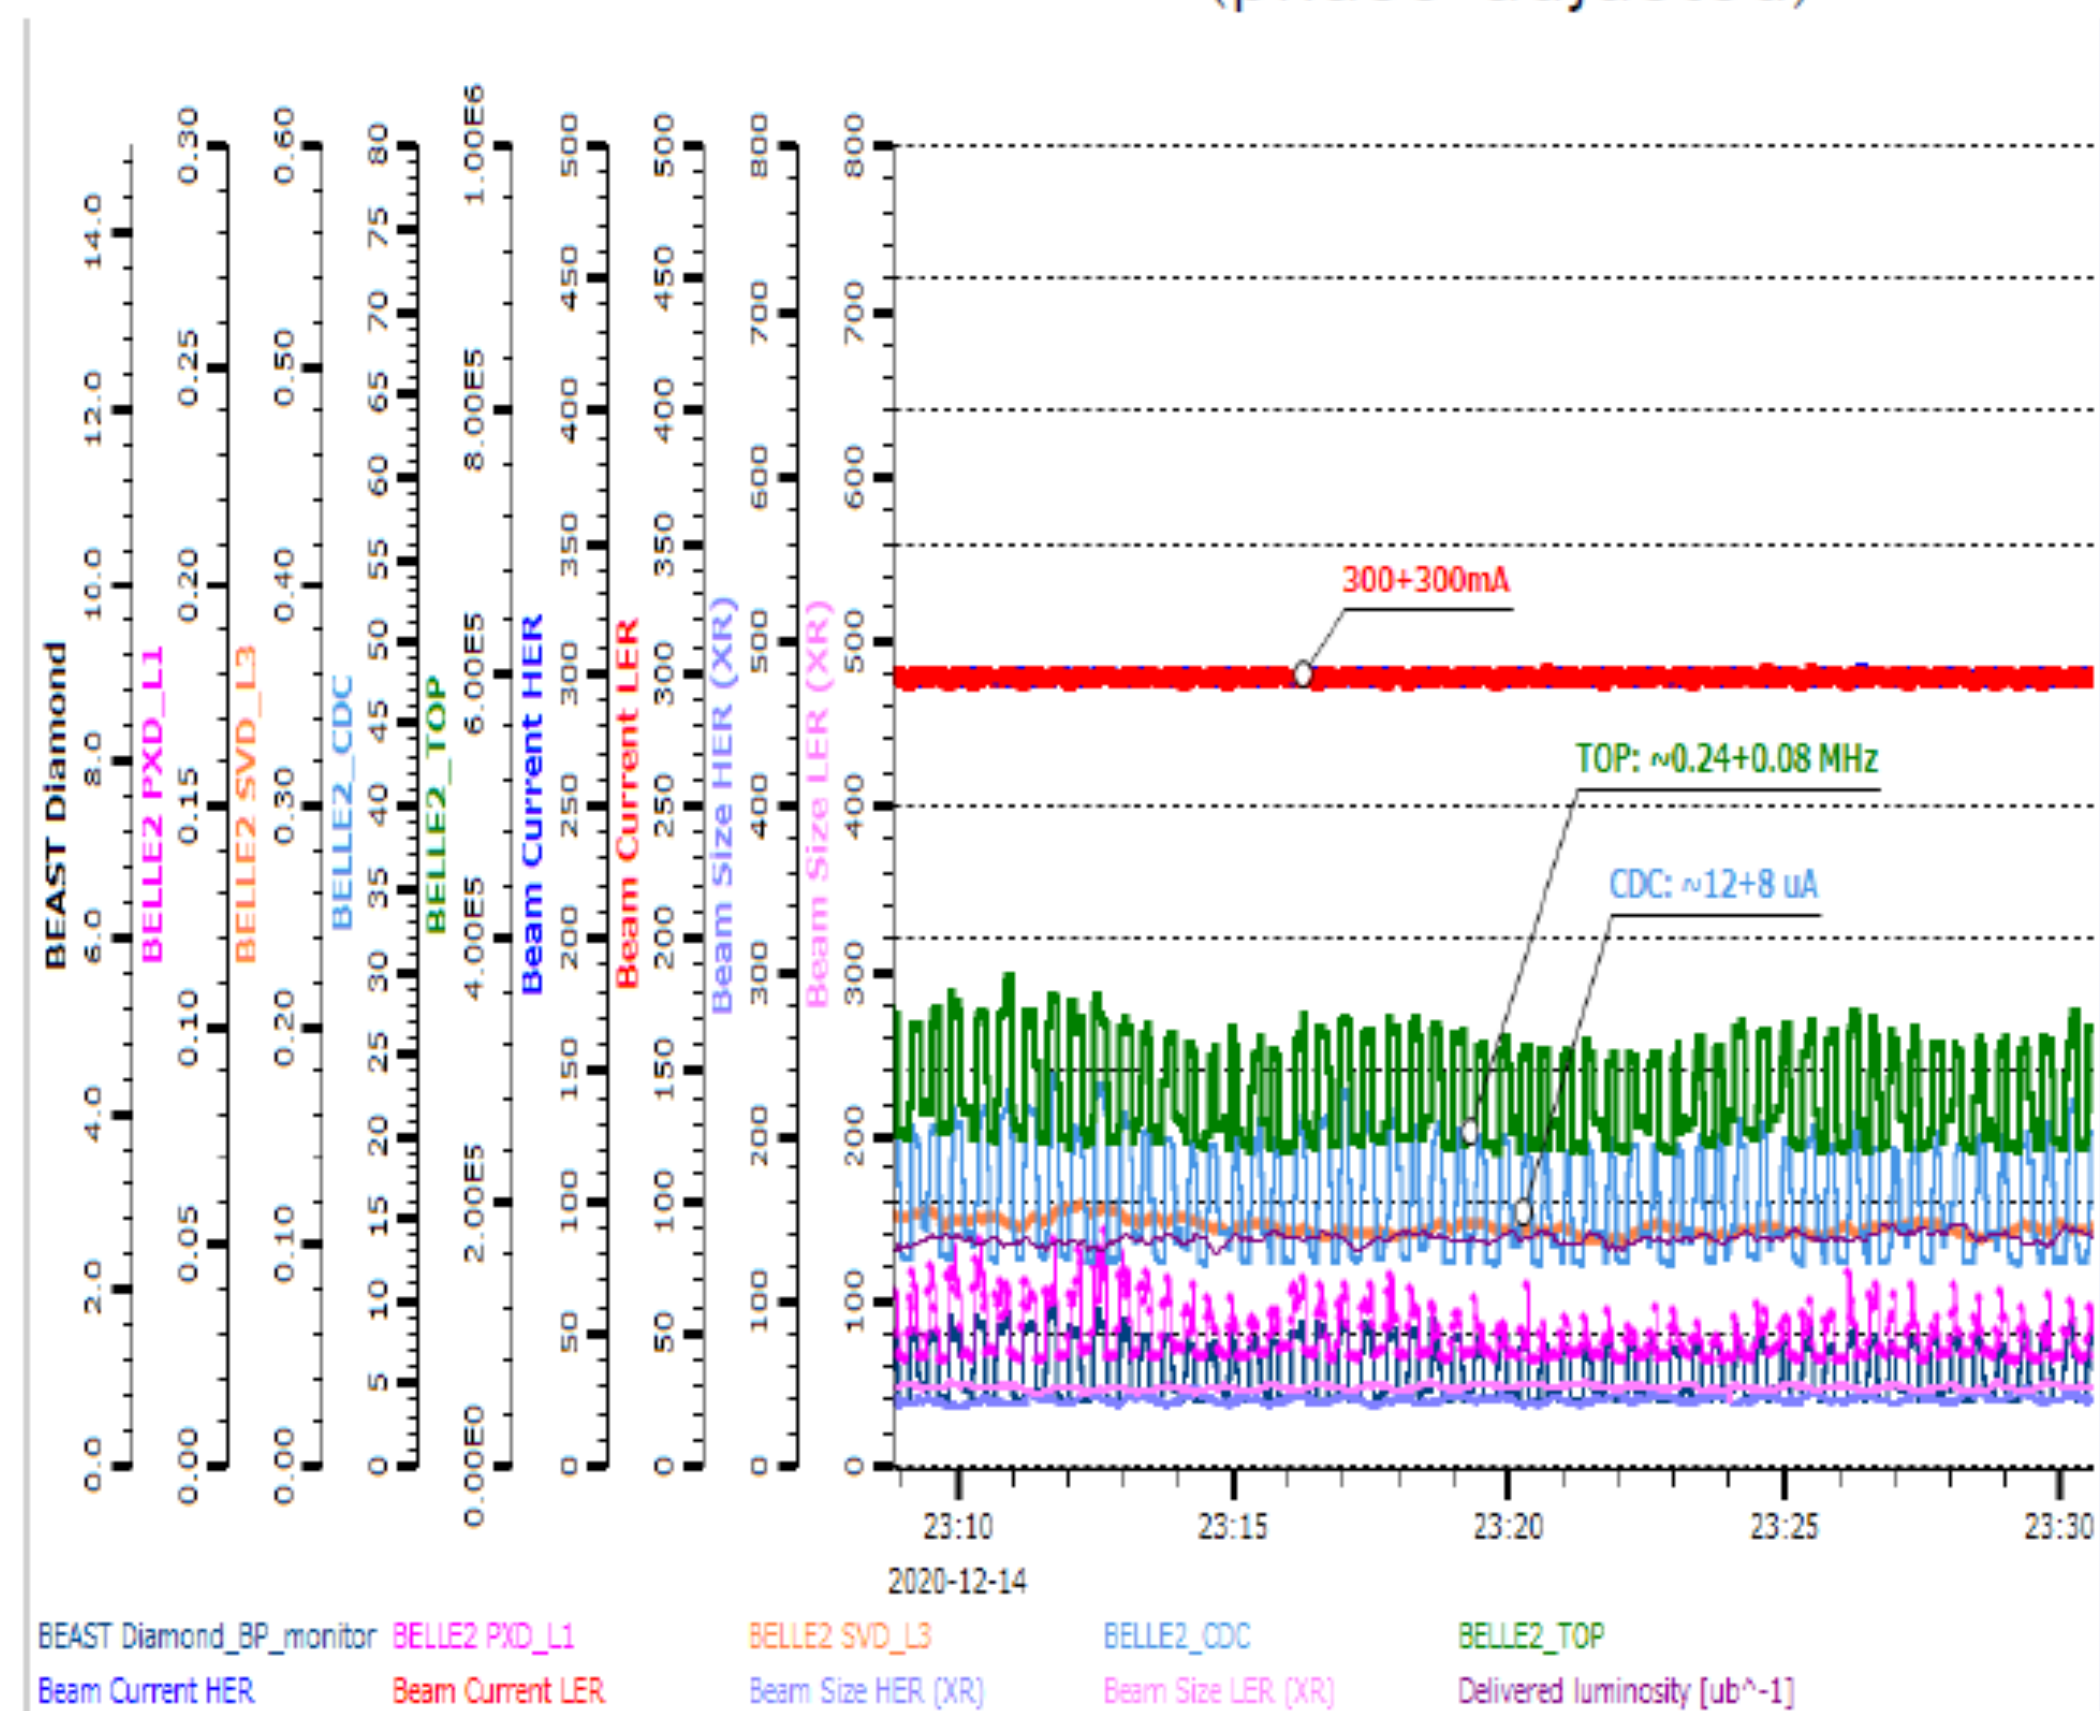
Dec. 14, 2020
(phase-adjusted)

- In its final stage (Dec. 14th), LER optics was changed to one where the phase advance between D02V1-D03V1 and D02V1-D06V1 are 3.5 and 16, respectively.
 - Protecting D02V1 by the two collimators.
- By closing the D03V1 aperture to ± 1 mm, the storage BG in TOP was decreased by 30-40%. However, injection BG in VXD was increased and the effect of collimators' impedance became prominent (talk later).

Hit rates of TOP and CDC

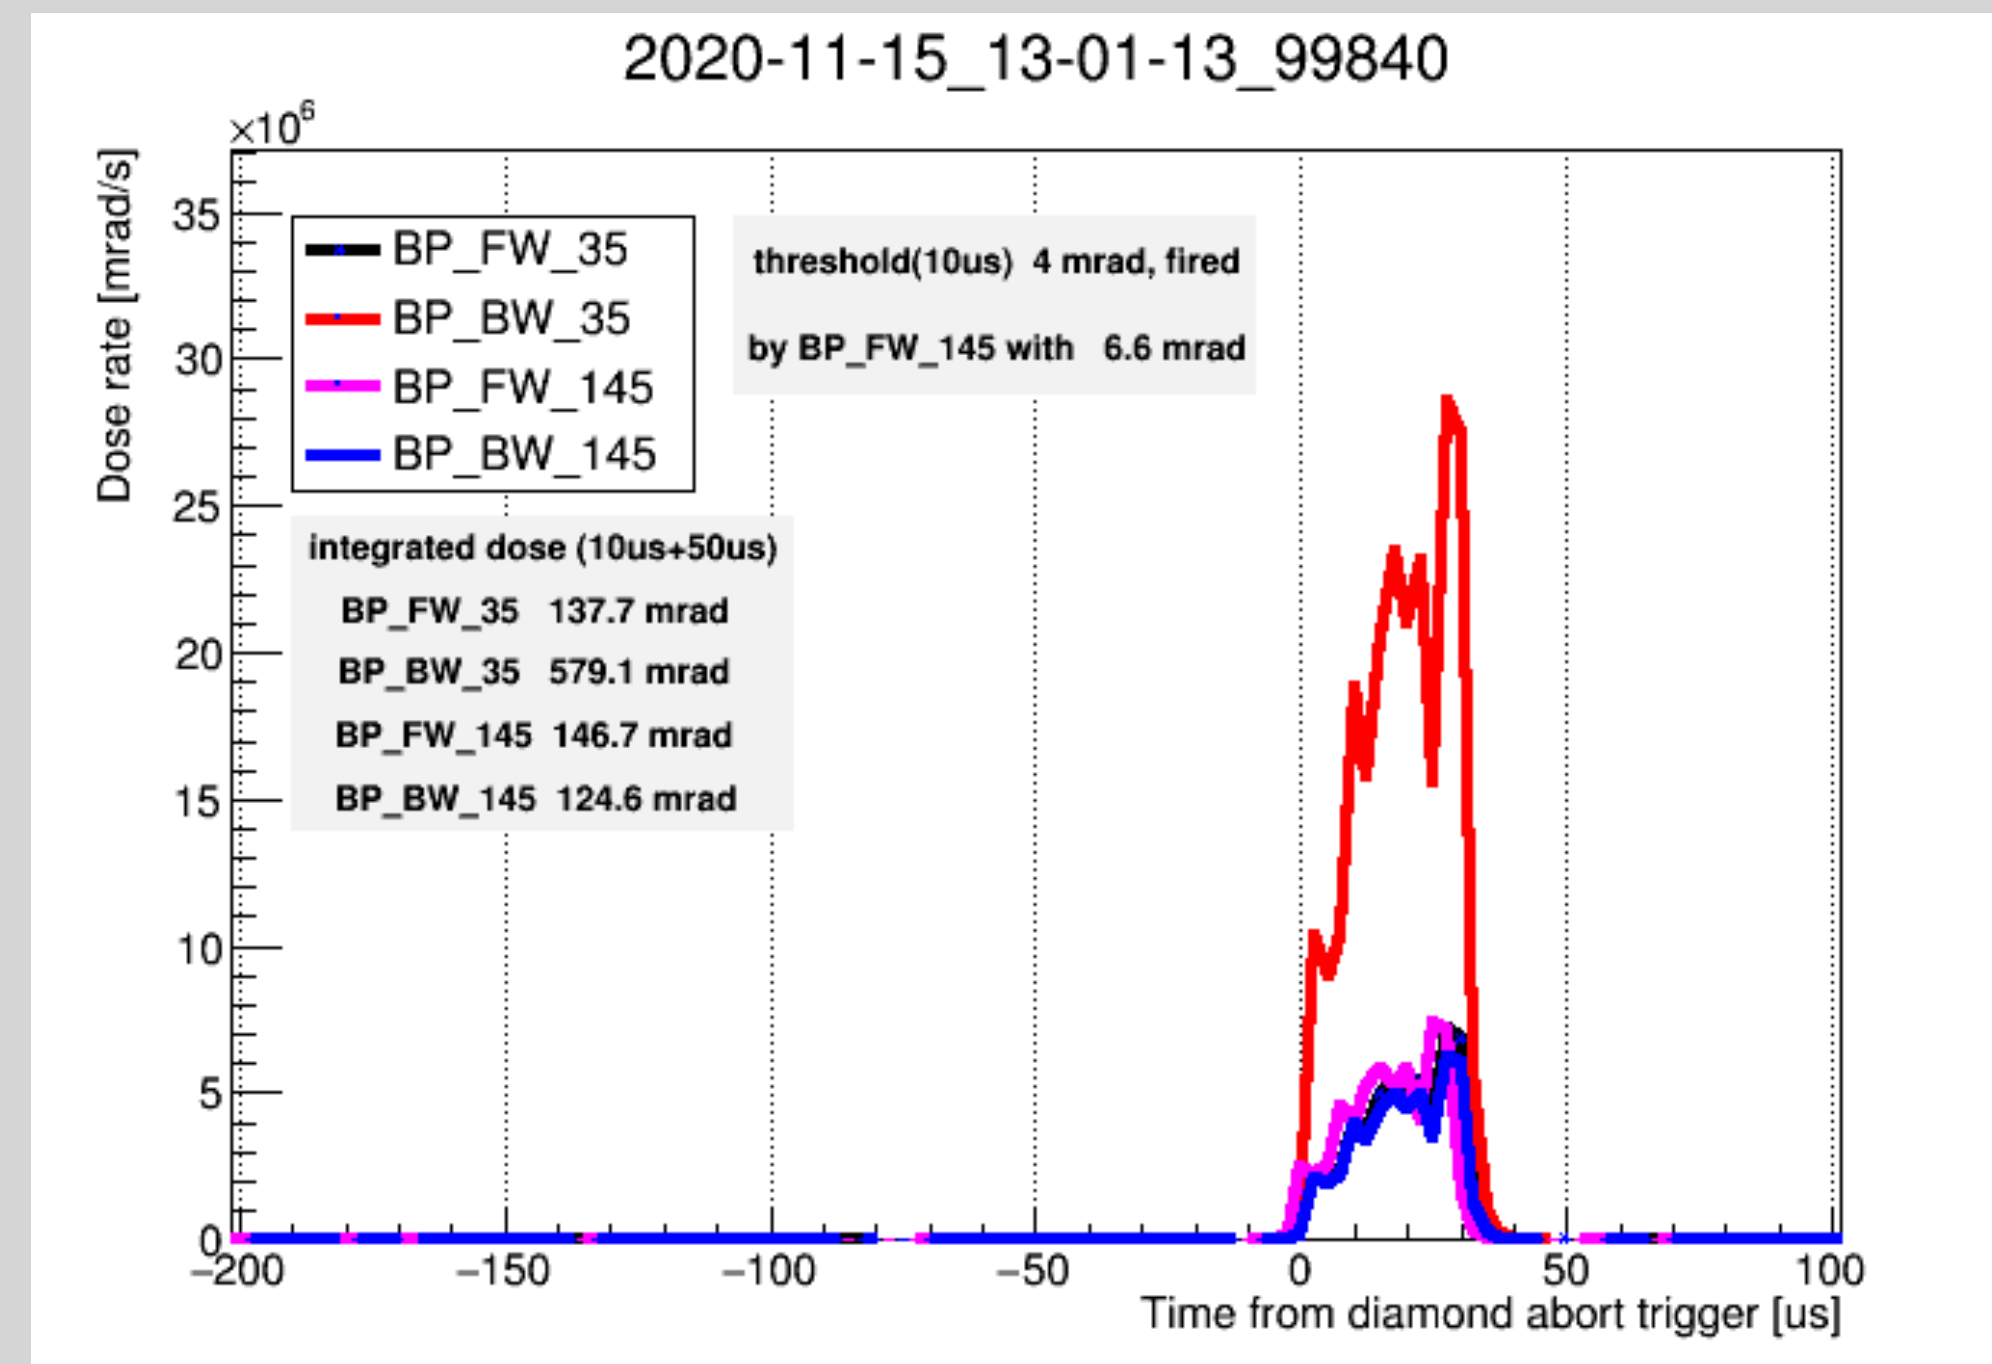
2020-11-15 13:01:13, beam abort with QCS quench

- LER: 509 mA, HER: 469.6 mA
- Pressure burst was observed in D02V1. The other pressure burst in D05 section was also observed (dust event?).
- After that, the BG levels were higher by a factor of 2 and limited the beam currents .
 - * D02V1 was shifted ~3.5 mm to outside of the ring to avoid scars, but the BG level was still high.
 - * Horizontal oscillation related to the injection seems larger than expected.
- The damaged jaws were replaced to spears from Nov. 18th to 21st.

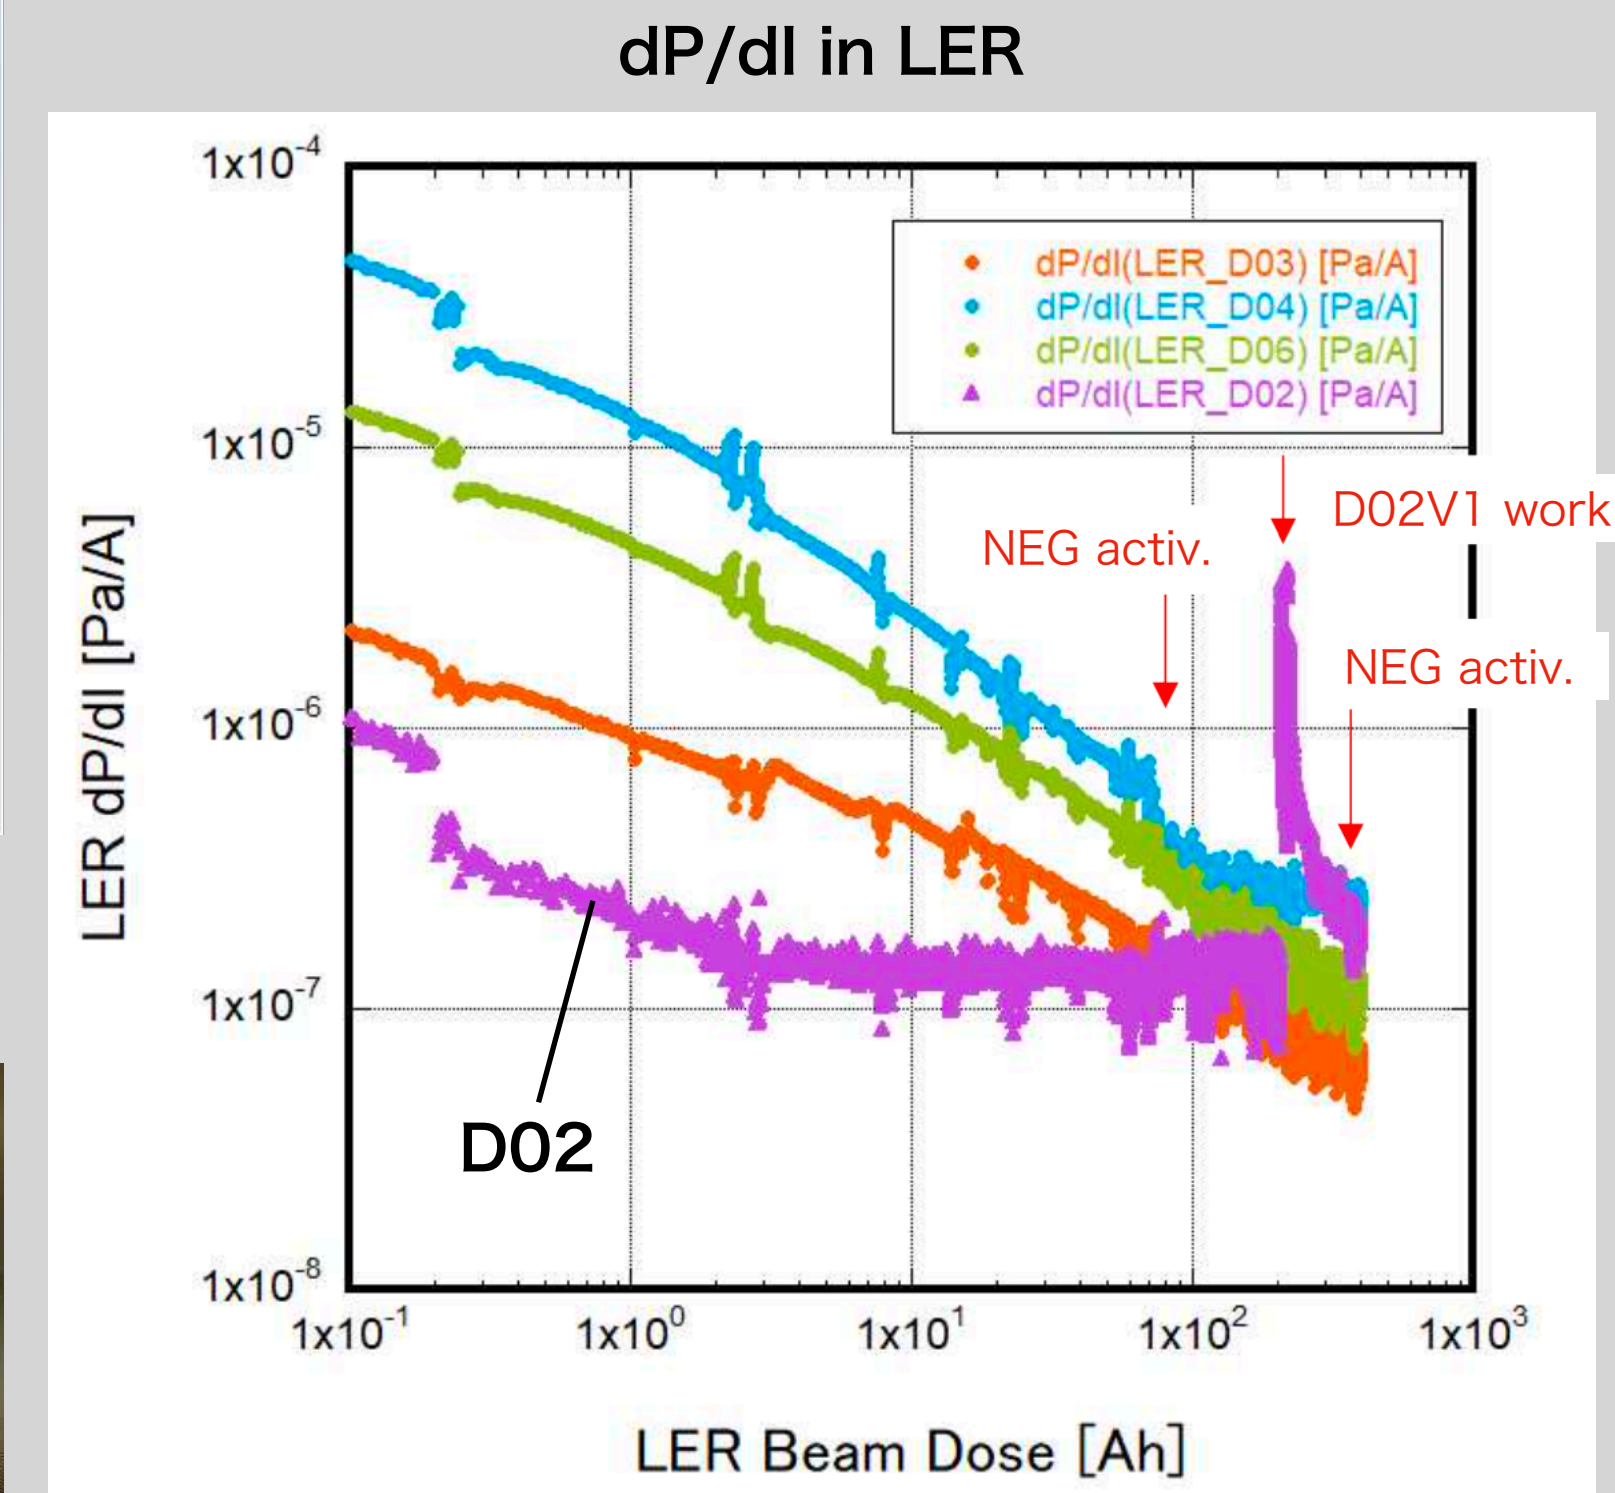
- On Nov. 23rd 0:28 (LER: 599.7 mA), a pressure burst happened in D02V1, and beam was aborted by it.
- Vacuum leakage was detected at the bottom side flange. A scar on the seal surface was found.
→ replaced to the spare one.
- On Nov. 24th, replacement work done and vacuum scrubbing resumed.
- On Nov. 27th, physics run resumed (LER $\beta_y^* = 2$ mm).
- The outgassing from the spare flange had been high, thus we baked-out D02V1 in-situ during this winter shutdown.

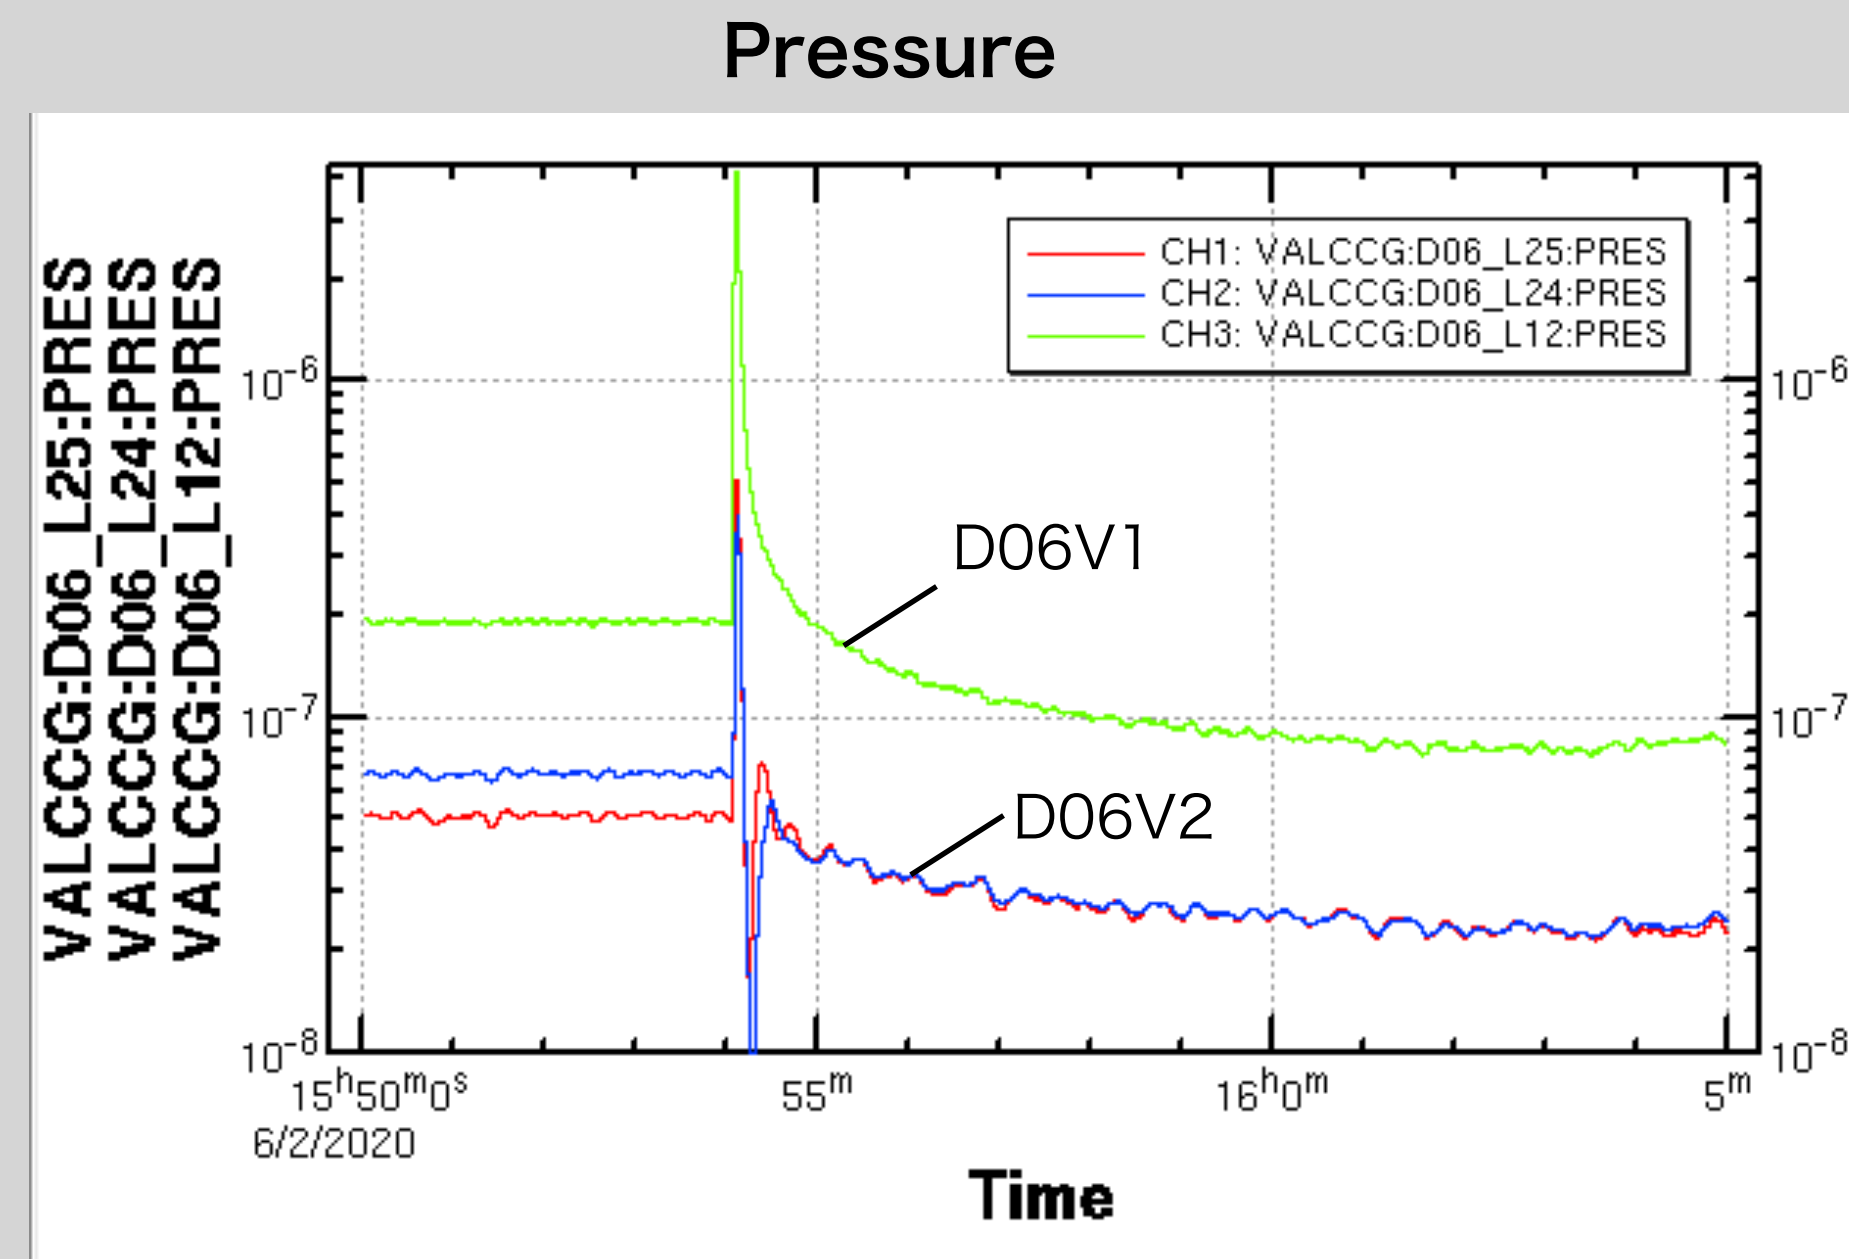
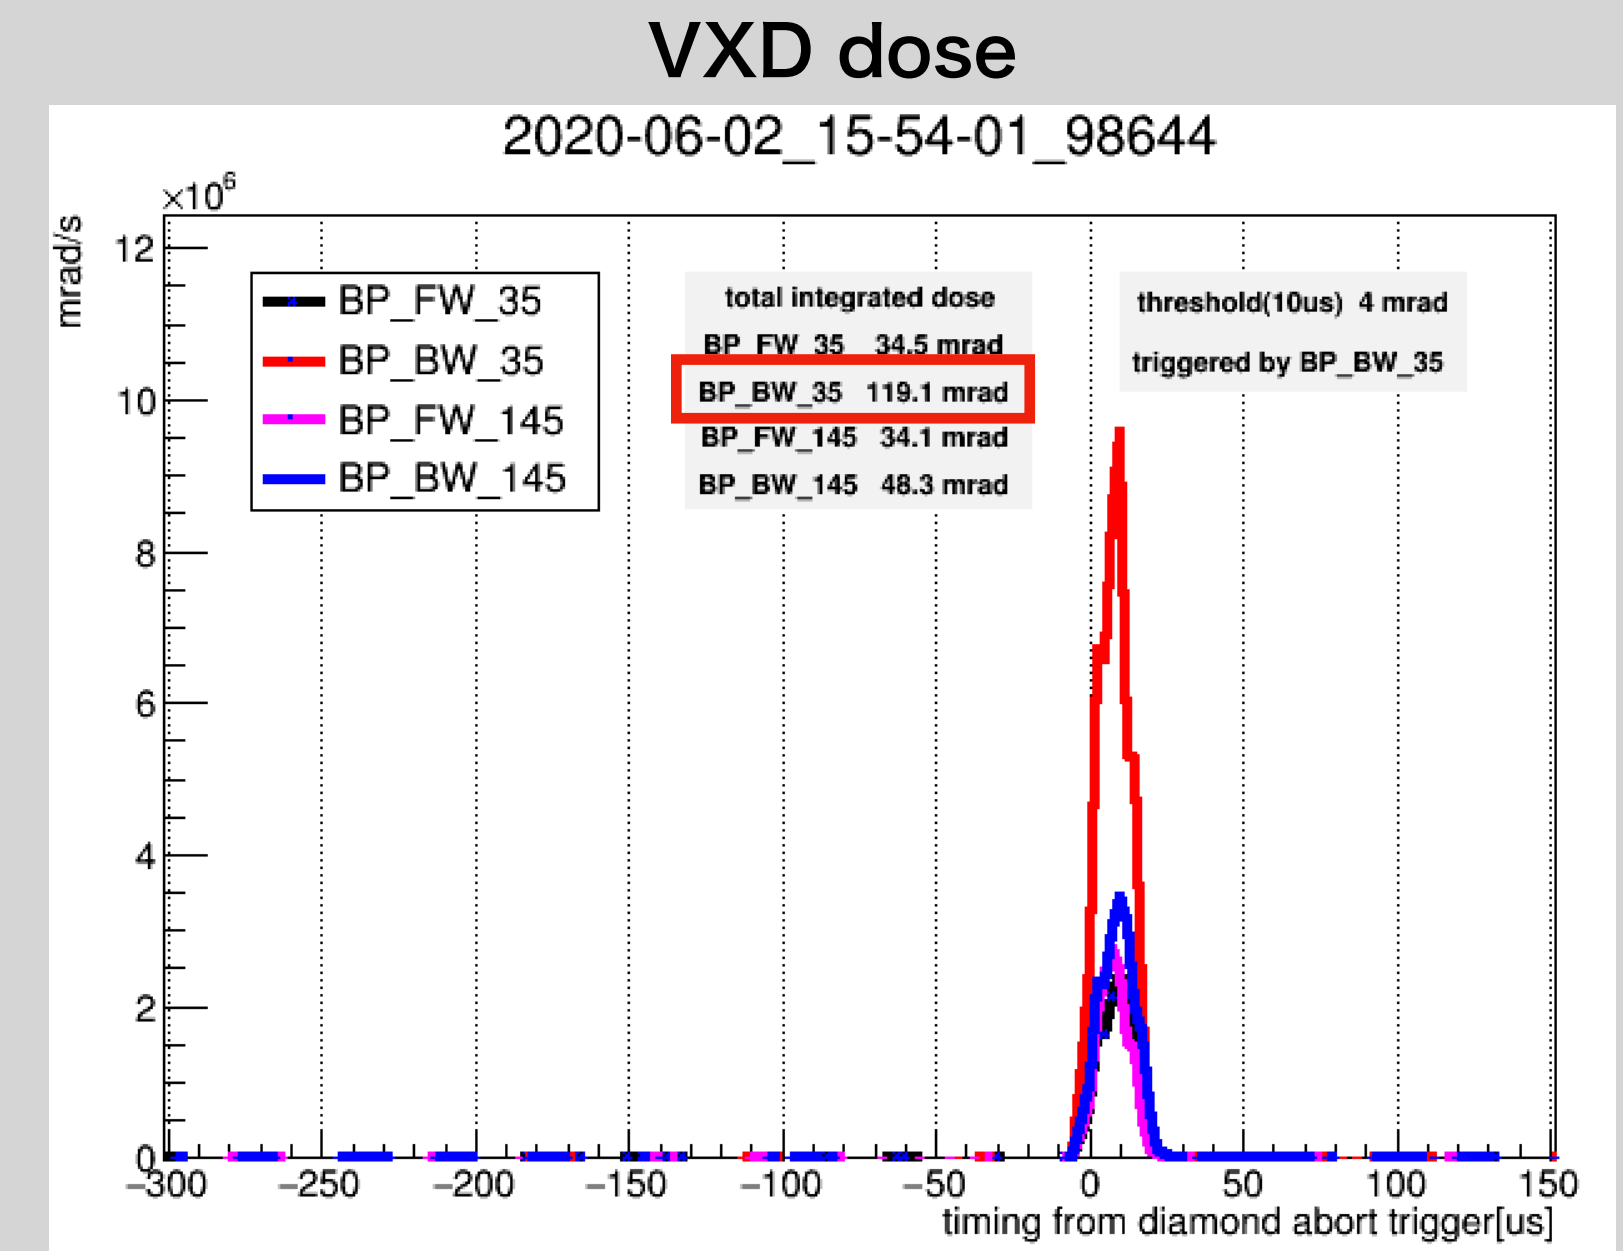
Tantalum jaw with 5 mm length

Reuse damaged tantalum jaws with short tip in D06V1 for 2021 ab

- We found the damage when we opened the collimator chamber for a carbon jaws' installation work in 2020 summer.
- There's a possibility that the jaws was damaged on 2020-06-02 15:54 (2020b).
 - Beam abort with pressure burst near D06V1 (LER: 546.8 mA, $\sim 4 \times 10^{-6}$ Pa).
 - Small pressure burst happened in D02V1 ($\sim 1.7 \times 10^{-7}$ Pa) and D06V2 ($\sim 5 \times 10^{-7}$ Pa).
 - VXD dose: ~ 119 mRad

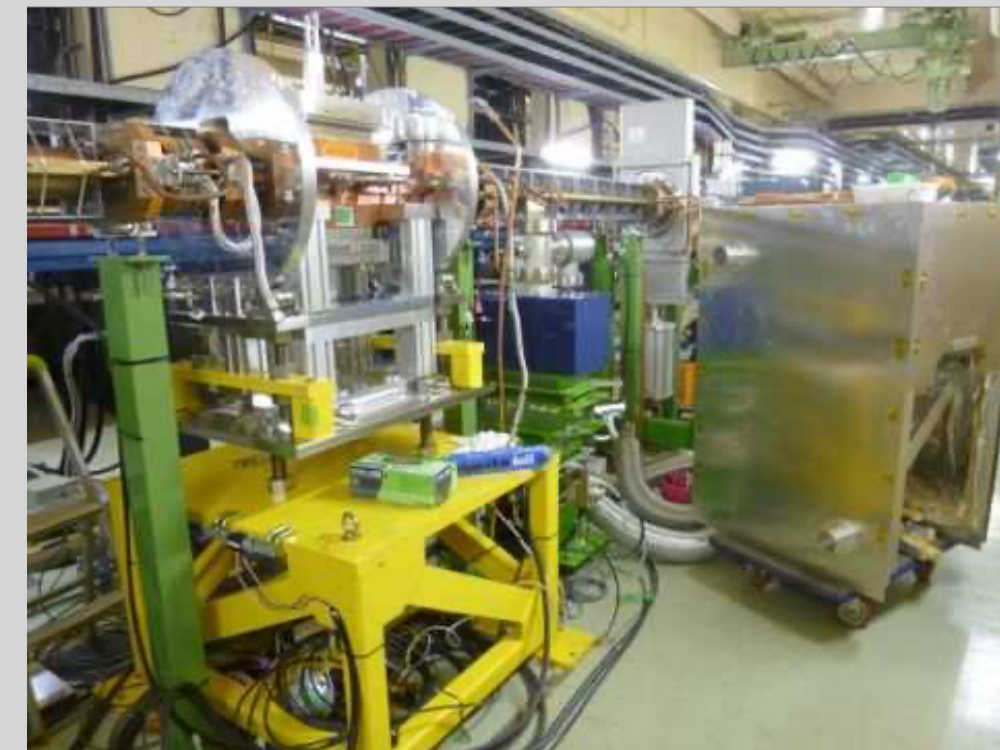
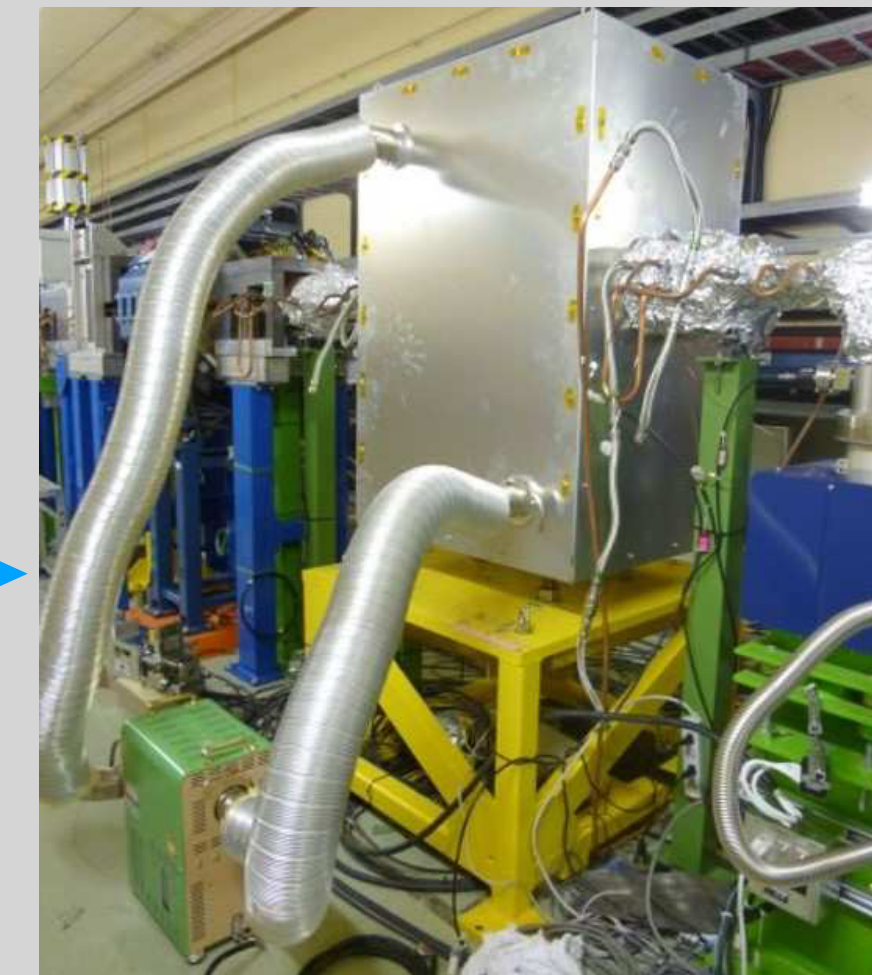
LER D02V1 in-situ baking

- Carbon jaws in D06V1 collimator were replaced with tantalum to reduce the impedance.
- In situ baking of D02V1 and D06V1 collimators to reduce the base pressure.

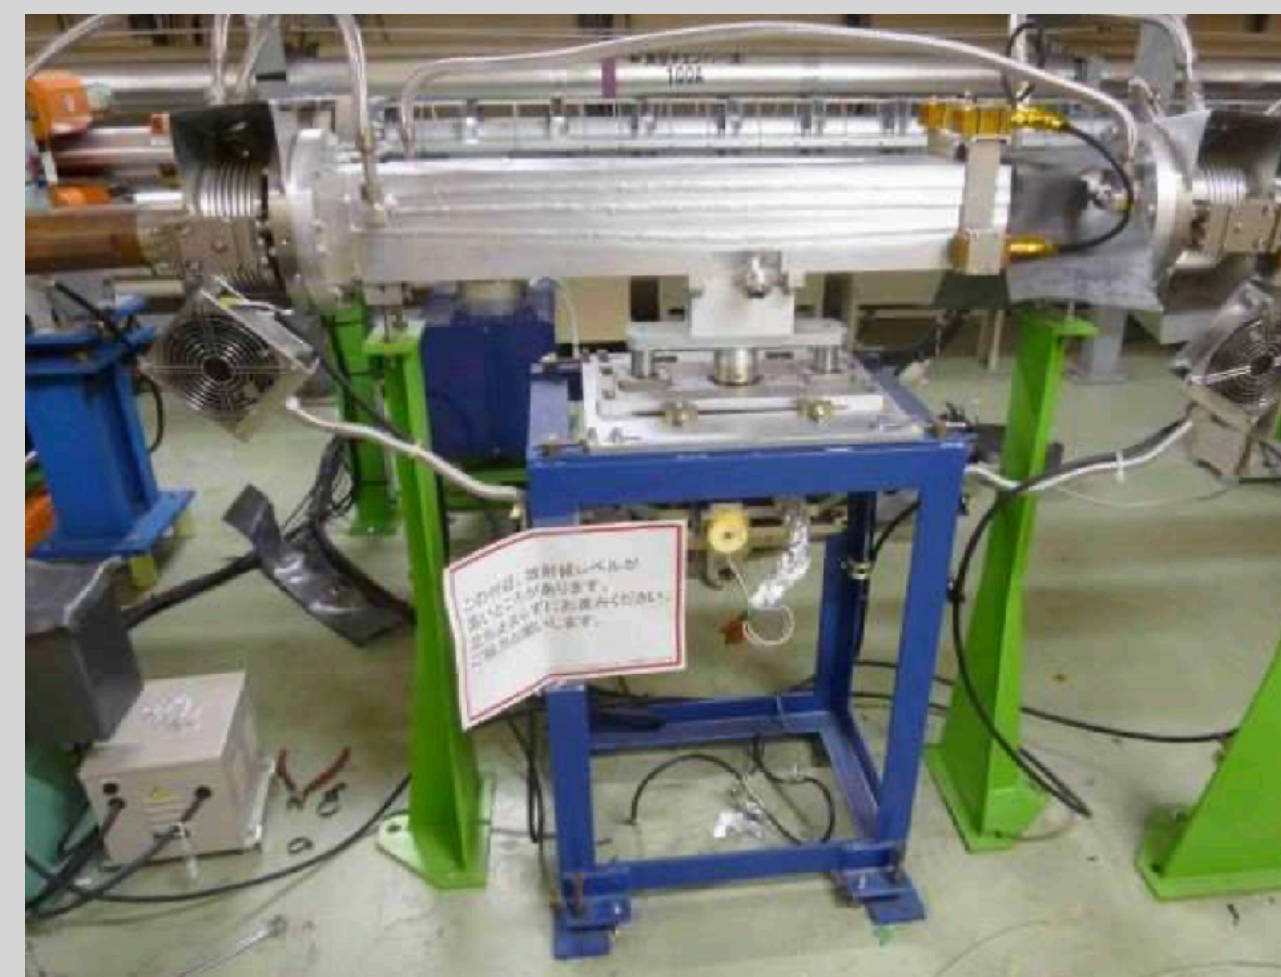
HER: D12V1 and drive mechanism - before

- Damaged jaw in D09V3 has been replaced with new one, which is copper coated titanium.
- Drive mechanism of D12V1 has been replaced with new one for precise positioning.

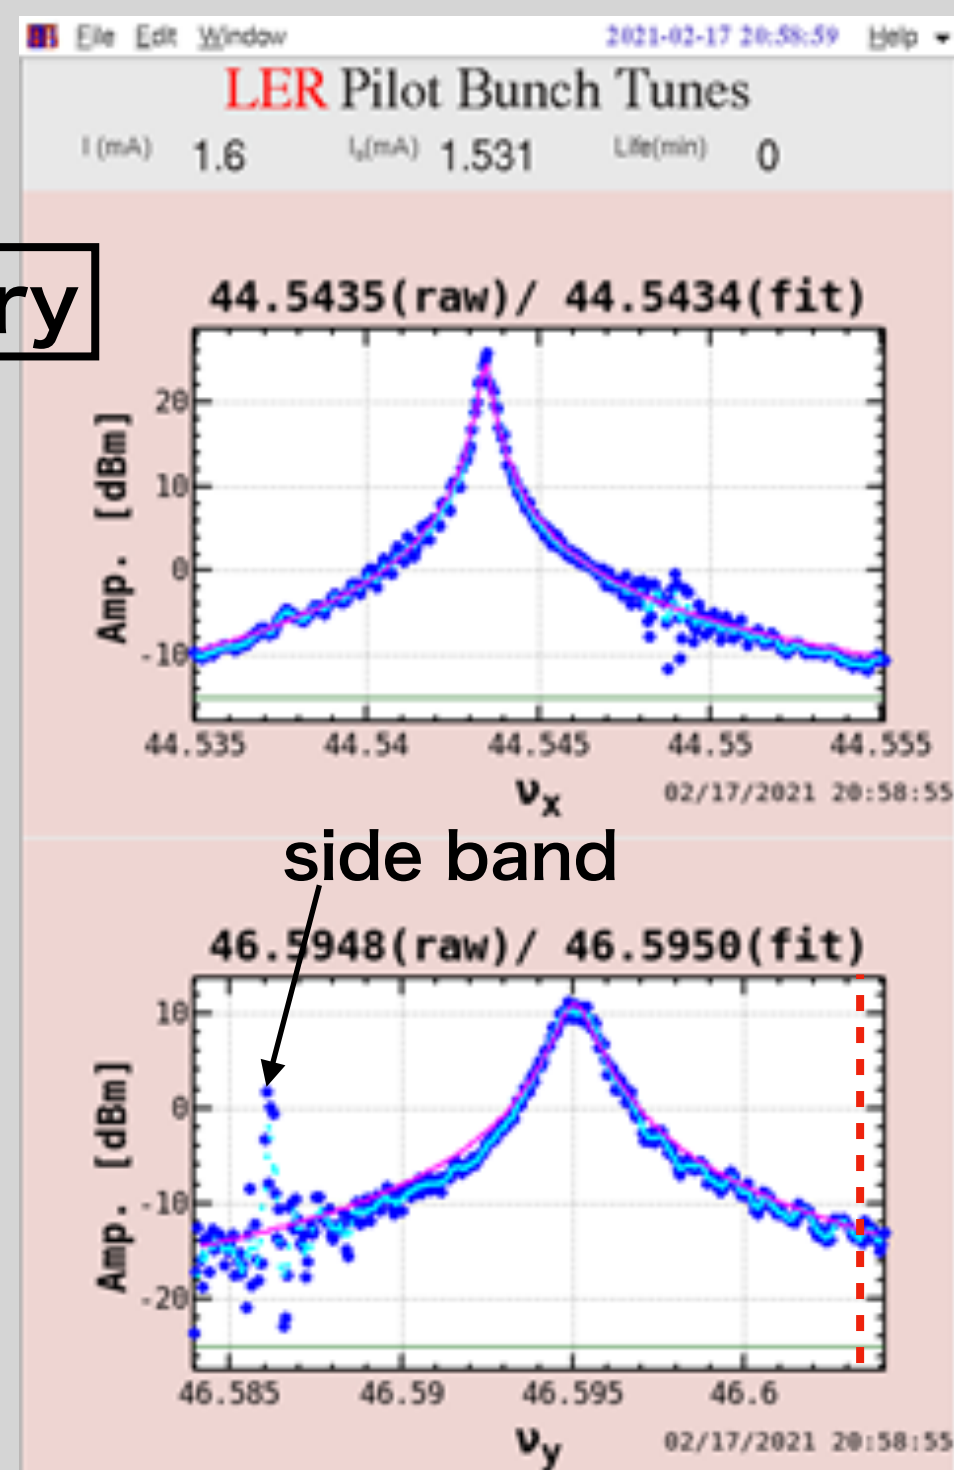
Tune shift: 0.008 mA⁻¹

We were not able to inject up to ~1.7 mA/bunch.

TMCI threshold (calc.): ~1.77 mA/bunch

Design: 1.44 mA/bunch

$\beta y^* = 8$ mm, single-bunch operation

- Tune shift measurement (see figure on lower left)
- High bunch current study (see figure on lower right)
 - remeasure them in the current situation (D06V1: Ta-5 mm)
- Chromaticity scan study [K. Ohmi]
 - measure the beam size and the threshold of the blowup with changing the chromaticity
 - ESRF, SOLEIL, NSLS-II operate with large positive chromaticity ($\xi > \sim 5$) and result in higher threshold (1 mA \rightarrow >10 mA) after 2000.

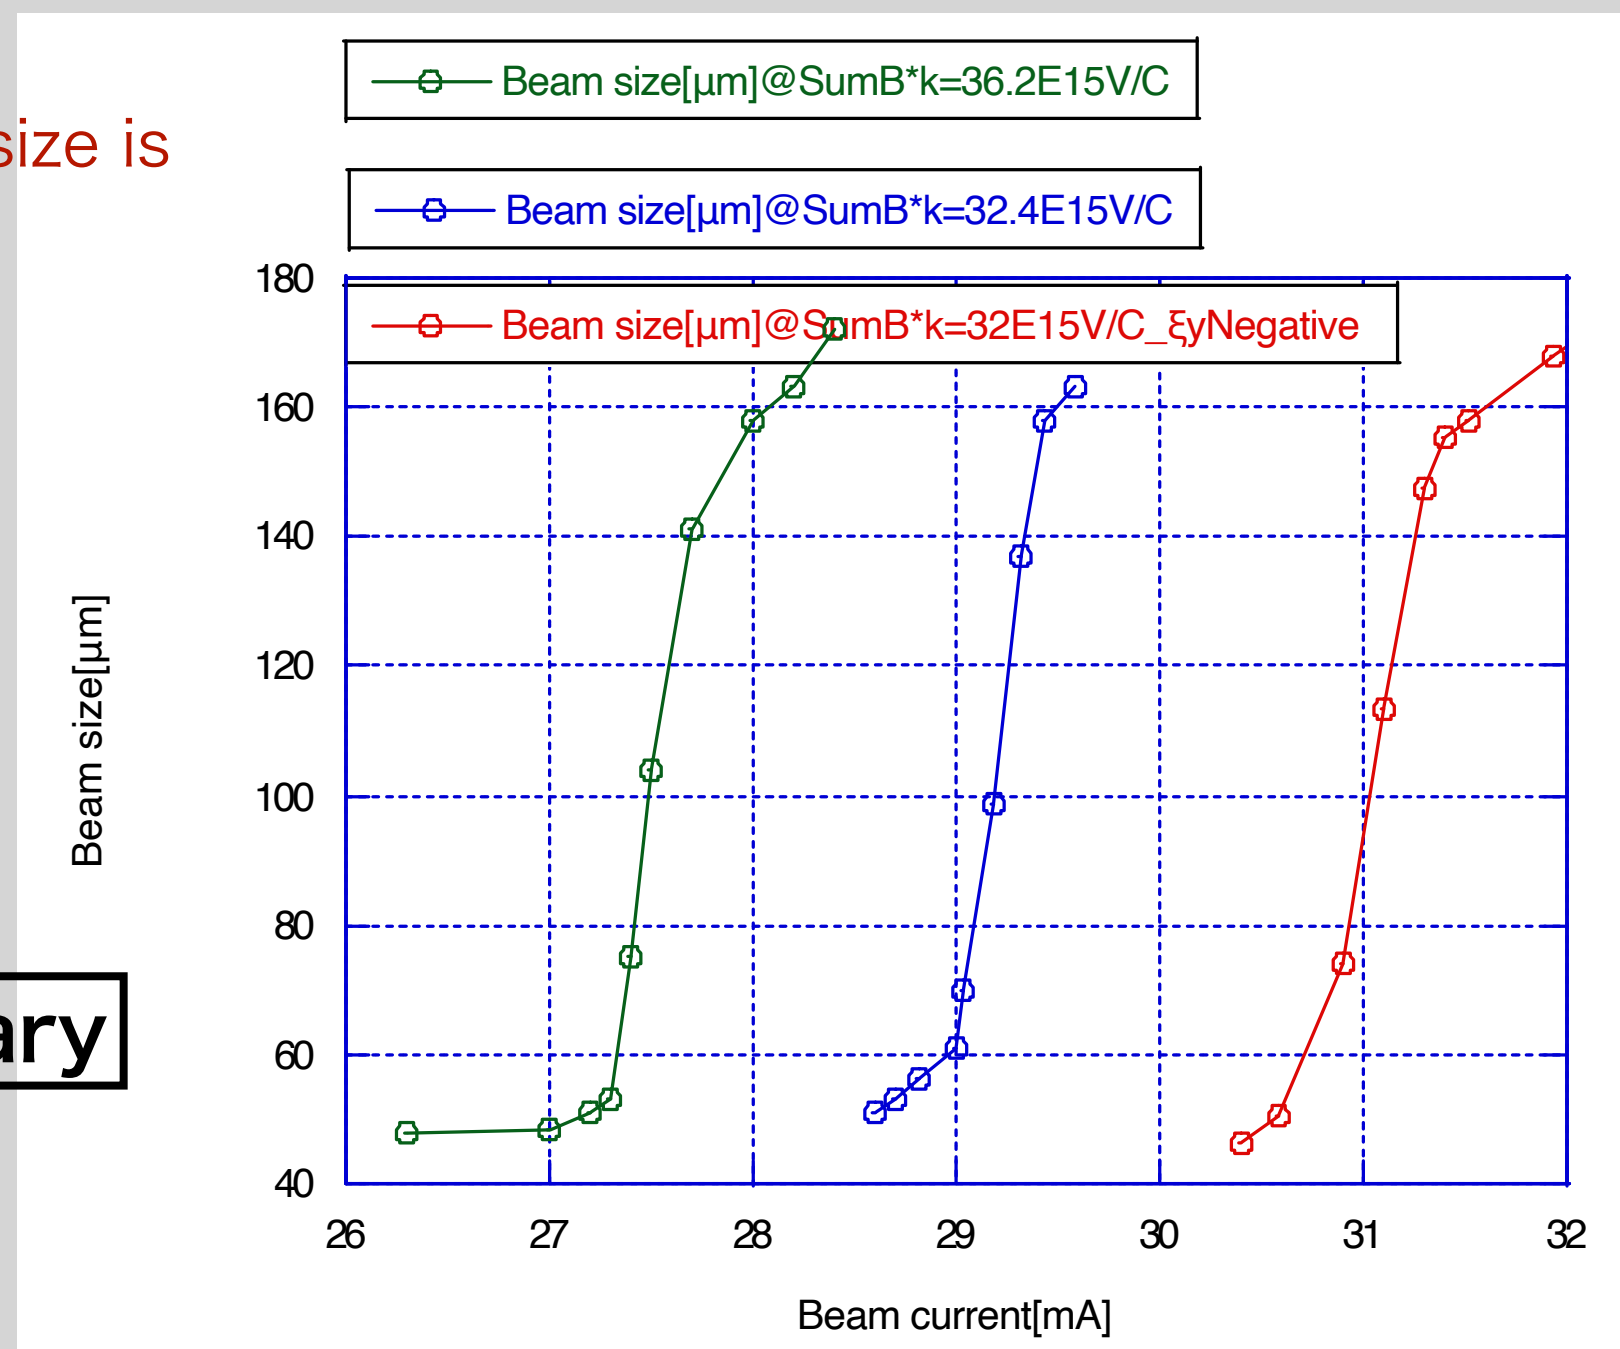
Threshold of the beam size is ~1 mA/bunch.

$\beta y^* = 2$ mm, 30-bunch operation
