Collimators and TMCI

15th annual Belle PAC Review meeting
Machine, MDI, Beam background, Operation plan
T. Ishibashi

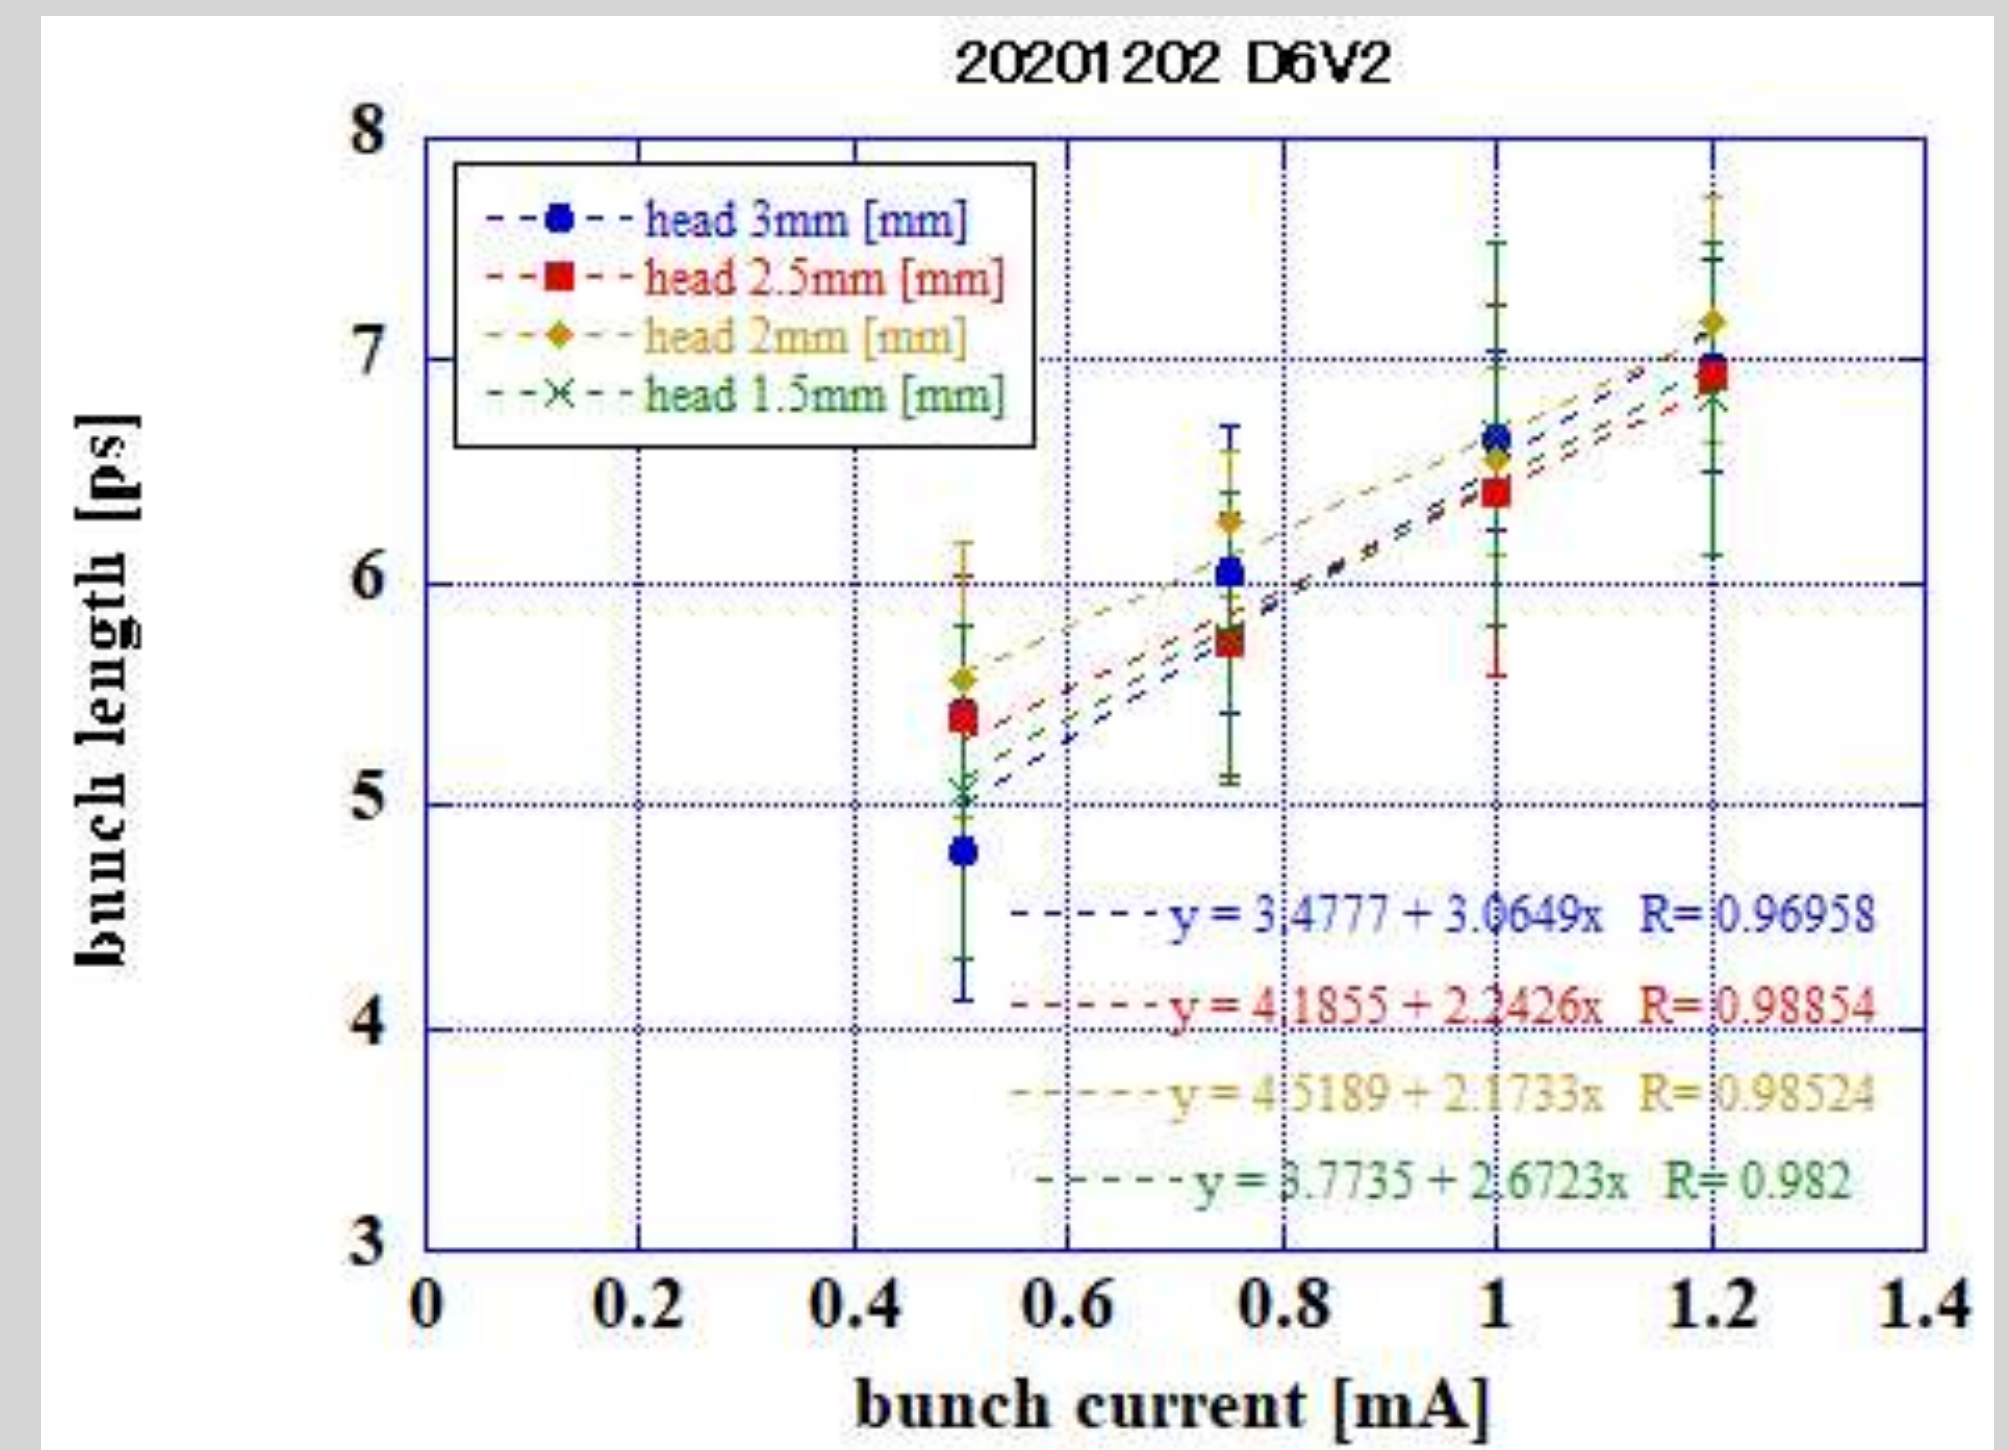
- We measured the bunch length in LER in the collimators' impedance study simultaneously.
- No correlation for the collimators' apertures.
- However, it's longer than expected.

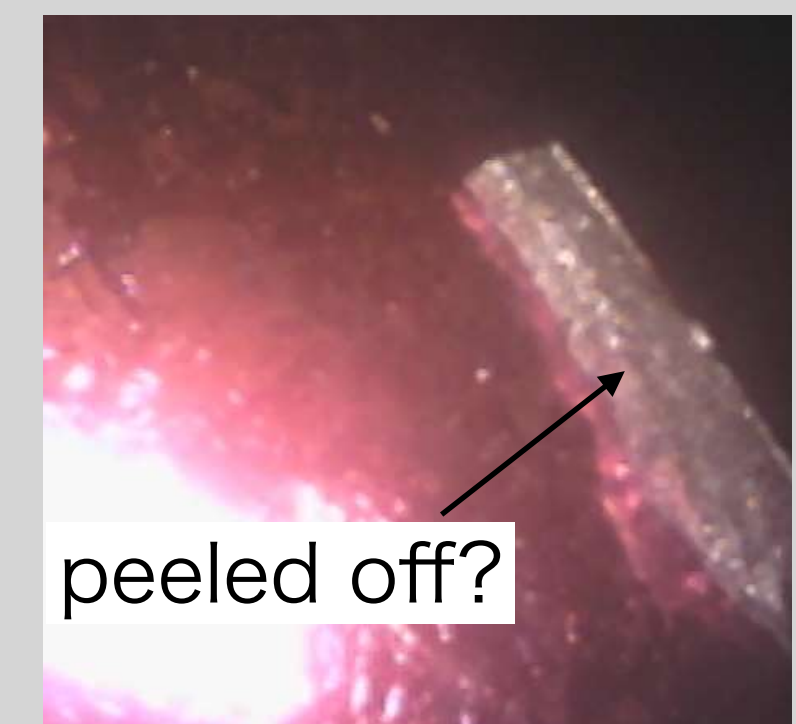
- 2020-12-14 0:55, beam abort (VXD diamond) with pressure burst at D06H3.
 - LER: 480 mA, HER: 449.9 mA
 - A part of the bunches was suddenly kicked (caused by a misfire in a kicker?)
 - There are no scars on the tip of D06H3 (tungsten) using a fiber scope after 2020c, but a part of the tip at the edge seems to be peeled off.

kicker misfire?

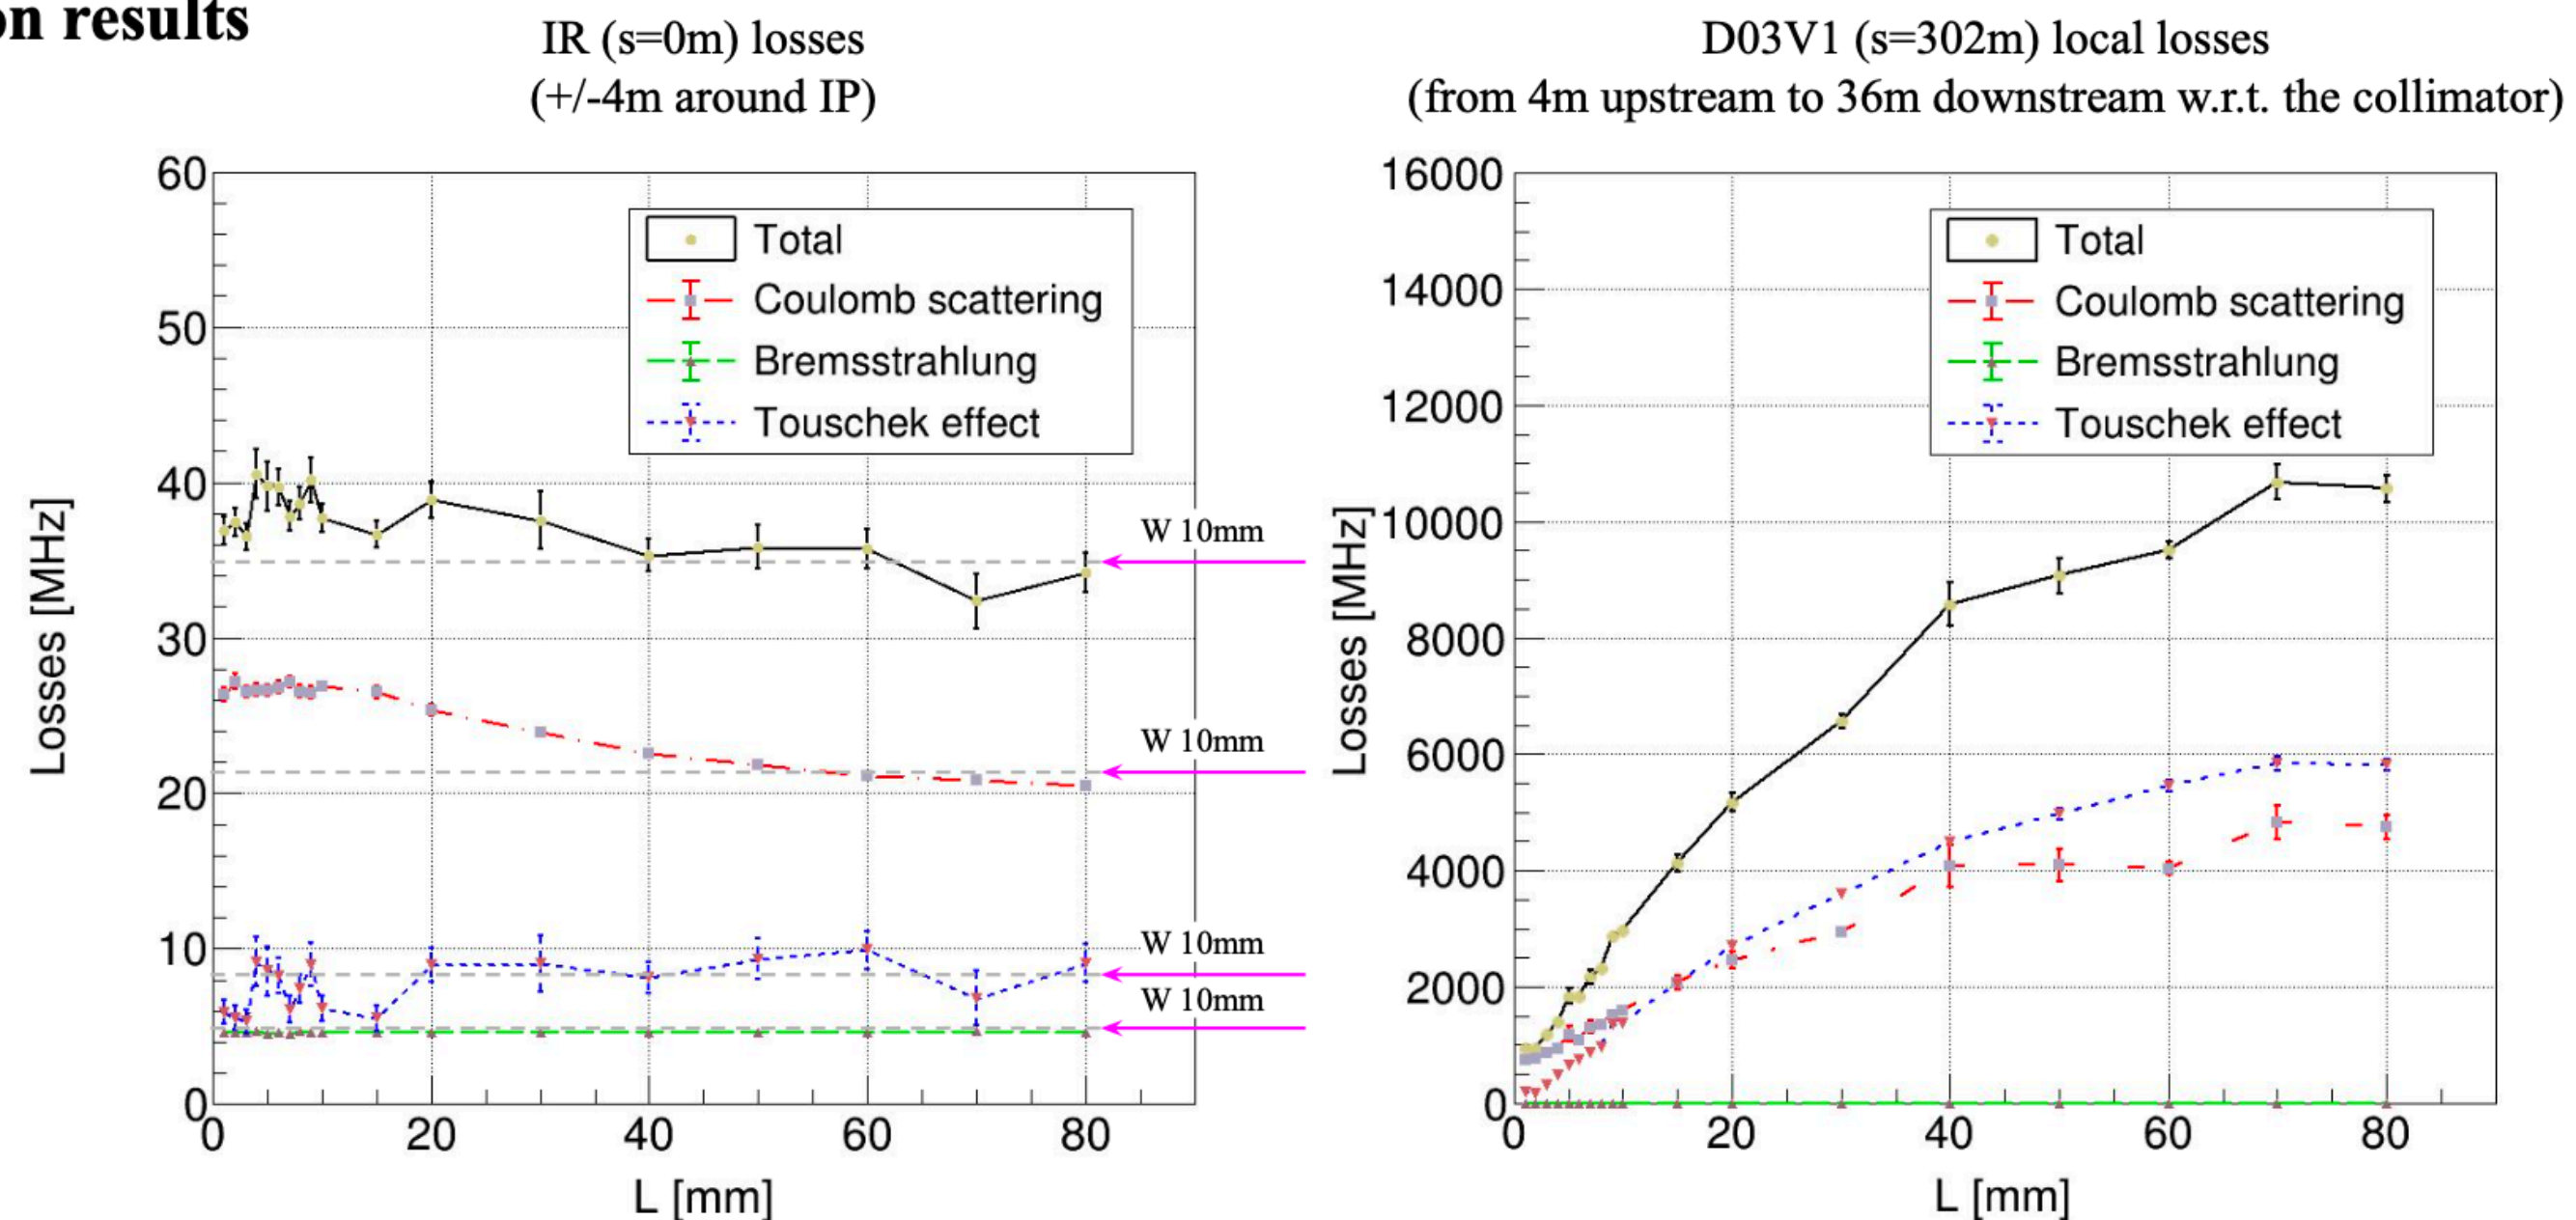
SAD simulation results

- We expect the same IR BG level with $L_z = 60\text{mm}$ for graphite head compared to tungsten with $L_z = 10\text{mm}$ (see ←).
- Changing the length of the tip-part of the collimator head:
 - Small reduction of IR losses:
 - $50\text{mm} < L_z < 80\text{mm}$ - flat Beam-gas losses behaviour.
 - $10\text{mm} < L_z < 50\text{mm}$ - almost linear dependence of Coulomb IR losses.
 - Increase of the local beam losses due to the absorption/collimation of stray particles and tip-scattering.
- Graphite radiation length (RL) = 19.32 cm

- Carbon with 60 mm length has almost same performance for the BG reduction as tungsten with 10 mm length.
- Carbon with 60 mm (~0.31 R.L.) is equivalent to tantalum with ~1.3 mm by the scaling.
- Is tantalum with 1.5-2 mm (0.36-0.5 R.L.) sufficient to reduce the BG? → need simulations

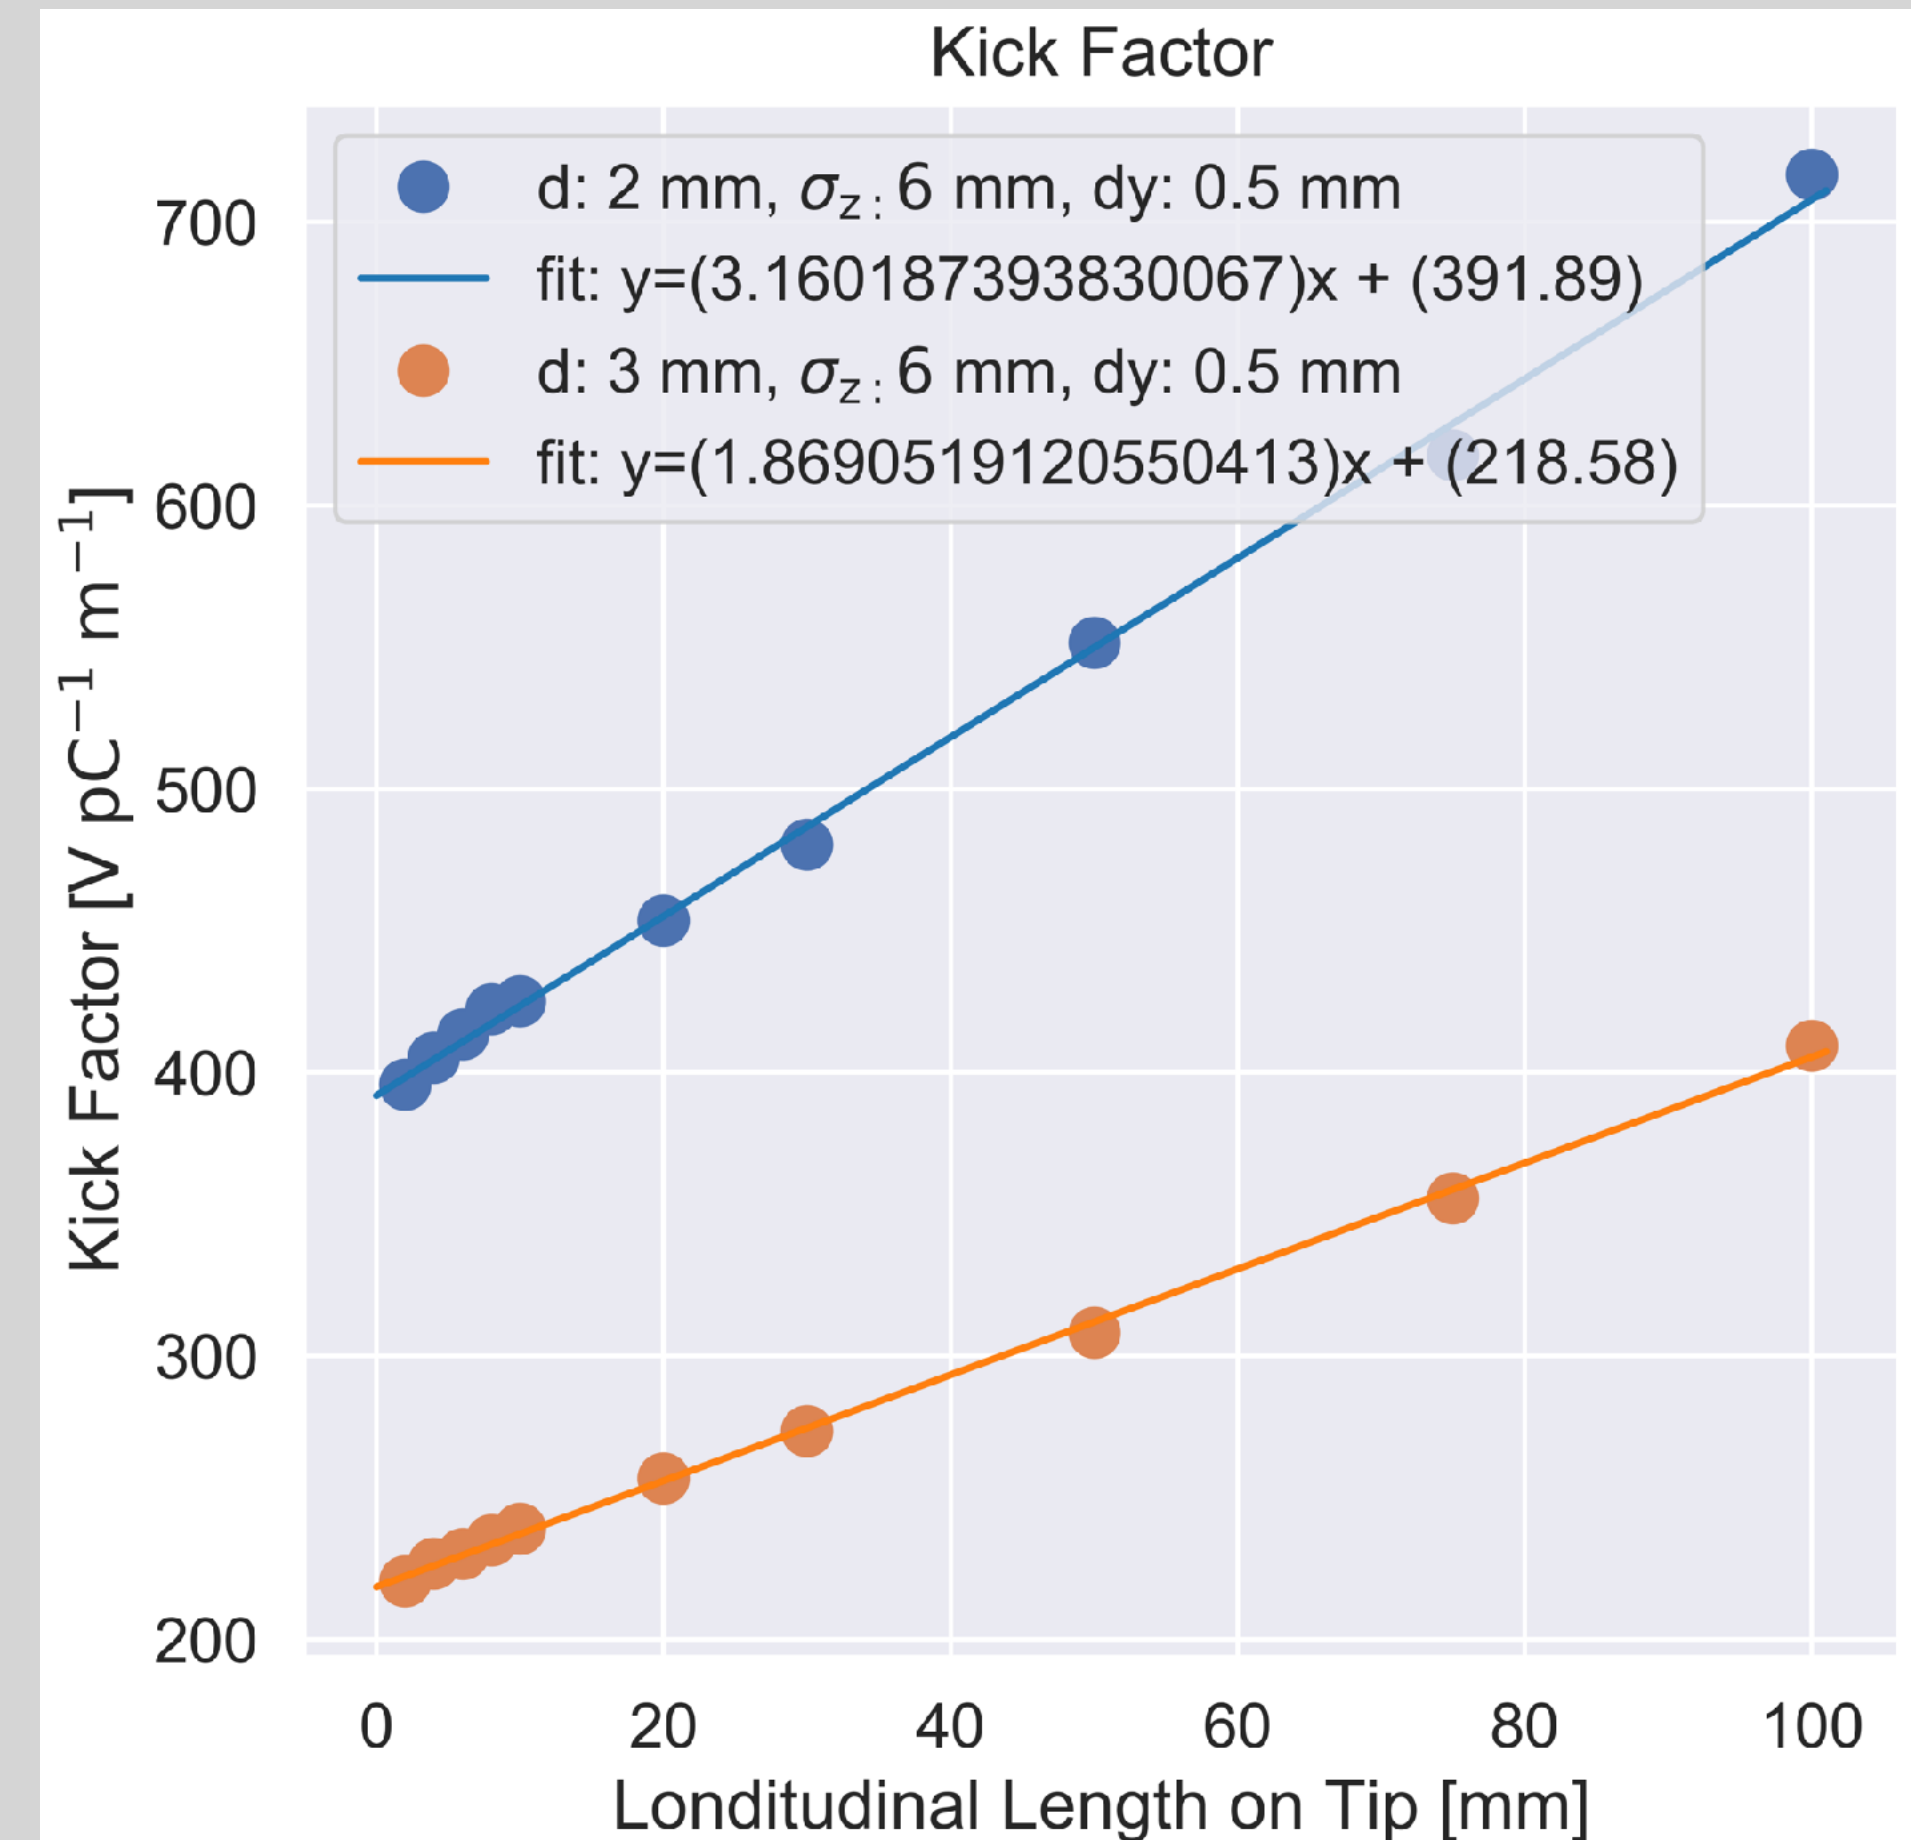
Short tip jaw - kick factor

- The kick factor of the 2 mm tip is ~7% smaller than that of the 10 mm tip.
- The kick factor of the 2 mm tip is ~30% smaller than that of the 50 mm tip.
