Issues in SuperKEKB Phase 2 Operation

Y. Funakoshi for the SuperKEKB commissioning team

Accelerator Laboratory, KEK

2018.10.15@B2GM

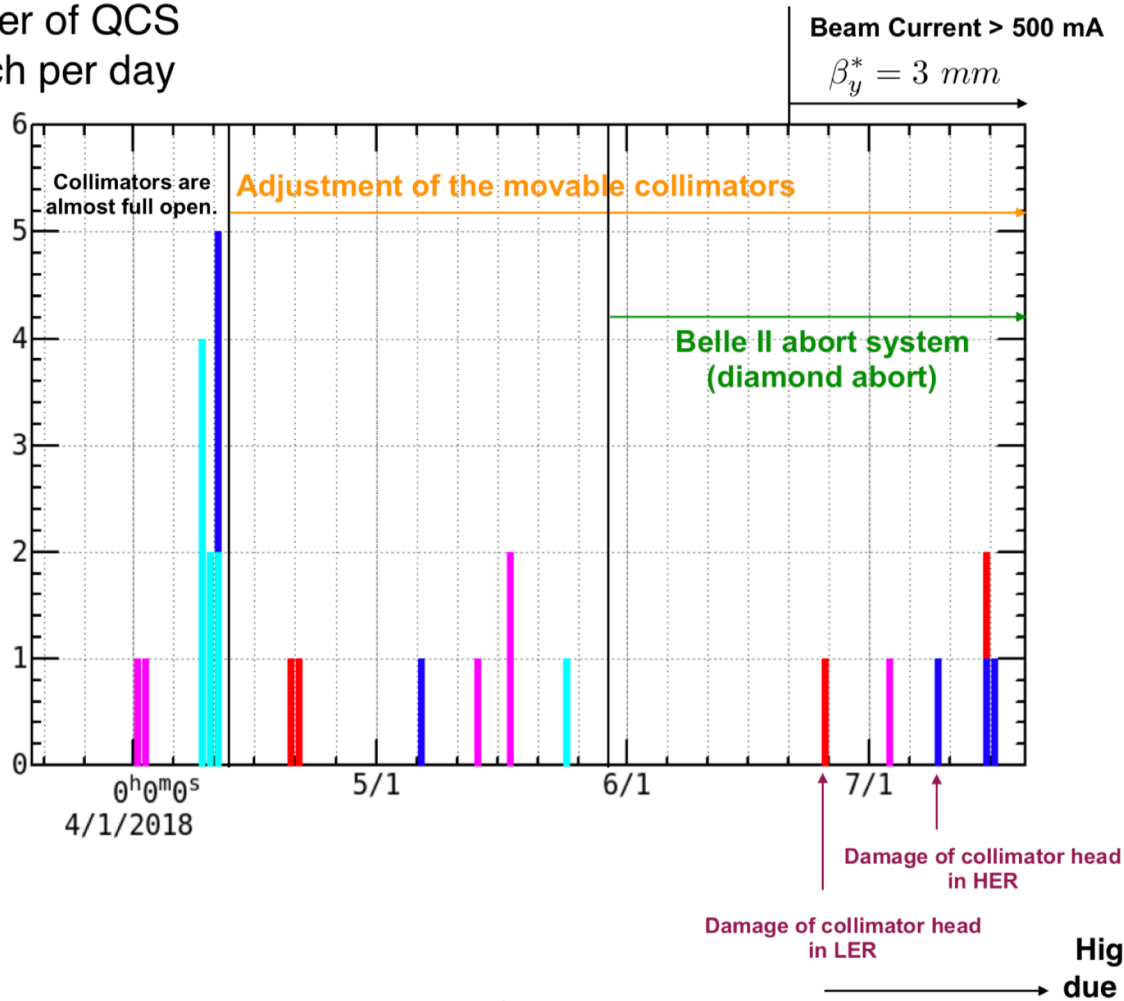
Frequency of QCS quenches

Number of QCS
quench per day

HER Injection
HER Storage
LER Injection
LER Storage

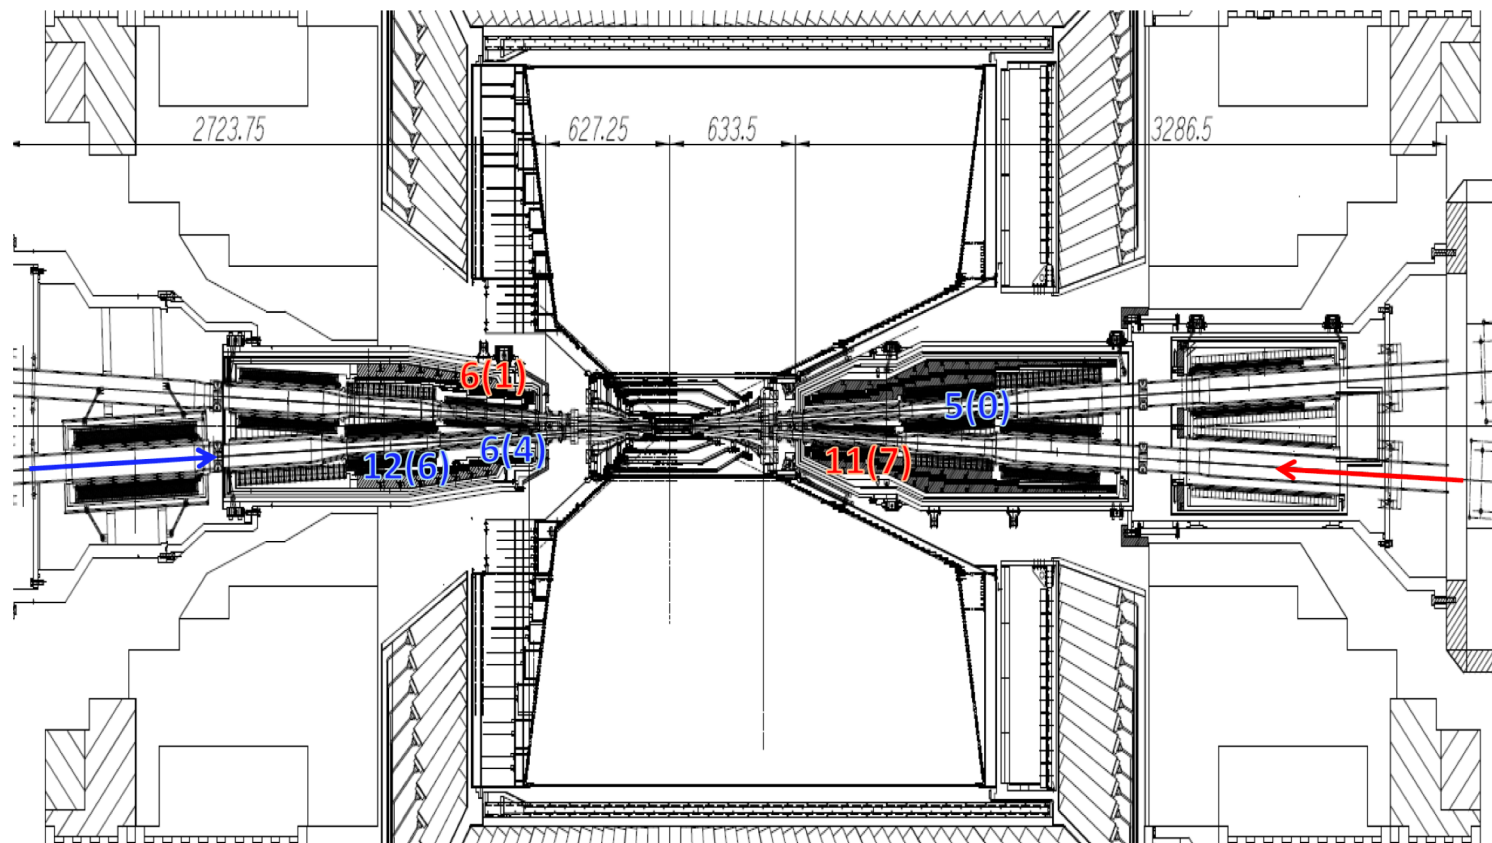
Locations of QCS quenches

- 5 quenches happened after June 25th.
 - 4 of them were induced stored beam accompanied with vacuum burst.
 - In 2 cases, beam hit vertical collimators and gave some damages.
 - The reason why beams hit collimators has not been understood.
 - No beam orbit change, no beam oscillation.
 - We suspect the dust trapping effect.

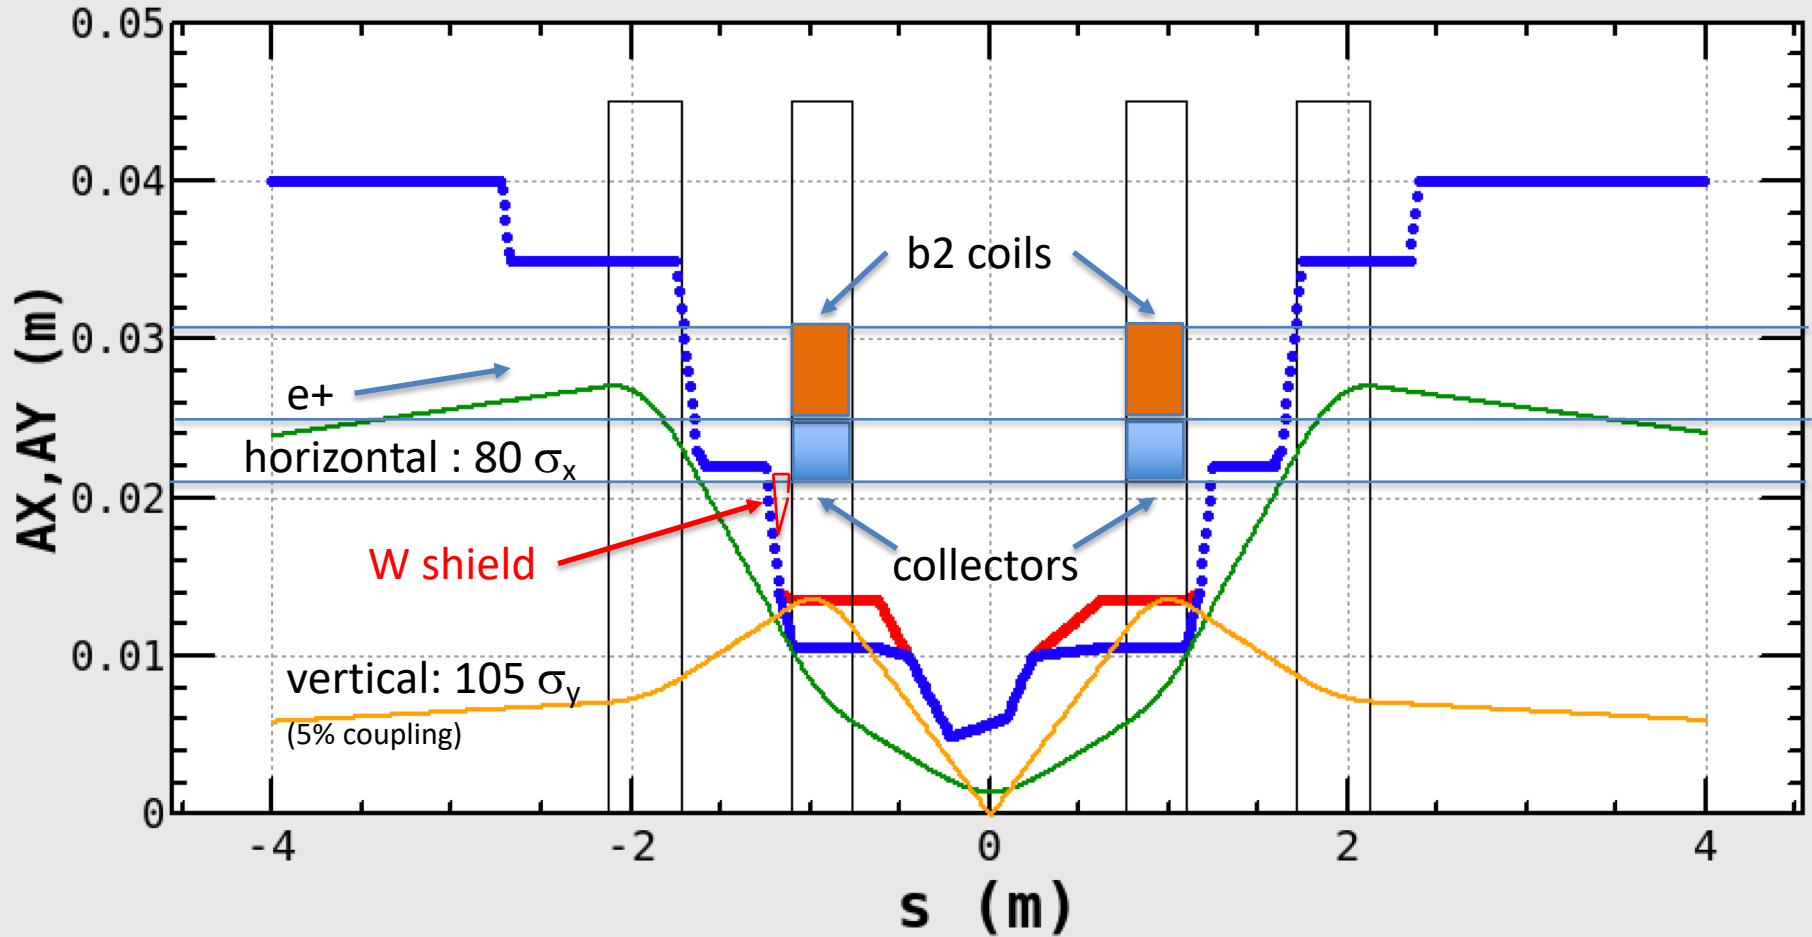
LER beam envelop

Quenches of downstream of IP: induced by horizontal oscillation?
Quenches of upstream of IP: induced by vertical oscillation?

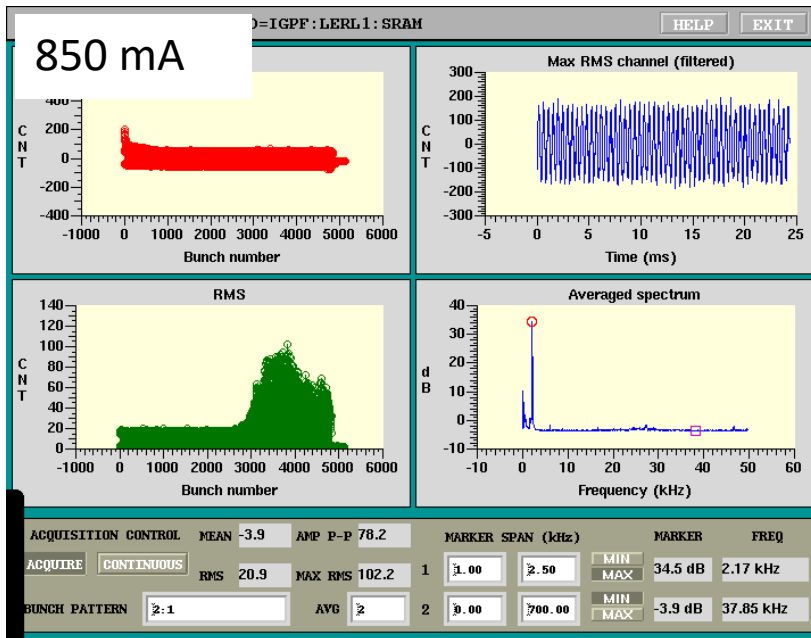
1576 bunch

When LER beam current exceeded 830mA, a longitudinal coupled bunch instability started to be observed.

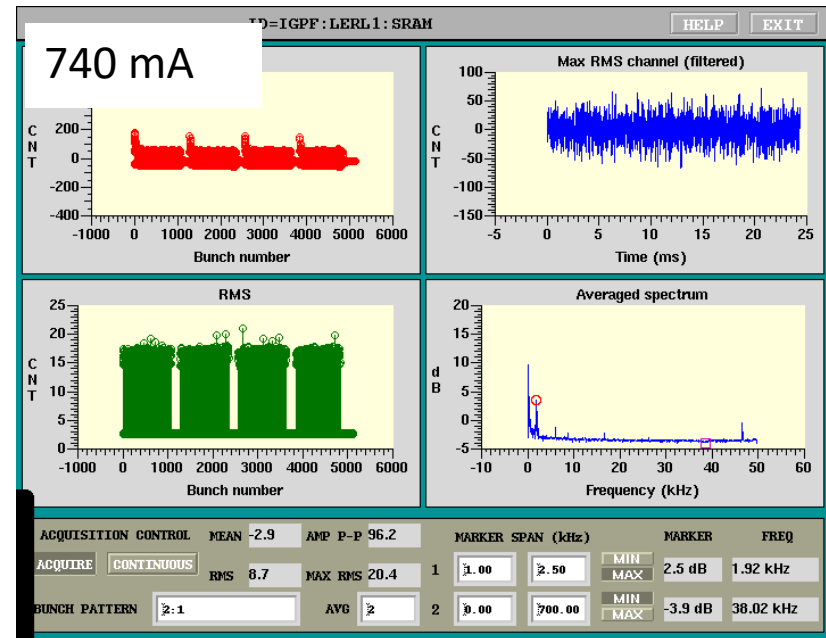
1372 bunch

With 4trains the instability was not observed with the same bunch current. But with a higher (total) beam current, the instability is induced again.

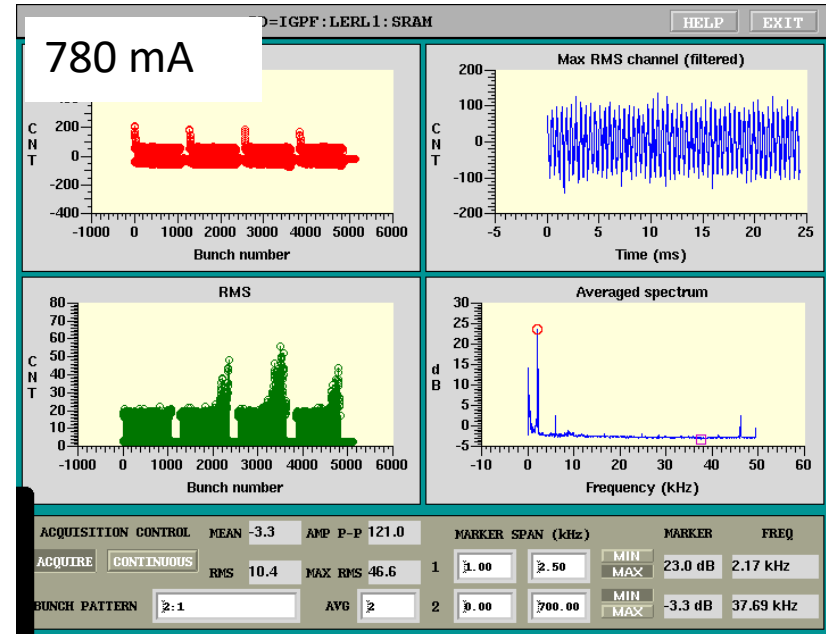
With changing D2H4 collimator setting, the instability became stronger.

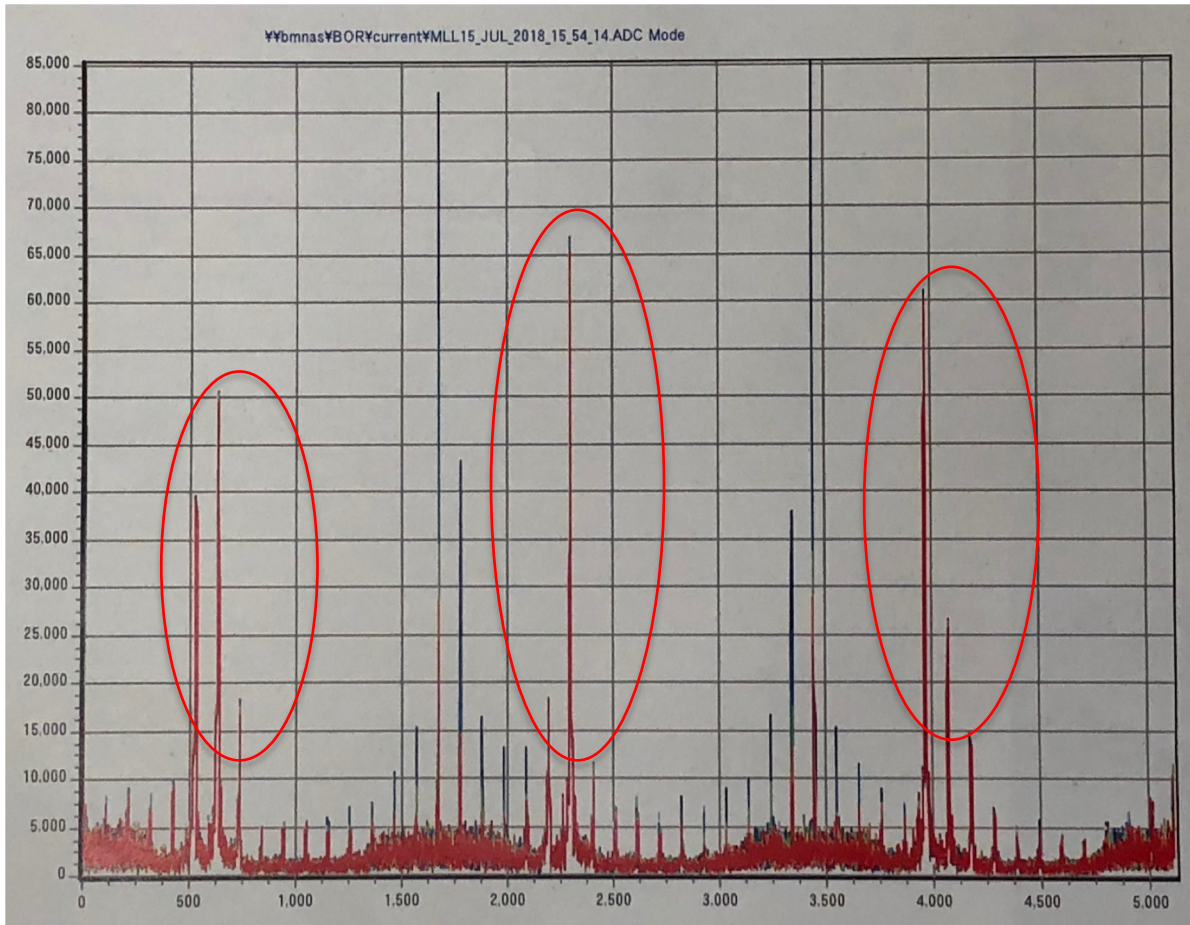
Spectrum when longitudinal instability occurred

Mode number = ~ 2300
This is not due to RF cavity.

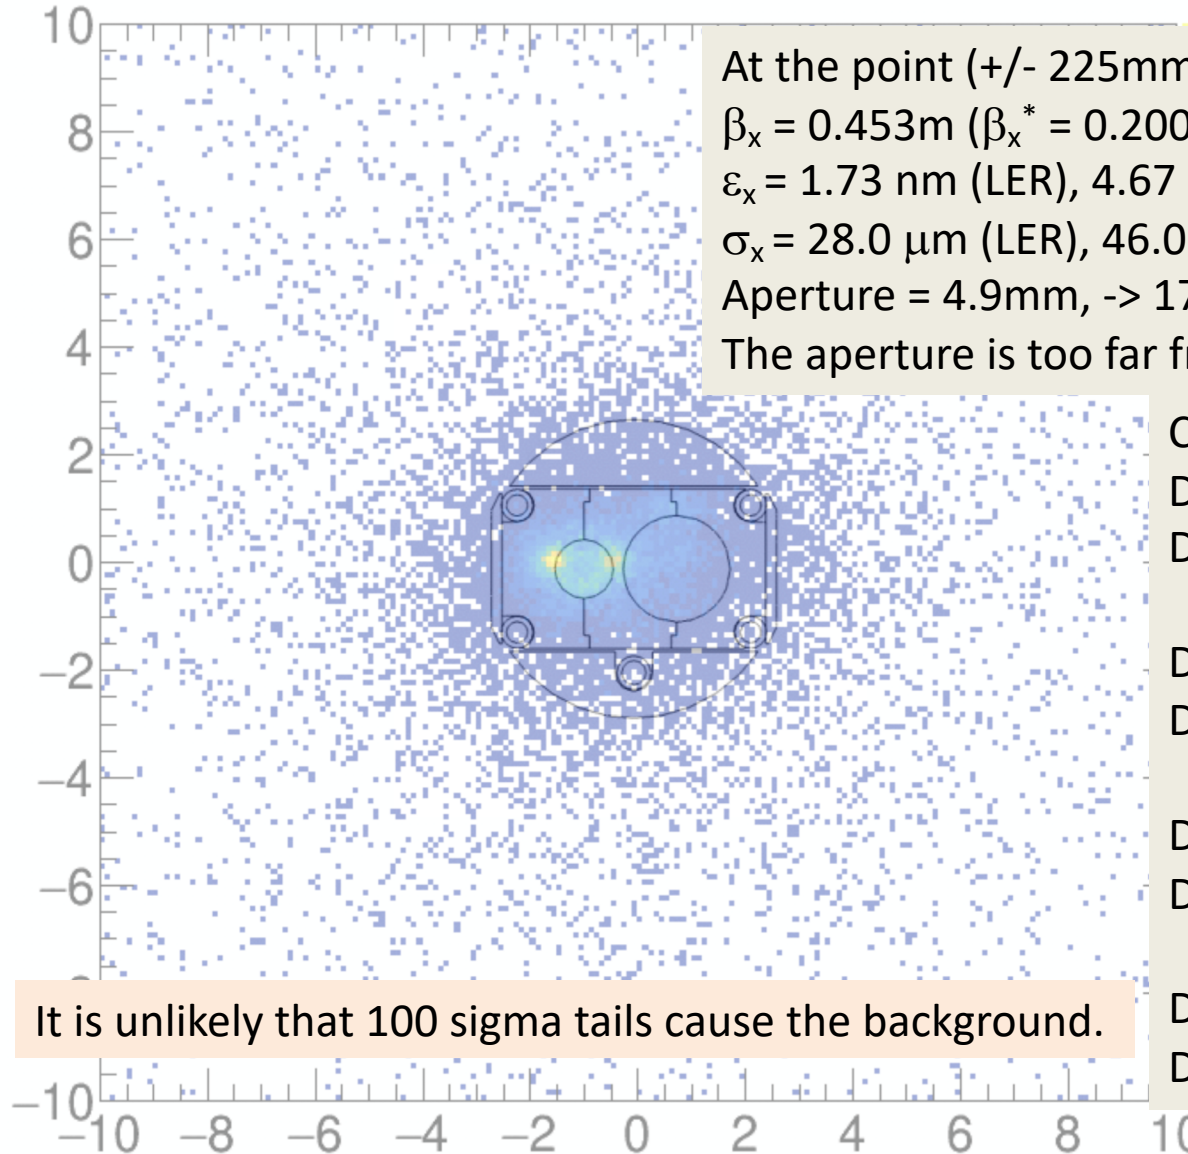
+225

At the point (+/- 225mm from IP)
 $\beta_x = 0.453\text{m}$ ($\beta_x^* = 0.200\text{m}$ at IP)
 $\epsilon_x = 1.73\text{ nm}$ (LER), 4.67 nm (HER)
 $\sigma_x = 28.0\text{ }\mu\text{m}$ (LER), $46.0\text{ }\mu\text{m}$ (HER)
Aperture = 4.9mm , $\rightarrow 175\text{ }\sigma_x$ (LER), $107\text{ }\sigma_x$ (HER)
The aperture is too far from the beam!

It is unlikely that 100 sigma tails cause the background.
